CHAPTER V

LANDSLIDE & ITS IMPACT ON ENVIRONMENT

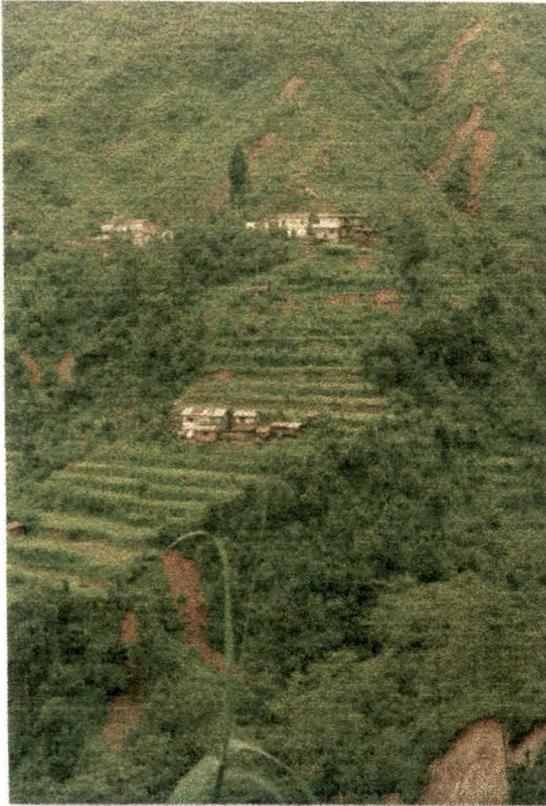
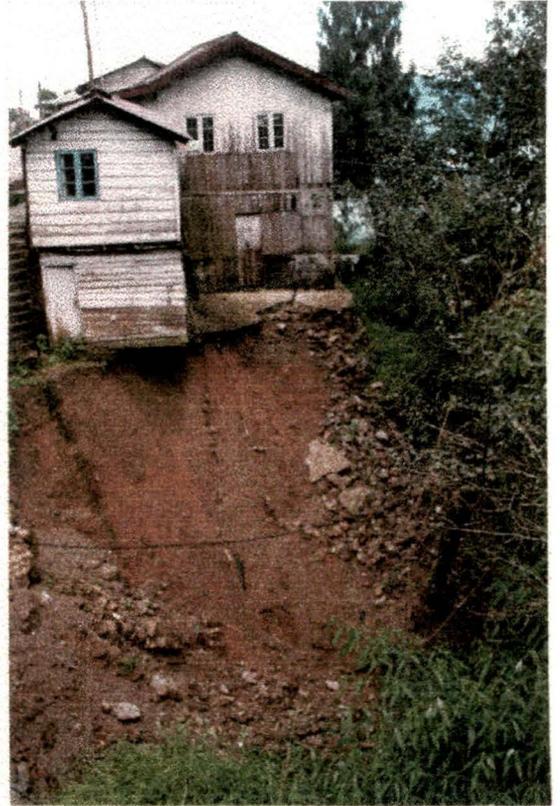
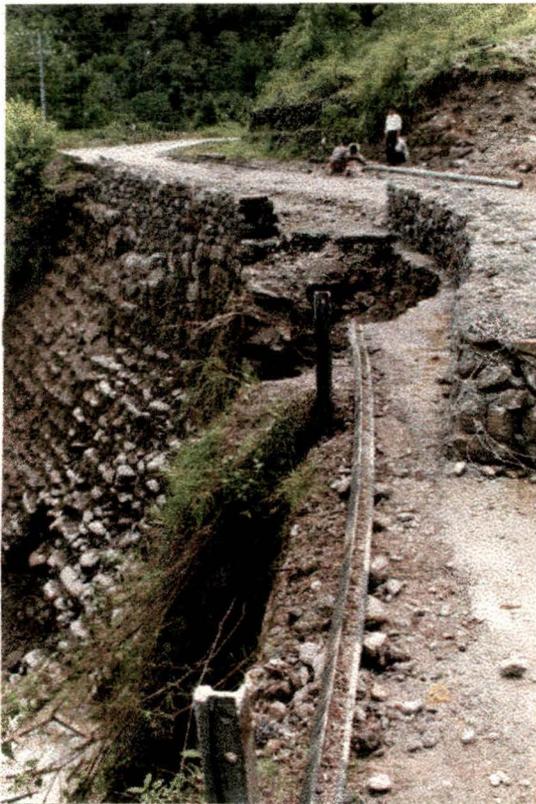
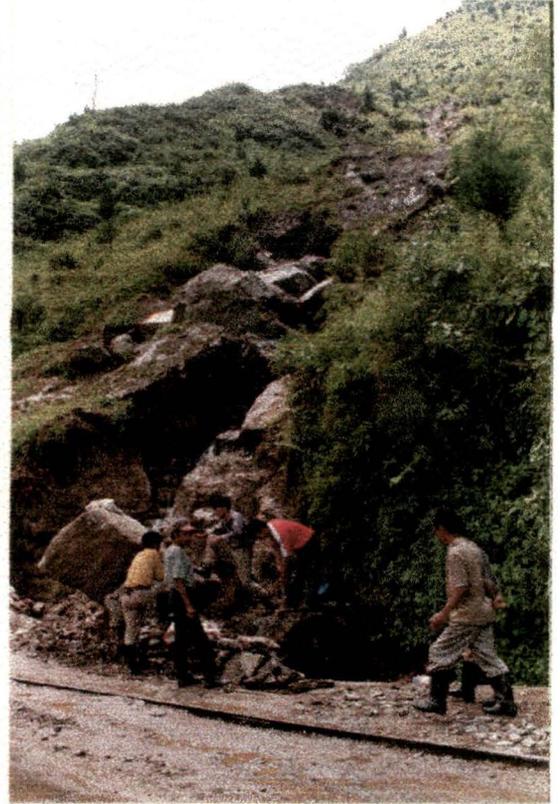
Photo. 5.1 Menace caused by Landslides around Kurseong

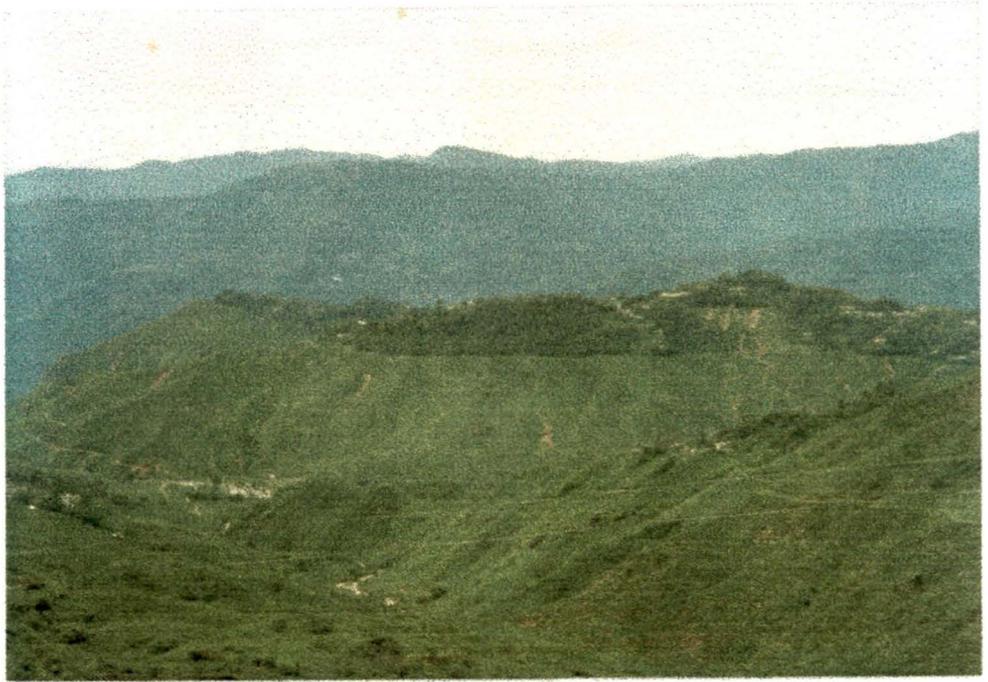
Photo. 5.2 **Landslide Scars in Hope Tea Garden**

Landslides occur in almost all types of slopes composed of various rocks in the Darjeeling Himalaya. Composite slides also take place involving soil or talus and underlying rocks. Slope failure is caused by shearing where the plane of shear taking the form of an arc of a circle in section leaving a parabolic outline of the slipped portion (Dutta, 1966). The most common occurrence of landslide is found along the springs (locally known as jhora) where, rock debris get detached from their parent body along the channel. Such channels later while carrying drainage water are generally widened by lateral erosion. Innumerable nalas (drainage channels) on hill slope developed due to slope failure and many landslides in some tea gardens and forests look like scars from a distance (Photo 5.2).

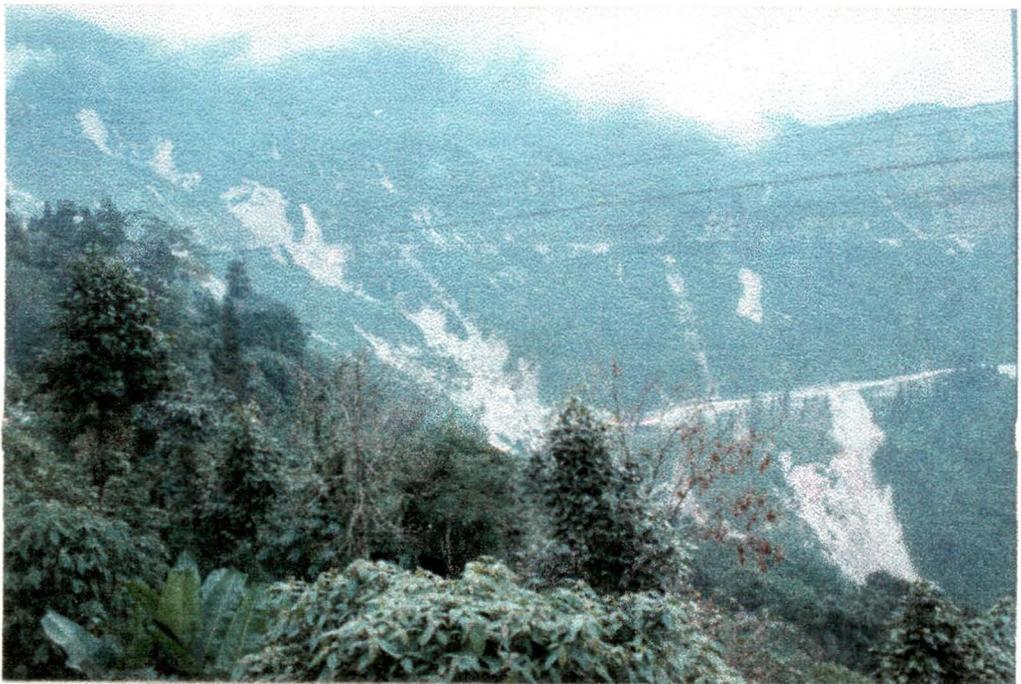
Photo. 5.4 **Slumping at Paglajhora**

Slumps generally have curved failure planes, and involve rotational movements of soil and rock materials. Slumping along many roads within the study area may be either due to the removal of basal support by water action or by overloading. Another potent cause of such slumping in the urban centre is due to human carelessness i.e., leakage of water pipe lines etc. Perhaps, the best example of slumping has been found near Paglajhora (Photo. 5.4).

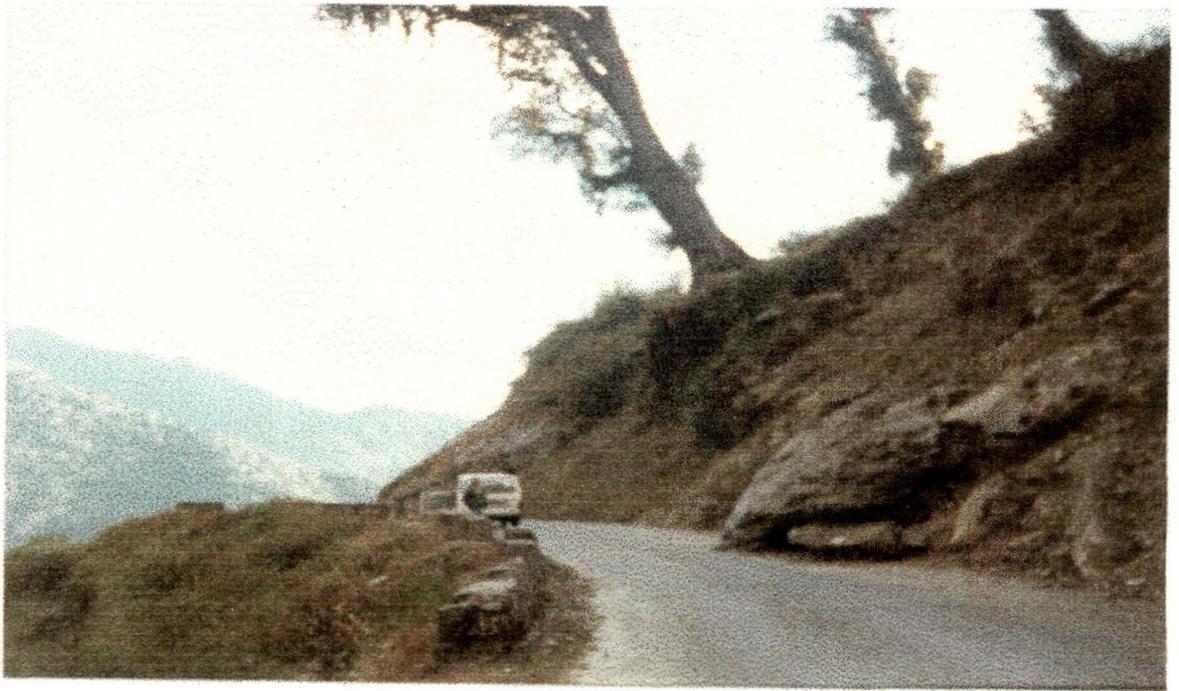
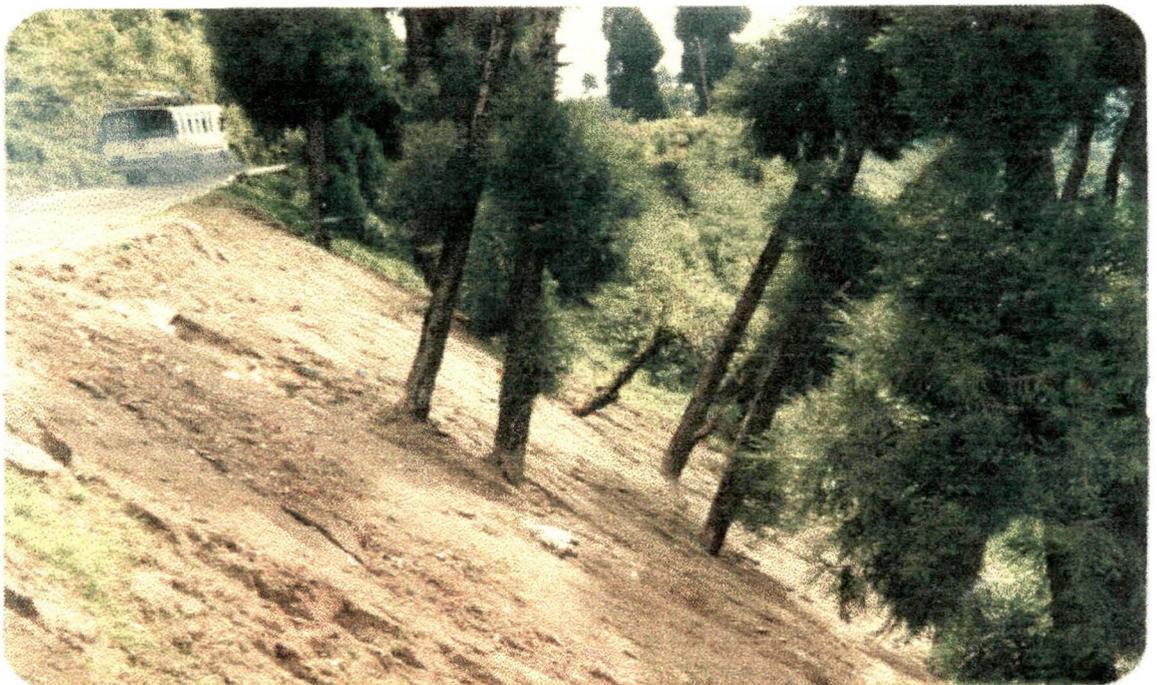
**Photo.5.3a
& 5.3b**

**Creeps developed on bedrocks
Creeps developed on superficial deposits**

The slow downslope movement of slope materials is called creep. This is usually imperceptible except to observations for long duration. The study area possesses many types of field evidences which have been held to demonstrate the existence of creep including outcrop curvature, tree curvature, tilting of structures and cracks (Photo. 5.3a & 5.3b). Creeping has often been found, above the T.N.Road near Mahanadi, Tung, near Sourini, south face of Dow Hills, Castleton T.G. below Sonada, Nagri, etc.

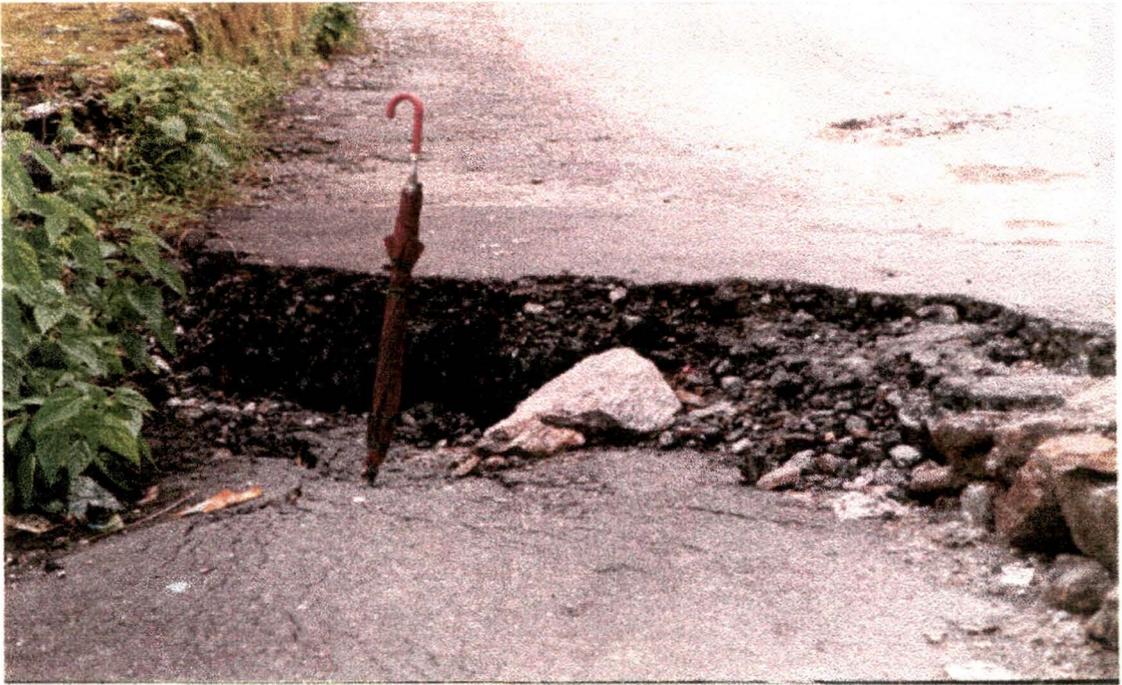
Photo. 5.5 Subsidence of T. N. Road near Dilaram in 1998

Apparent subsidence of the T.N. Road near lower Paglajhora (23rd. milepost) stretching for a length of about 500 meter was first recorded by Dutta in 1966. Evidences show that during 1950's disastrous landslides, a huge amount of debris was deposited below the T.N. Road, along the main Paglajhora. Subsequently, the river followed an underground channel draining through joints of the existing bedrock. Due to the enlargement of the underground passage through continuous erosion and corrosion, the basal support of the road is lost inducing the subsidence (Photo. 5.5). The rate of such movement has been estimated to be about 2.9 meters in between 1982-1986 (Basu & Sarkar, 1987).

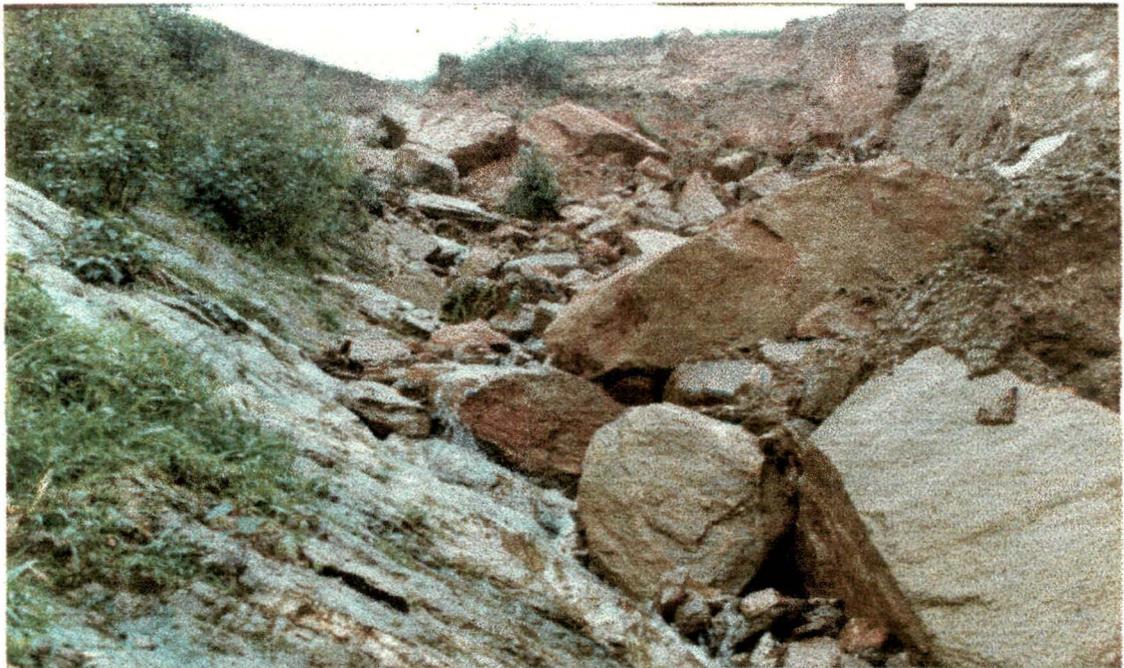
Photo. 5.6 Debris Slide near Mirik

Debris slides are generally of greater magnitude and are common and devastating too. Debris slide is caused along the weak plane even when they have gentler inclination than the "angle of sliding frictions" by the reduction of cohesion due to weathering and the rise of piezometric head. Debris slides are very common in and around Tindharia, Chunabhati, Mahanadi (Photo. 5.6).

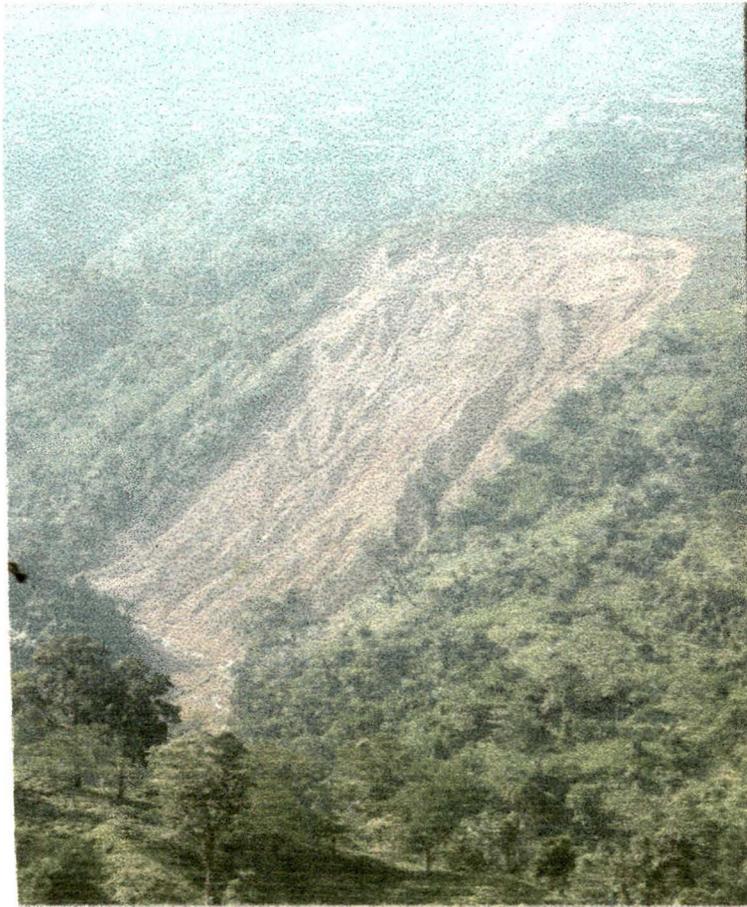
Photo. 5.8 Debris Flow near Tindharia

This is another very common form of landslide found in the Kurseong Sub- Division. Here, over saturated slope material slide down at very high speed (Photo. 5.8).

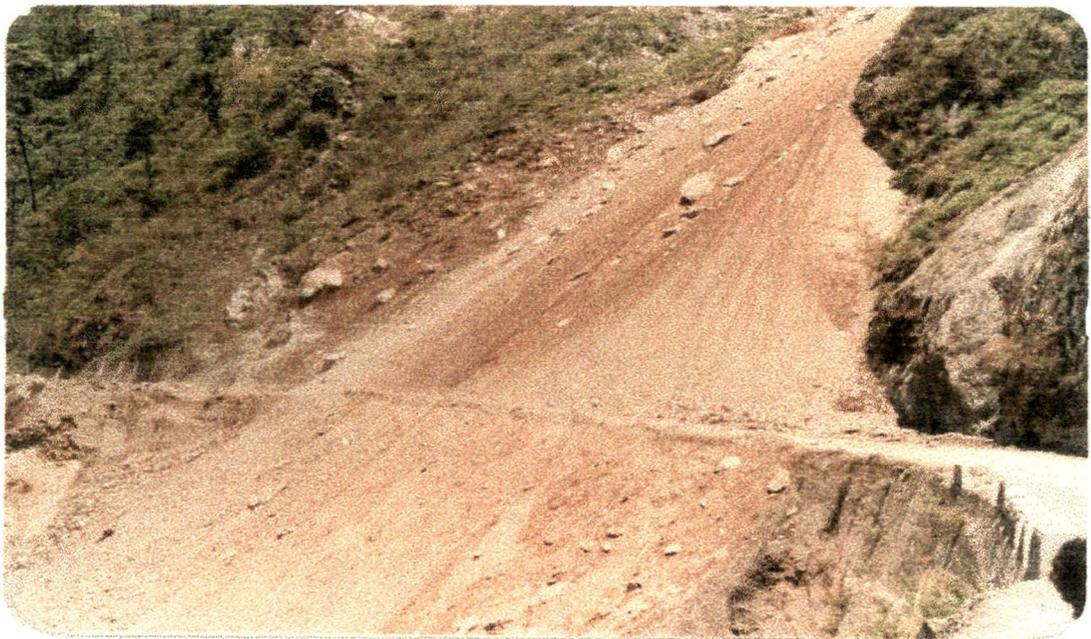
Photo. 5.7 Mud-Rock Flow along T. N. Road

rock flows. This type of landslide is very common in and around the lower Darjeeling Hills, particularly along the natural and artificial waterways (Photo. 5.7).

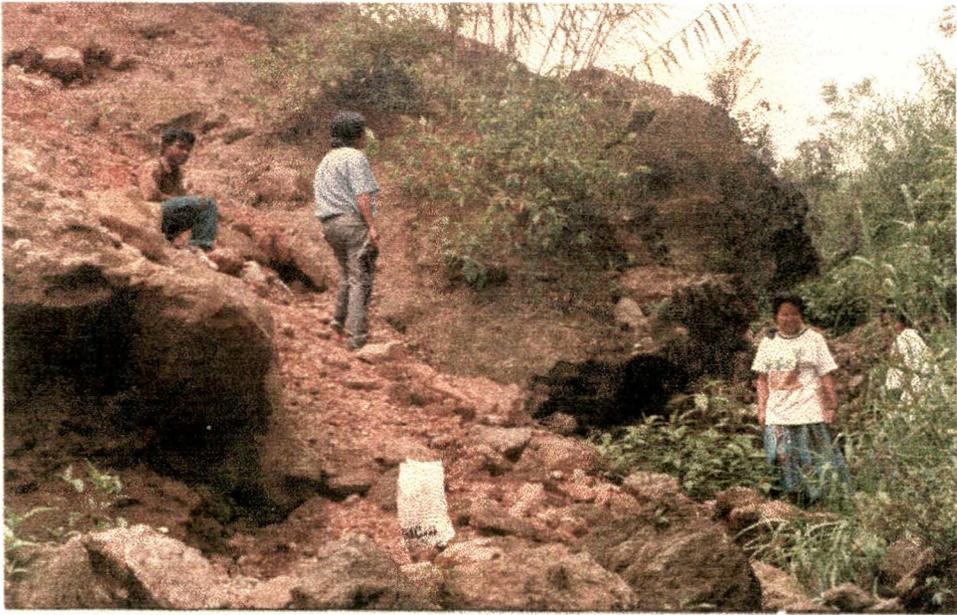
Photo. 5.9 **Landslide at St. Mary's Hill**

On the August 26, 1994, following heavy shower amounting 56.3 millimetres within a period of 1 hour and 35 minutes, with a maximum intensity of 55mm/h^{-1} , recorded at Dilaram, the hill slopes at 4.2 kilometres from Kurseong to Darjeeling, on the right hand side of the Tenzing Norgay Road, experienced a devastating landslide (Photo. 5.9). disrupting the traffic flow from Kurseong to Darjeeling (Fig. 5.3 & 5.4).

The basal support of the steep slopes due to construction of roads have to be strengthened by construction of proper retaining walls which should be regularly maintained. The steep slopes caused by the landslide have to be re-graded to gentle slopes over which grasses and quick growing shrubs and trees can be grown along the contours. The flow of jhoras has to be controlled by carefully designed guide walls and drop structures so as to minimise the scouring effect of water and toe erosion. Terrace cultivation near the landslide area and along the jhora banks should be discouraged. Cultivation near the household areas should be practised along contour terraces.

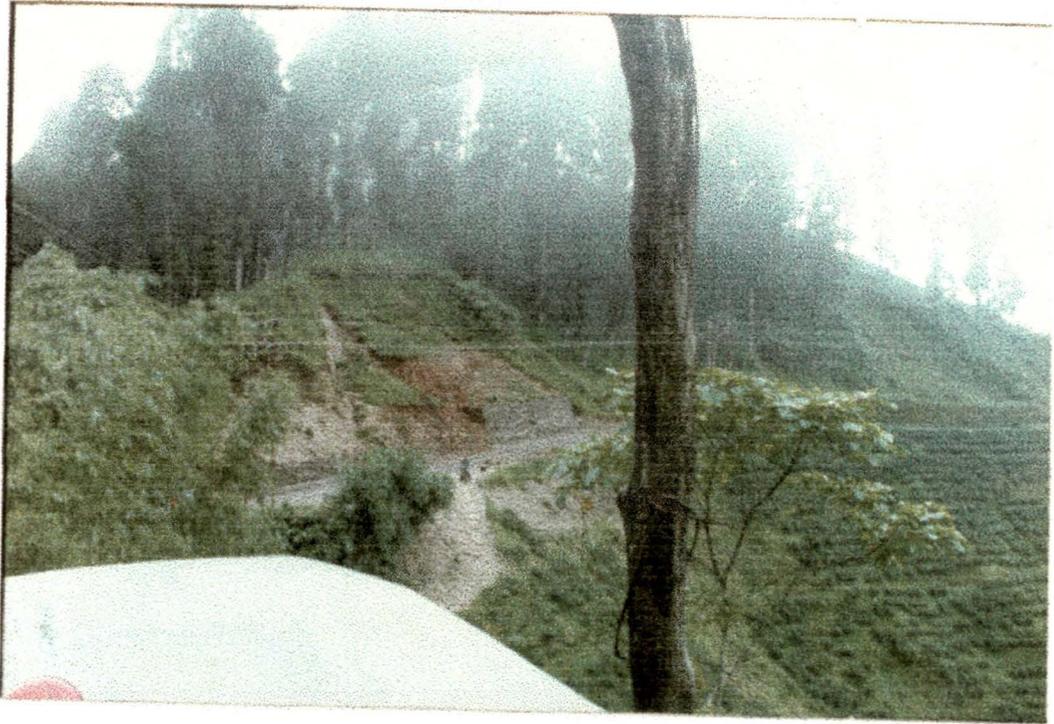
Photo **5.10** Landslide at Bhanjan

During 2nd July, 1995, the hill slope and crest at 48 kilometres on the Siliguri-Mirik Road (Latitude 26° 58' N and Longitude 88° 10' E), experienced a devastating landslide, disrupting the road communication for a couple of days (Photo 5.10). To comprehend the exact nature of this menace and to understand the mechanism behind such failure, the investigator has initiated an intensive survey and field investigation during August 13th 1995.

A few closely spaced excavations may be carried out at the foot of thick overburden situated above the road, to rotate the entire mass of regolith towards the jhora and hence, minimise load. This slide is also closely related to the existing hydrological conditions, where an increase in hydrostatic pressure often initiates the downhill movement. The proper drainage help to increase the resisting force of the slope materials and hence, hill-slope stability be maintained. A number of temporary drains may be constructed over the affected area, to cut off all sources of surface water. The collected water may be conveyed through the natural way into the jhora down to the river Mechi. Afforestation is also an important remedial measure for a long-term control against check wall collapse and soil movement. Fast growing species may be planted all along the affected area.

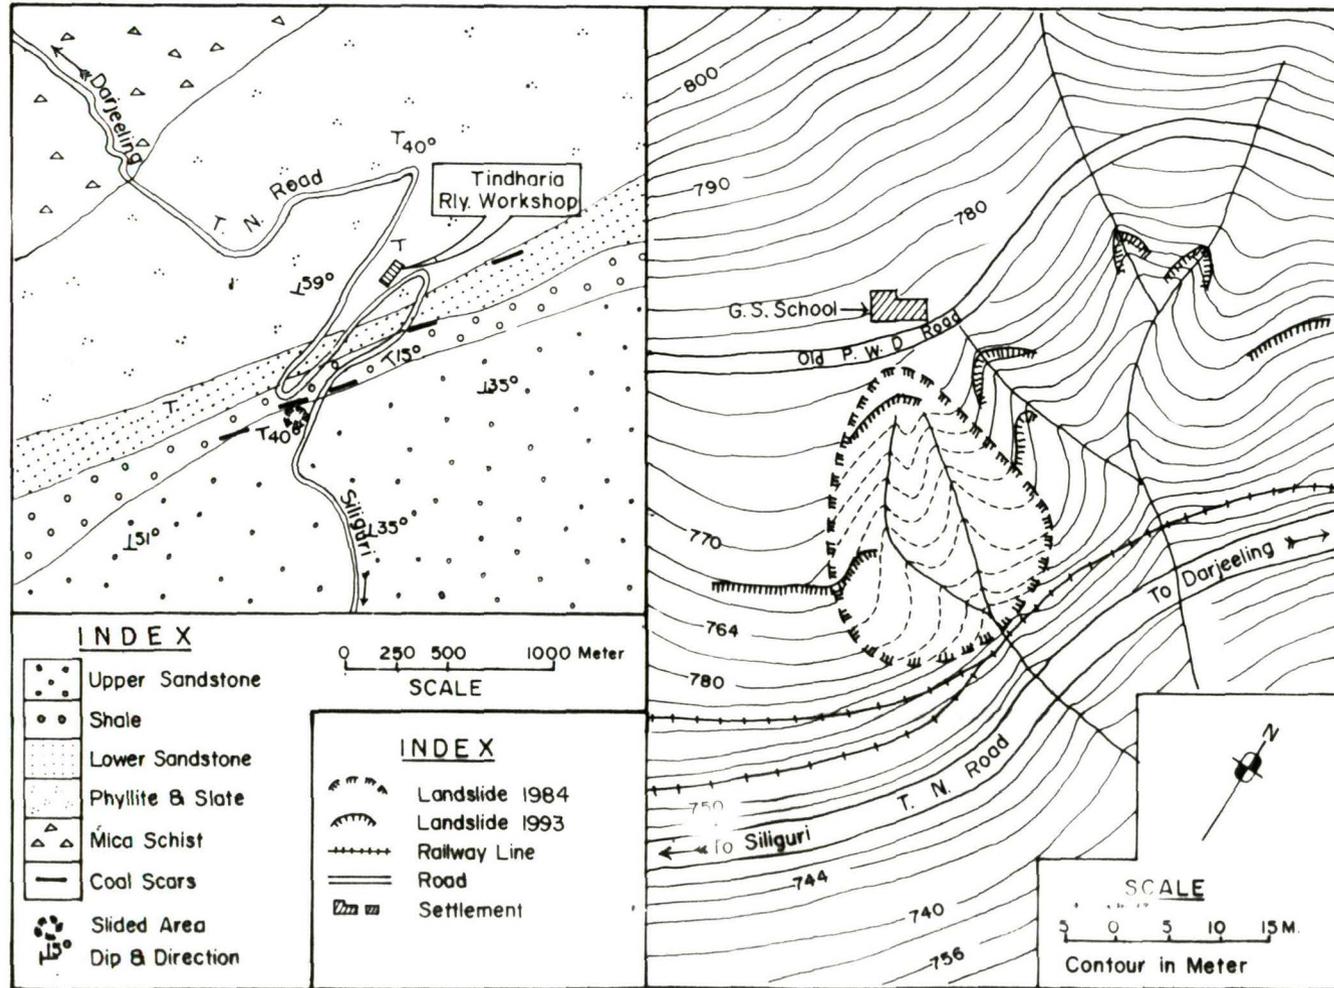
Fig. 5.10

THE KALIMATI LANDSLIDE, TINDHARIA

Gondwana formation (Damuda Series) of which sandstone and shale are noteworthy. Small and thin coal seams are found occasionally in sandstone. The sandstone is characterised by cataclastic deformation, which destroyed the clastic texture with intense granulation along ramifying narrow zones of fracture. The inclination of this rock is generally steep (30° - 45°) towards the road.
