Chapter - IV

L A N D S L I D E S

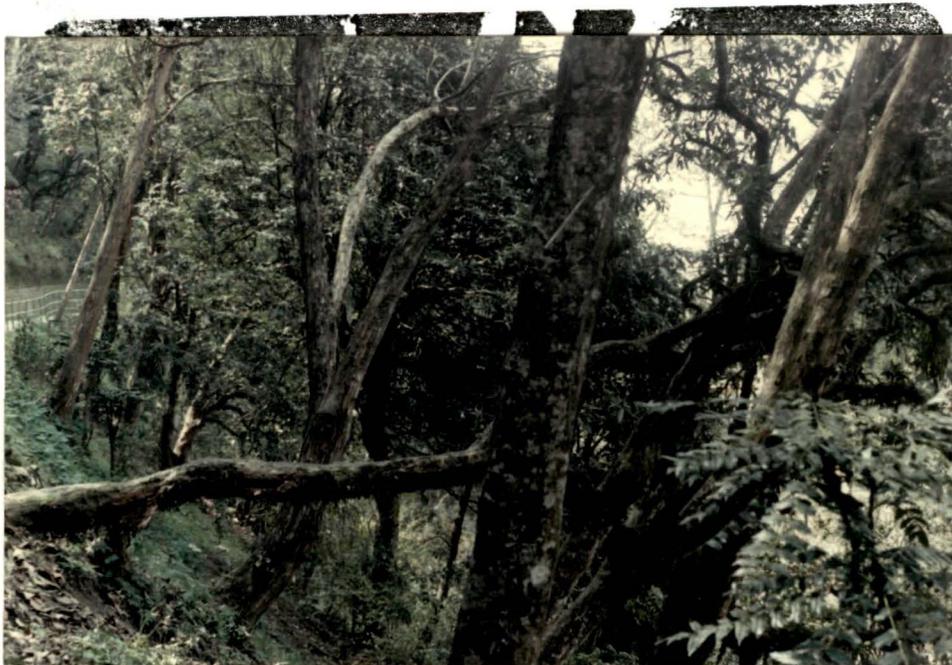
4.1 Leaning trees showing the
unstability of the slope.

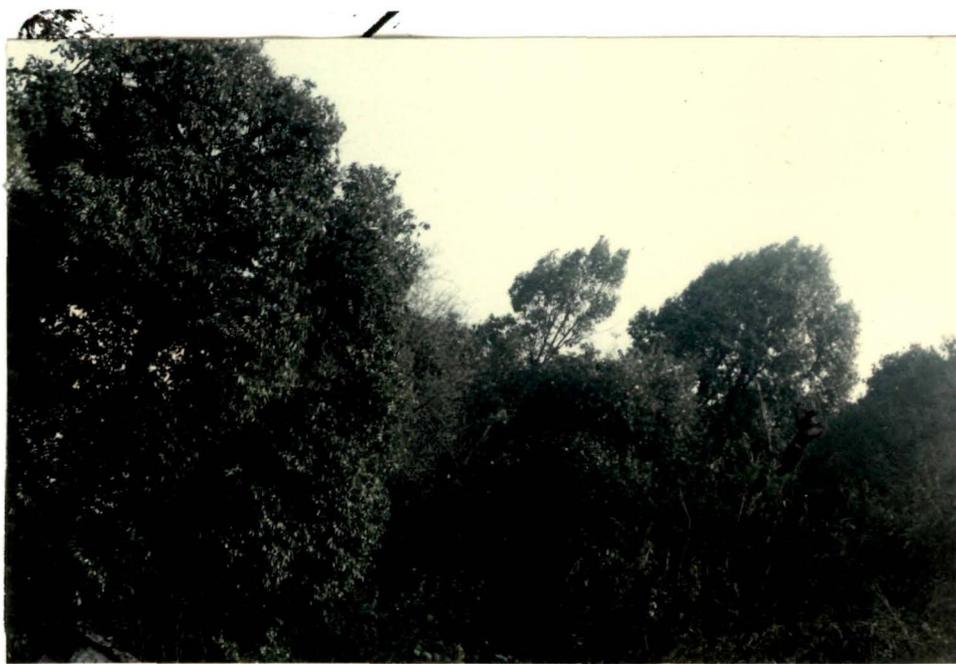
4.2 Unstable slope utilised for housing
above the Lebong Cart Rd.

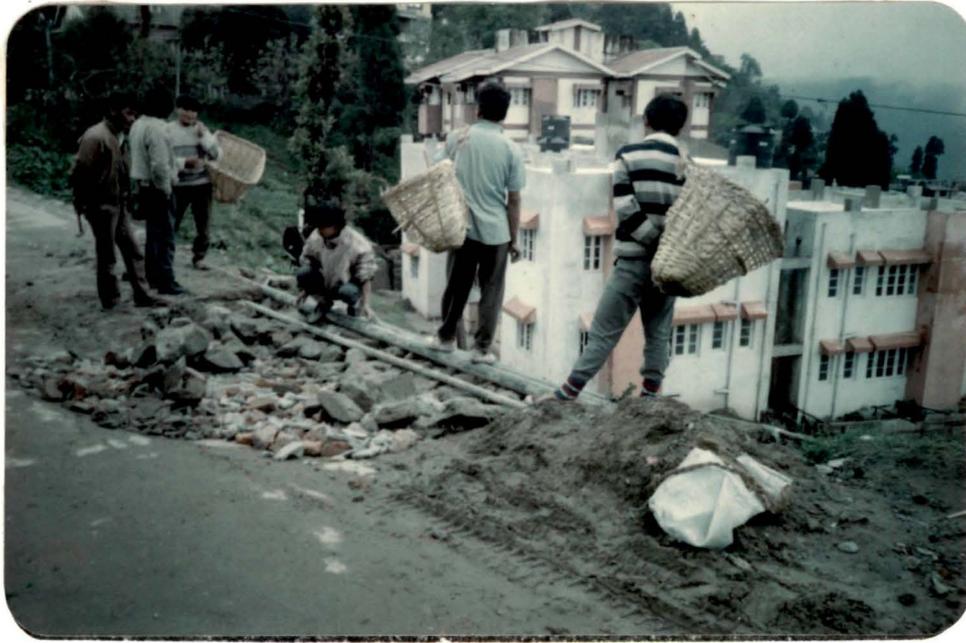
Slumps generally have curved failure planes, and involve rotational movement of soil and rock materials. Slumping along many roads within the study area may be either due to the removal of basal support by water action or by overloading. Another potent

cause of such slumping in the urban centre is due to human carelessness i.e. leakage in water pipe lines of the municipal water works (Photo 4.5 & 4.6).

4.5 Digging out soil leads to the
loss of basal support.

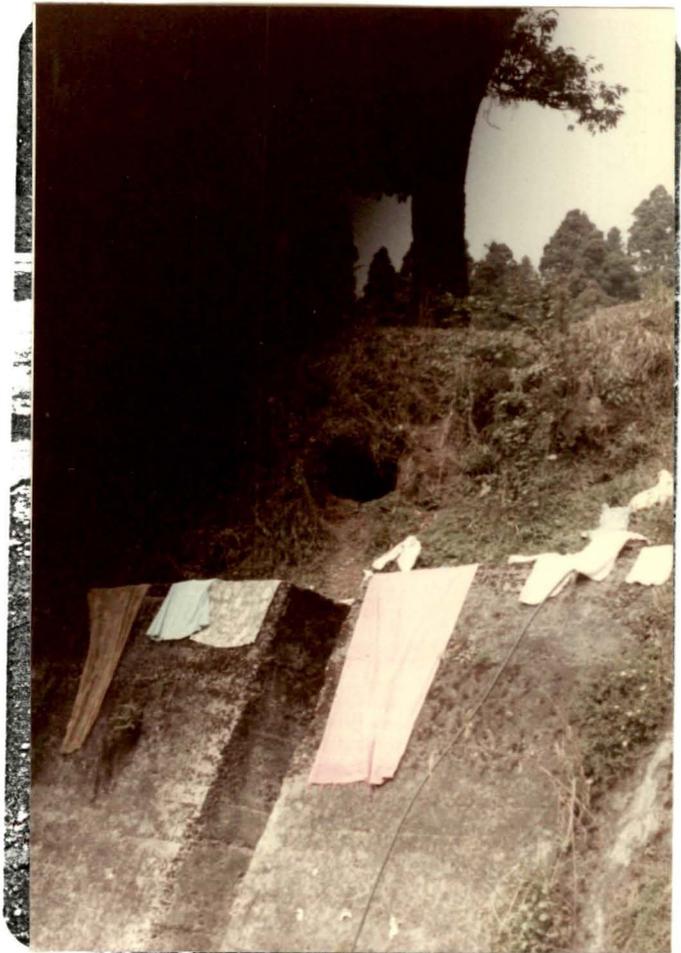
Water erosion in the subsoil 4.6
leading to caving of roads.

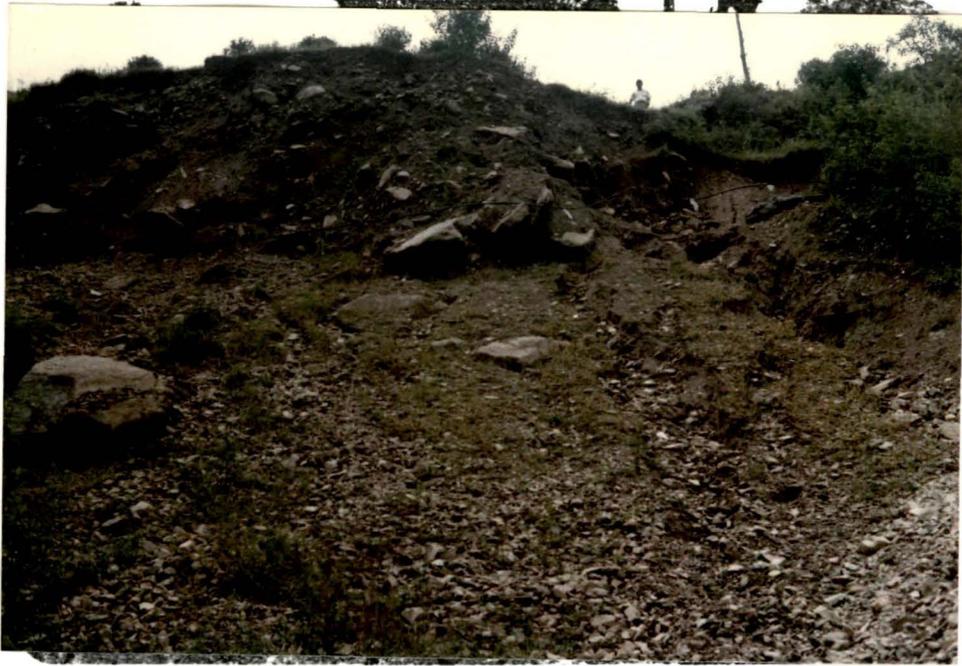
The soil slips are generally of a small magnitude regarding their lengths and their affected areas. Such soil slips are very common and in fact found almost everywhere within the town particularly along the western spur of the ridge. (Photo 4.7).

4.7 Mud flow and debris slide near Lebong.

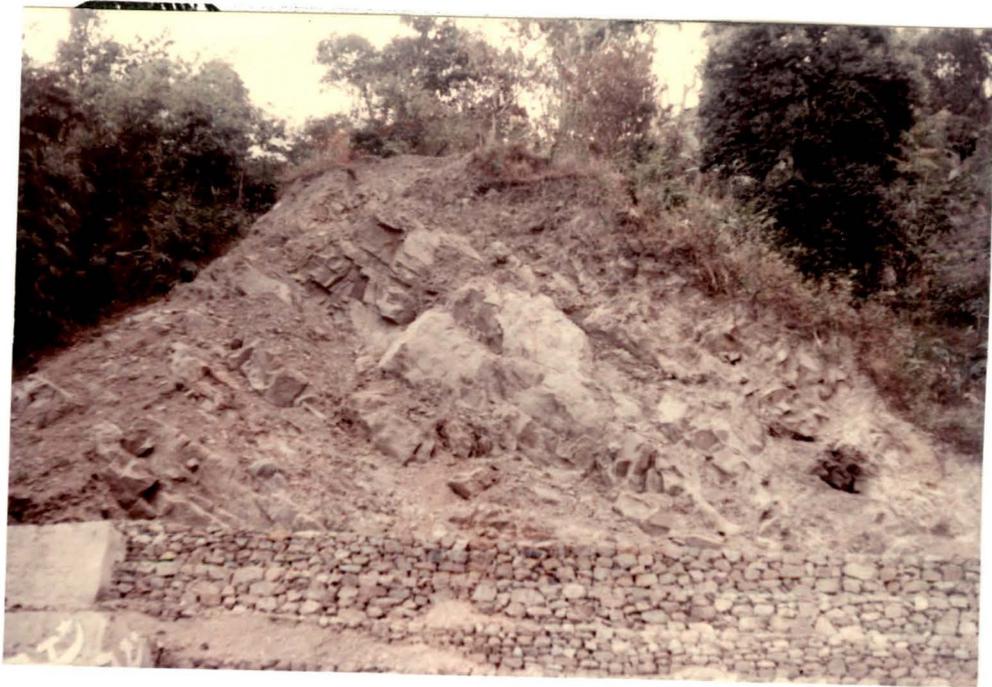
Debris-slides are generally of greater magnitude and are quite common and devastating too. Debris-slide is caused along the weak plane even when they have gentler inclinations than the "angle of sliding friction" by the reduction of cohesion due to weathering and the rise of piezometric head (Photo 4.8).

4.8 Tonga Rd. (New Rd.) Landslip.

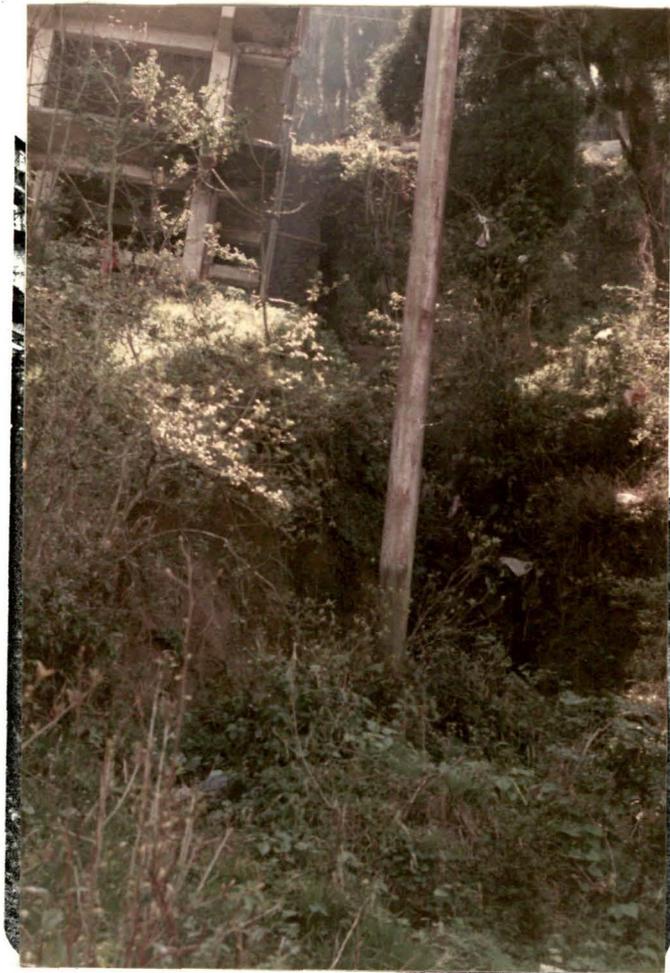
4.9 Massive construction at upper Toongsoong (for commercial purpose)

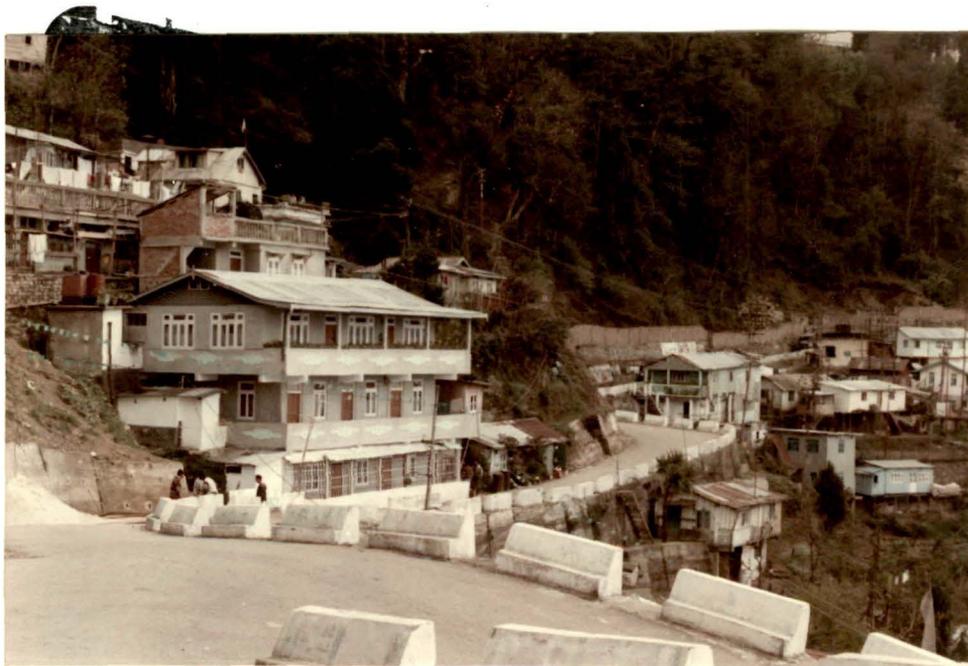
4.10 Vulnerable slopes being utilised for construction in upper Toongsoong.

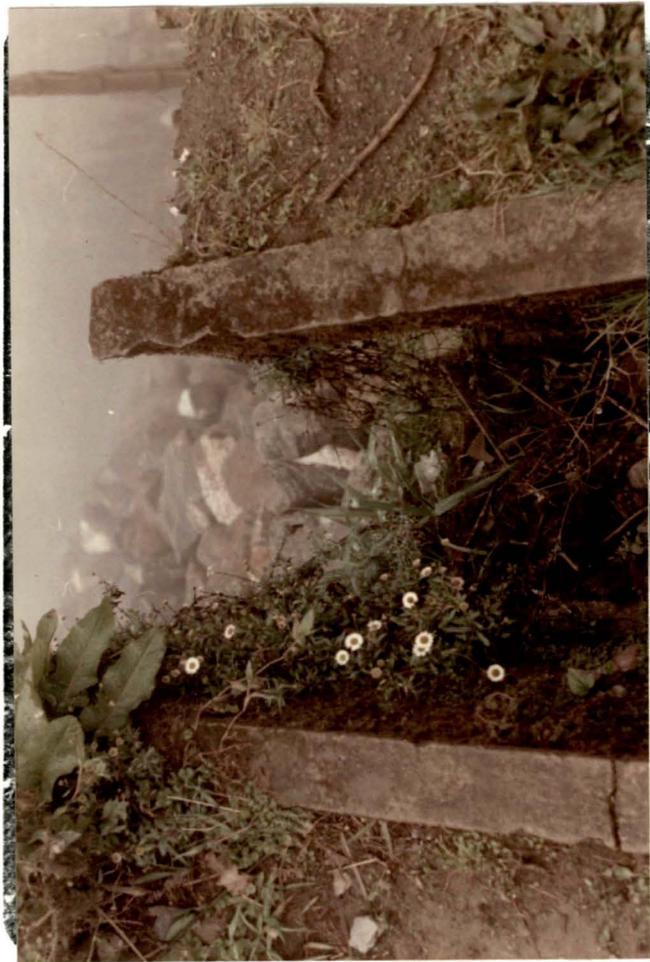
4.11

Landslips behind St.Paul's School above Tenzing N. Rd.

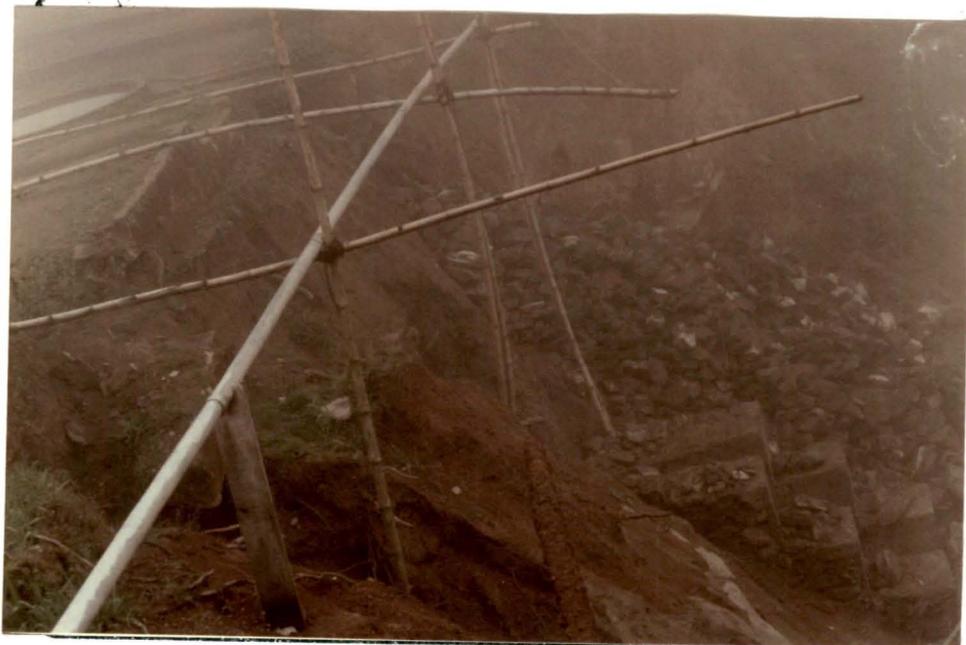
4.12

From the foregoing analysis it is clear that the eastern slopes and spurs of the Katapahar-Jalapahar ridge i.e. Toongsoong and Bhutia busty of Ward No. 7 and 9 have most seriously been affected by landslips and related phenomena since 1899. After the 1950 disaster, the G.S.I. Scientists advised not to allow any more construction along this slope. But, construction has been carried out even along the disturbed slopes and at present the investigator has noticed many new massive constructions of both residential and commercial nature, during the field study (Photo 4.9 & 4.10). Consequently, landslips have become more frequent and since 1980, almost in every year the Toongsoong and Bhutia busty have been affected by landslips of different magnitude and intensity (Photo 4.11 & 4.12).

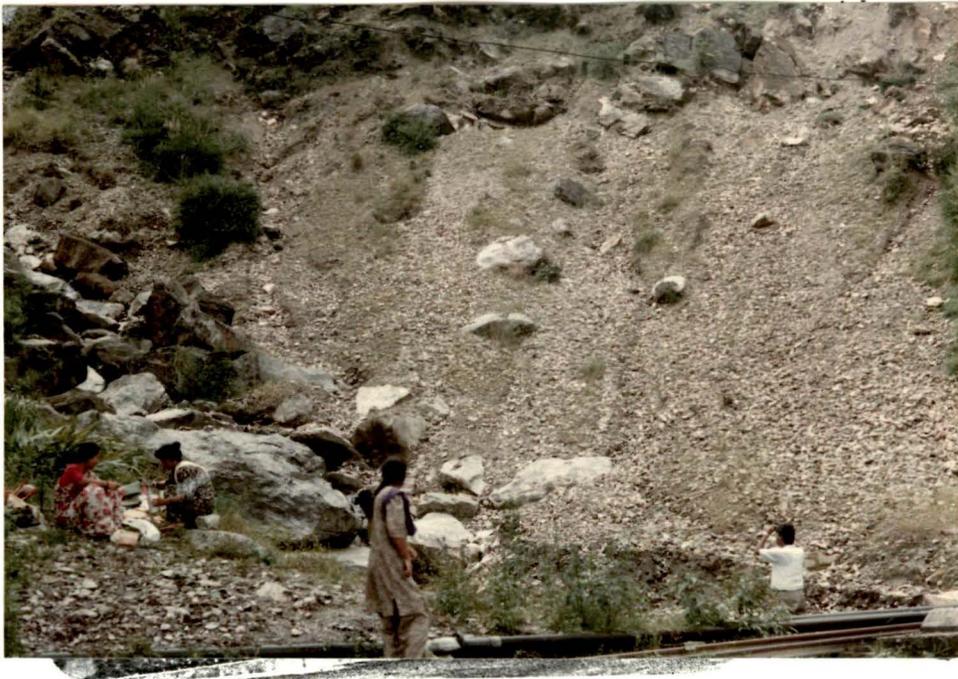
The author standing near the Tonga Rd. landslip.

Tonga Rd. and the old Military Rd., experienced a serious landslip, (Photo 4.13 & Fig.4.8).

The New Rd. (Tonga Rd.) landslip has occurred following a period of heavy shower which therefore, appear to be the cause of the slip. But its action is more like the trigger in the gun, as it gives the last stroke when other factors have already brought the slope nearly to the point of failure. However, in the particular case, a rather common factor i.e. steepening of natural slope by the cutting of basal support for the construction of road, invites failure. The following are the important factors of slope instability (Fig.4.9).

The first step in corrective efforts should be to construct retaining walls at the base of a slip with a good drainage system. The slopes above the walls should be so constructed as to allow a gentle gradient as far as possible. Afforestation is a must to prevent uncontrolled infiltration and run-off, as suitable sapling should be planted on these slopes to check an appreciable amount of soil erosion. The triggering problem that is unique in this landslide, however, will not be easily solved i.e. the New Rd. must be there, so the cutting of basal support will always remain dormant

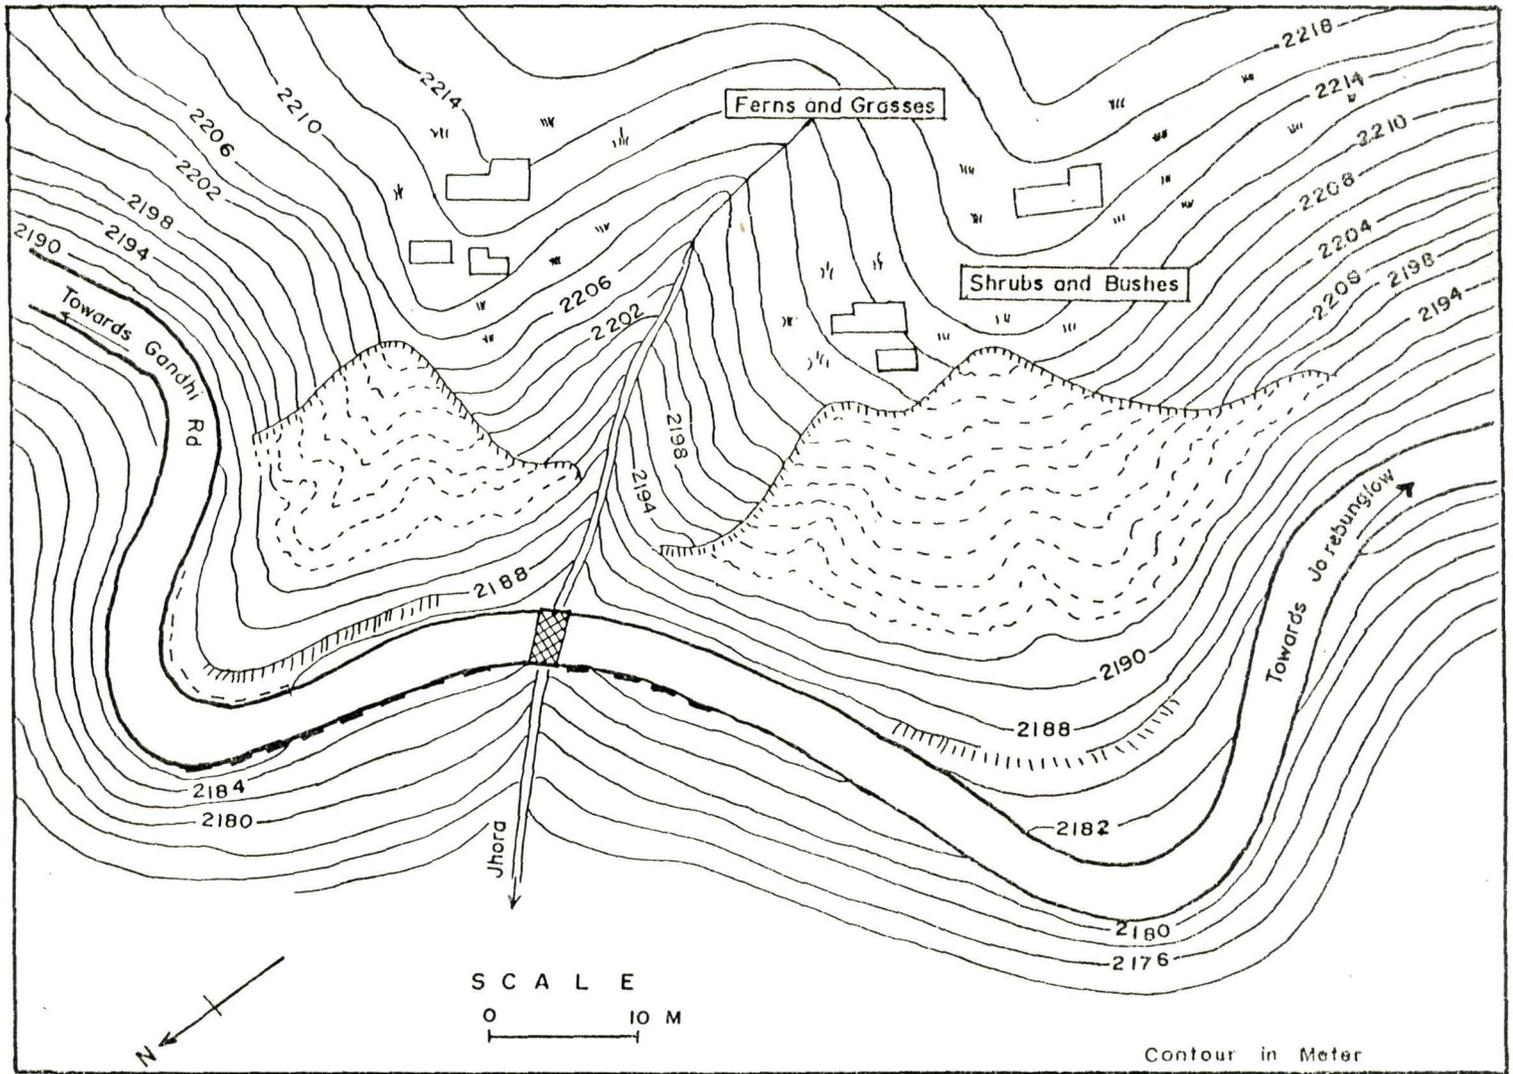
Fig-4.9

In the slipped area, rain water percolates through the joints, cracks and pore-spaces of the soil materials and also through the joints of the bedrock. This increases the pore-water pressure and changes the consistency as well as the shear resistance of the soil, internal friction sets in, the soil ultimately loses its cohesion. Under such suitable circumstances, with the onset of monsoon, rill cutting as well as gully erosion starts and the slope becomes further denuded as the surface water flows through these channels.

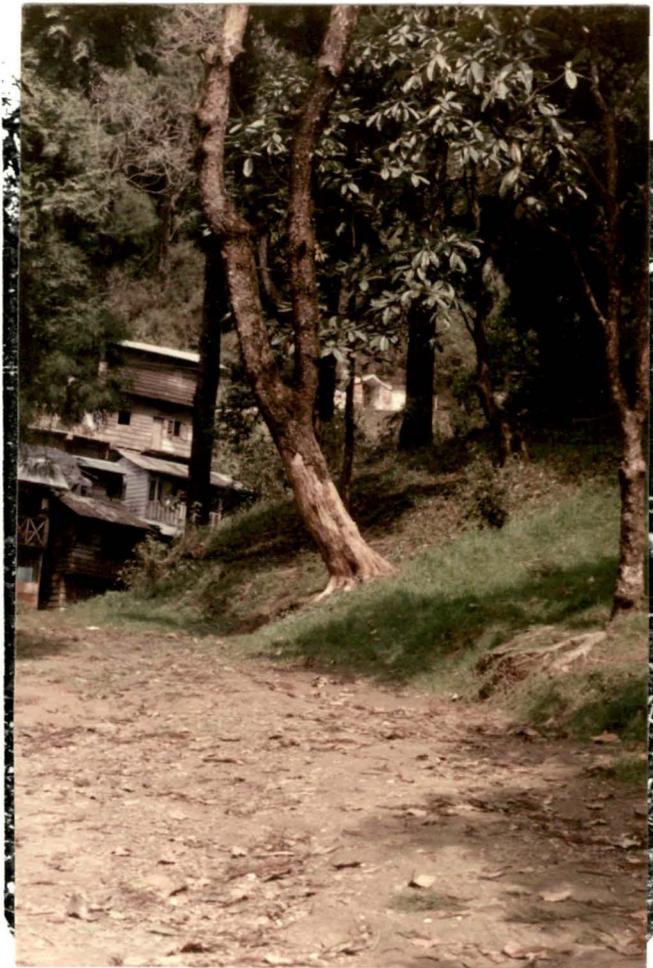
4.15

Creeping slopes of the Botanical Garden
with leaning trees.

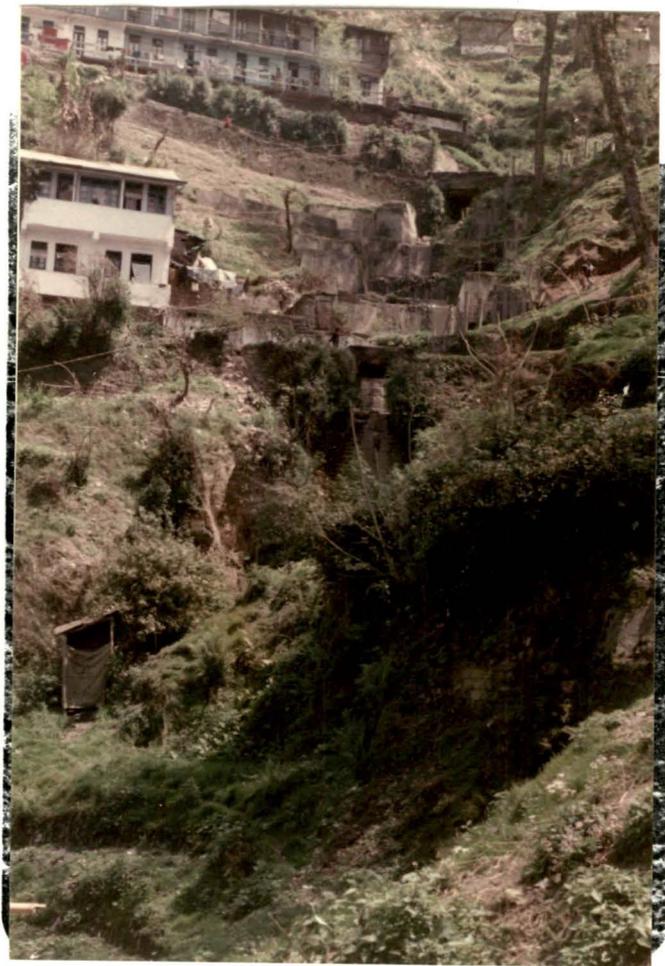
4.17

An old septic tank with eroded
out-lets above the Victoria Rd.

lower level of the town. The investigator has also found many unplastered sewars in many parts of the town (Photo 4.17) and has recommended plastered sewars for the storm-water disposal system.
