CHAPTER 9

ENVIRONMENT IMPACT ASSESSMENT

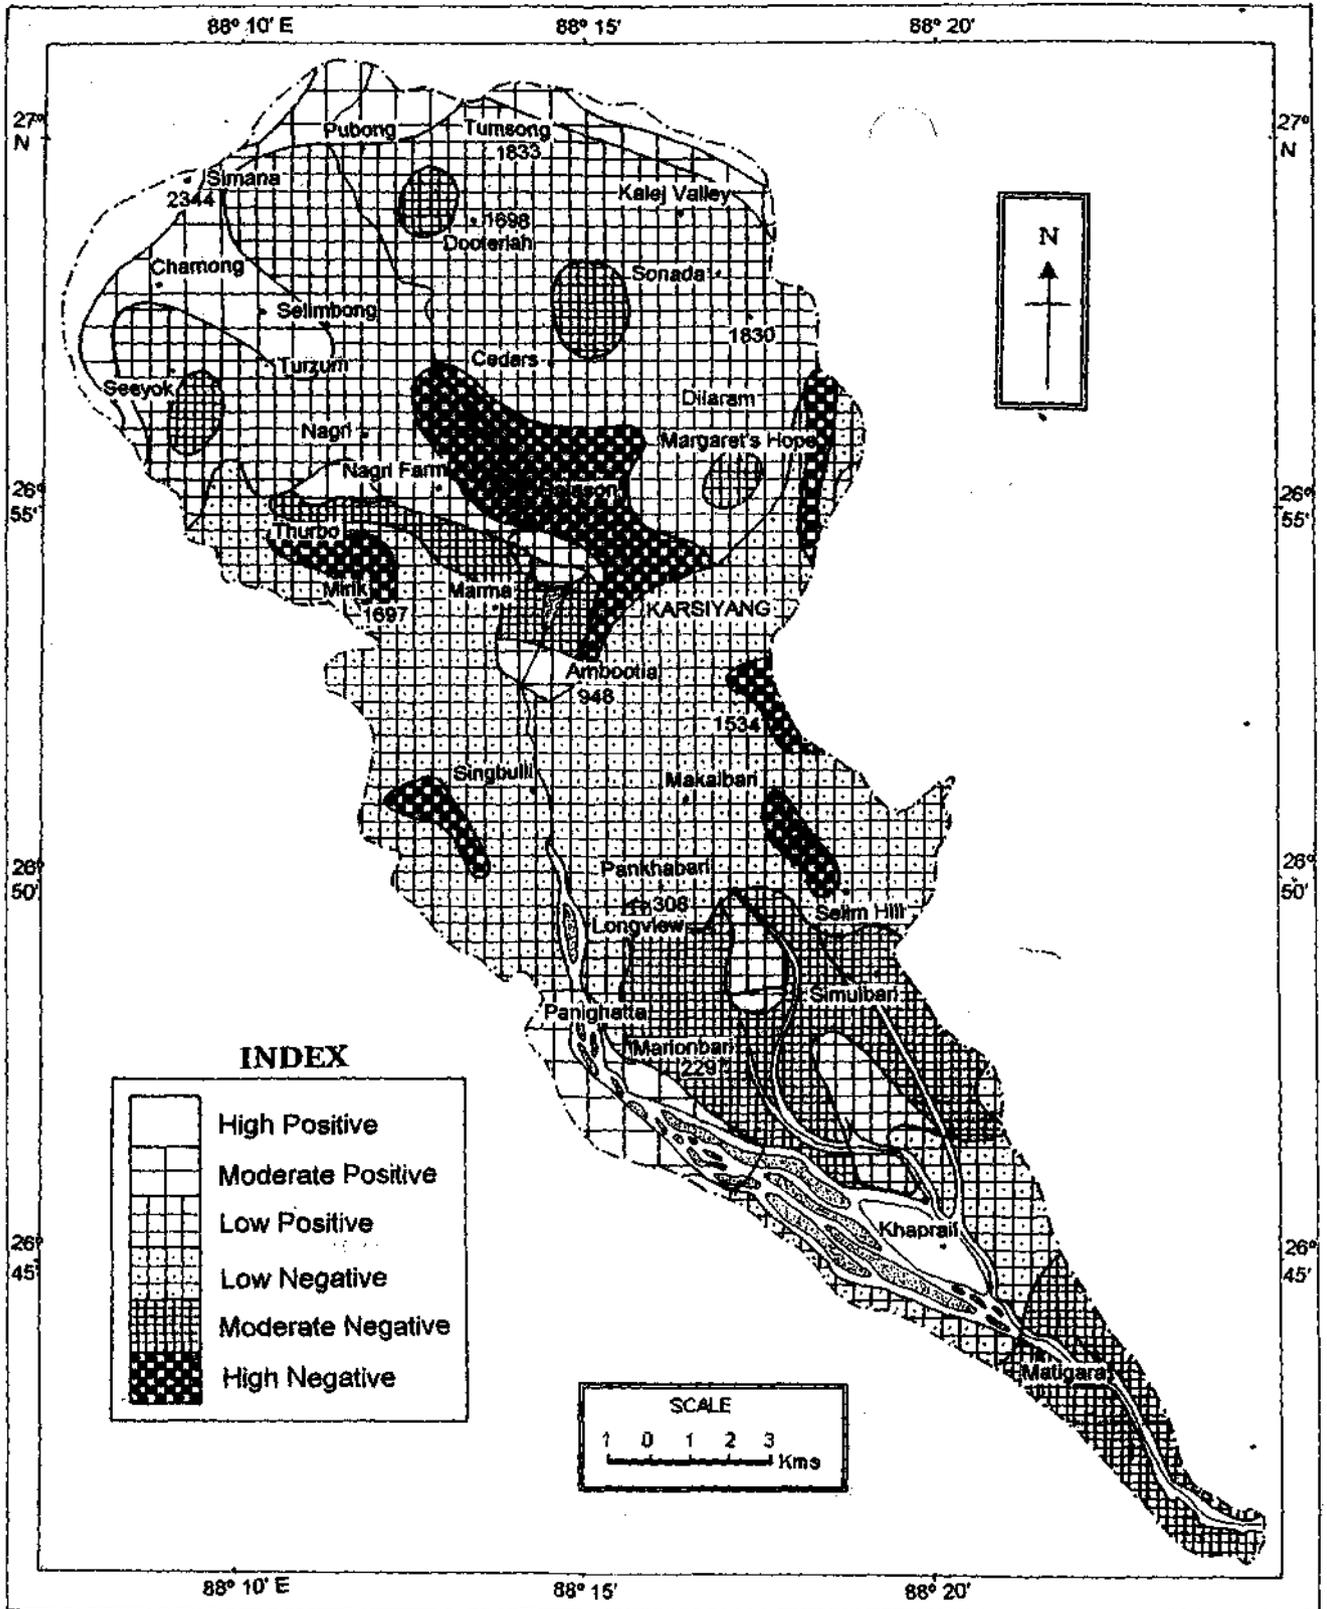
Figure 9.1

Figure 9.1. depicts the different zones of the magnitude of environmental impact of development activities. Impact magnitude are found to vary from highly positive (300) to highly negative (-300). In general various magnitude of positive impacts have been found to be more wide spread in the northern half of the study area; while the negative impacts of different magnitude predominated the southern foothills of the study area. The present investigator with the help of the following classes has attempted a more specific distribution of the different kinds of impact magnitude.

MAGNITUDE OF ENVIRONMENTAL IMPACT IN THE BALASON BASIN

Class I. High positive impact occurs in two very narrow strips bordering the extreme north-western (along Simana) and north eastern peripheries of the study area. These areas are still under virgin forest cover and hardly affected by adverse developmental impact on environment.

Class II. Moderate positive impact has been identified in the southern sections of the former zone, extending through Pubong and arching further east, culminating just above Kalej Valley. A wedge like protuberance extends south-eastwards. A small wedge occurs in and around Panighatta. These tracts are still under natural forest cover of different species. Positive impact of silviculture activities can also be observed.

Class III. Low positive impact predominates over the northern half of the study area from Seeyok in the west to Tumsong in the north, through Kalej valley, Sonada and Dilaram in the east and as a narrow elongated strip along Nagri farm in the southern section of this zone. These tracts are dominated by tea plantations and forested areas. Although, the large scale plantations have detrimental effect on biodiversity, these plantations also have a beneficial impact on landscape and soil-water management since soil erosion is checked and ground water aquifers are recharged. Consequently, a low degree of positive impact is attained.

Class IV. Low negative impact covers an extensive section in the central region of the study area from Mirik through Karsiyang, Ambootia and then to Singbuli, Makaibari and Selim Hill. The Khaprail region also exhibits low negative impact. In this zone human settlements and large scale cultivation and arable farming along with the introduction of tea gardens have destroyed the regional biodiversity, thereby exerting a negative impact on the environment.

Class V. Moderate negative impact spreads throughout the study area. In the northern sections, they are found in small pockets around the Dooteriah, Cedar, Seeyok and Margaret's hope tea gardens. A narrow strip occurs just north of Thurbo and extends eastwards into Marma. In the southern half of the study area, more extensive regions are marked from Longview and Simulbari into Marionbari. Another wedge occupies the southern extremity along Matigara. These zones are mostly tea garden areas.

Class VI. High negative impact are found scattered in pockets in the central section of the study area. The most noteworthy is in a broad wedge east of Nagri Farm along the Balason tea garden. This area is characterized by the highest degree of deforestation and excessive human settlements. Consequently, haphazard constructions, inadequate drainage and unsystematic land use have established a vicious circle of degradation leading to a high to very high negative impact of the 'developmental activities' on the environment.

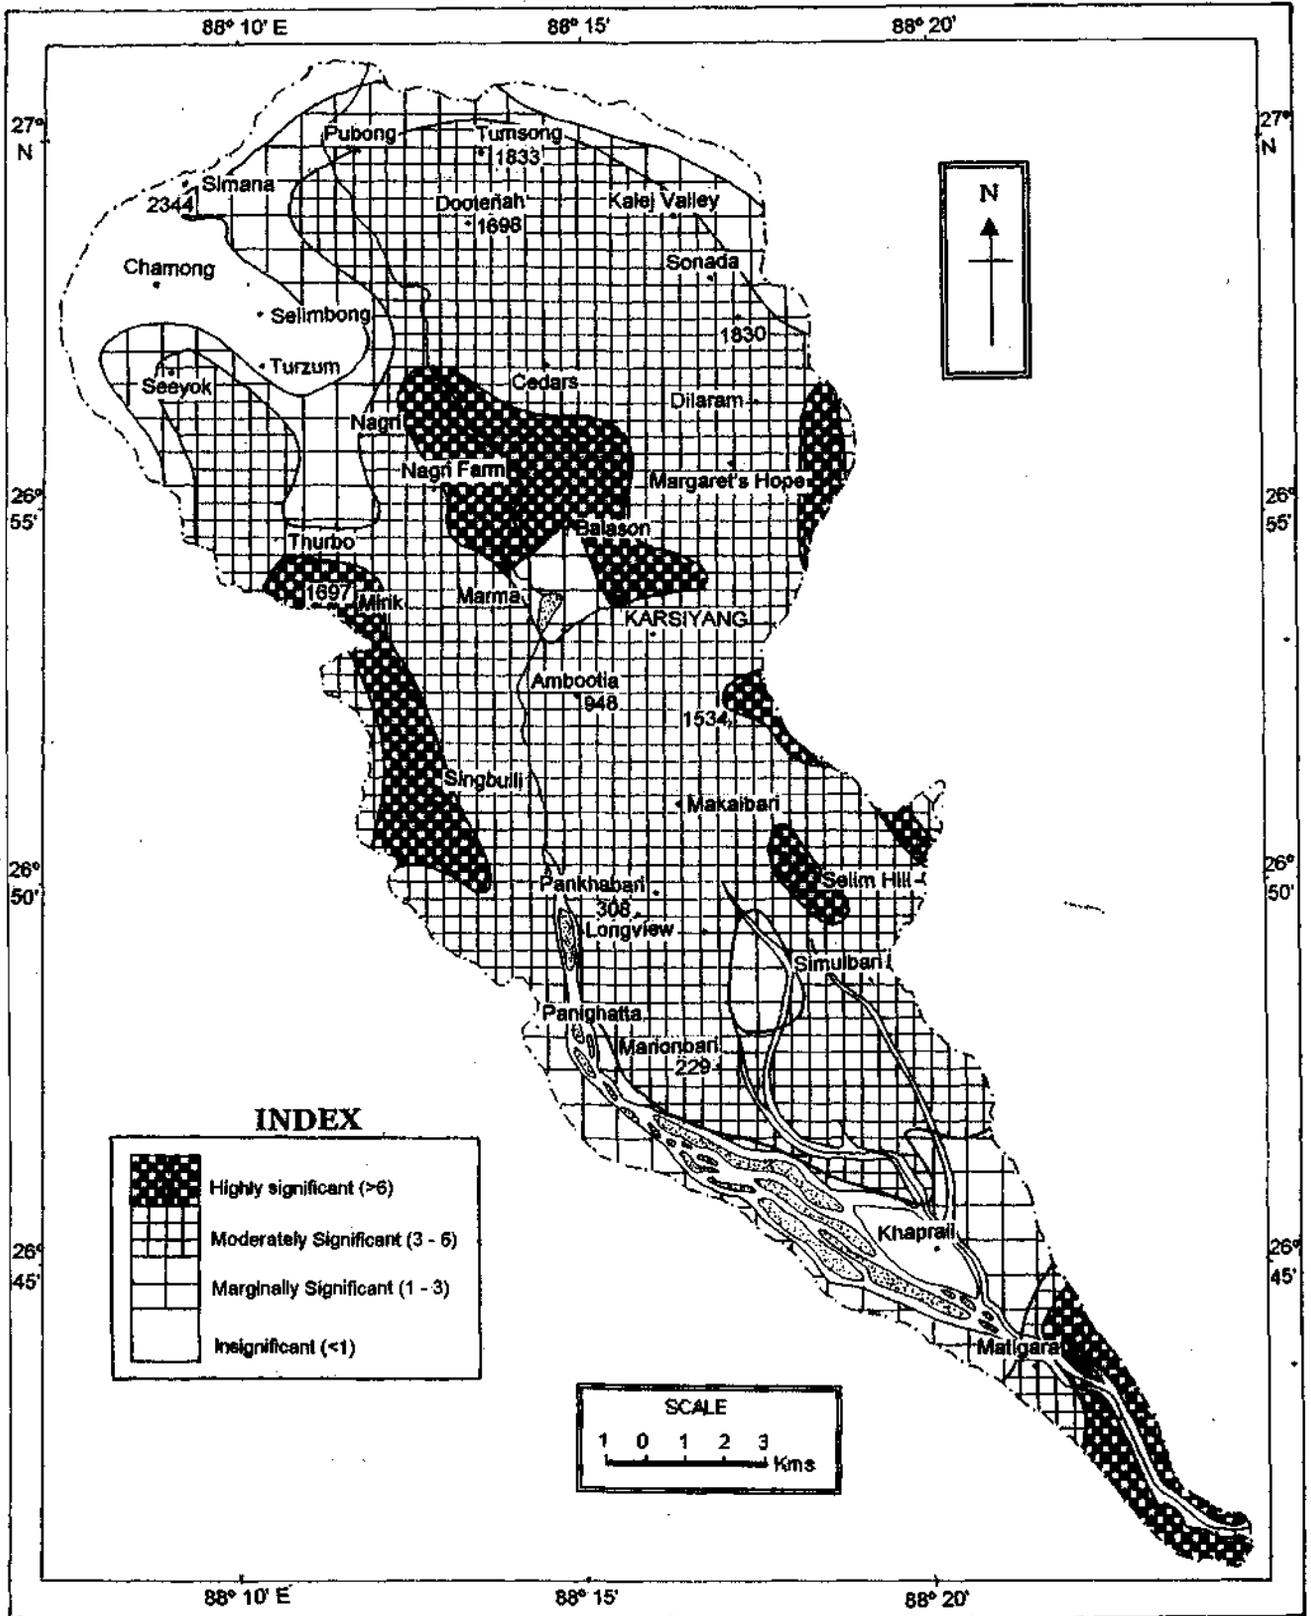
Figure 9.2

The spatial distribution of environmental impact significance has been identified based on modified Leopold matrix (table 9.1.). Such semi-quantitative rating value has been obtained from 45 sites chosen randomly and plotted on the map. The impact significance map thus prepared based on interpolation method (figure 9.2). It has been found that the impact significance varies from very high (8) to insignificant (1). The following significant classes have been identified:

ENVIRONMENTAL IMPACT SIGNIFICANCE IN THE BALASON BASIN

Class I. Highly significant impact has been identified along a few elongated tracts i.e., along the Dilaram-Karsiyang areas, Mirik-Thurbo-Soureni areas, east of Singubuli, a large area engulfing the Nagri, Nagri Farm and Balason tea garden, Ambootia, Makaibari-Selim Hill region . These areas experienced most devastating impact of development activities on environment. Ever increasing population growth and unplanned developmental activities are also found responsible for such high significance of environment impact.

Class II. Moderately significant impact is most widespread and has been identified in most of the tea garden areas. Large scale destruction of hill slope biodiversity exerts tremendous stress on the delicate hill ecosystem. Use of fertilizers, pesticides and herbicides to augment tea production also have detrimental effects on the quality of land, water and atmosphere of the area. Innumerable

Class III. Marginally significant impact has been noticed in degraded forested areas and in plantation tracts. Reduction of biodiversity and natural regeneration, coupled with marginal development activities, have exerted such adverse impact.

Class IV: Insignificant environmental impact has been noticed in the north western part of the study area around Simana Busty, Chamong, Selimbong and Turzum and in the Panighatta and Khaprail area in the southern part of the study area. These areas are still free from any significant development and/or modification impact and are largely covered by dense natural forests. An overview of the matrix suggests high interactions between the components under modification of regime with those of flora, fauna and land-use. The modification of regime brought about by the introduction of new species and management practice has negative impact on the environmental components, particularly flora and fauna and is quite significant.

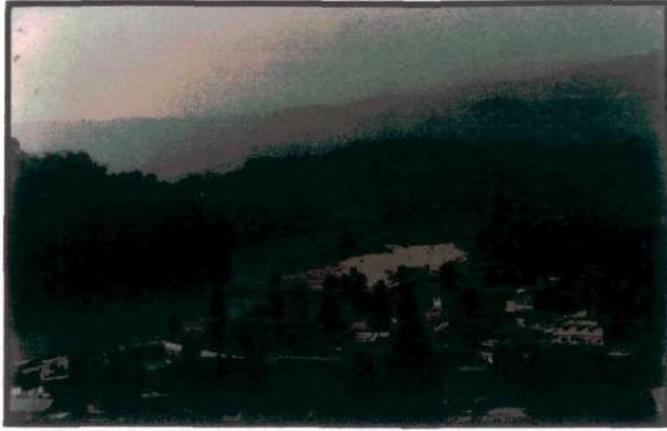
Photo 9.1 Mirik-site of impact analysis of *Cryptomeria Japonica*

To understand the impact of the effects of dhupi plantation, the investigator carried out vegetational analysis in the middle hill areas near Mirik to determine the impact of growing monocrop of dhupi on the biodiversity with particular reference to the plant species (photo 9.1). A similar investigation had been earlier carried out in Mahaldiram block of Kurseong Forest Division, one having natural forest consisting of miscellaneous species and the other of pure dhupi plantation of 1929-31 (Bhutia, 2000).

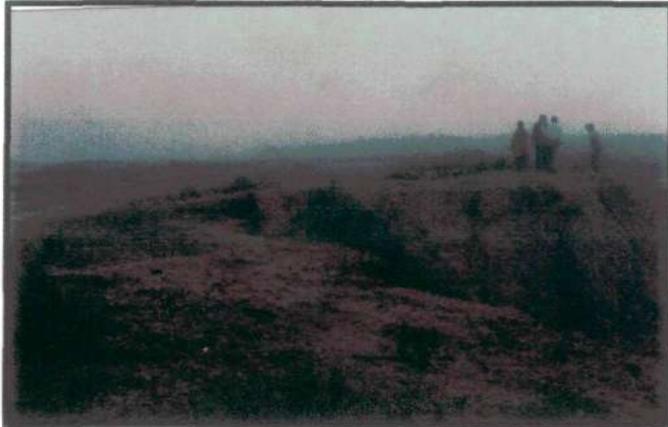
Photo 9.2 Flattened Mirik Dome : note the deep gully formation

The disposal of talus materials, resulting from the excavation of hill slopes and hill tops for so called development purposes, and in many cases into jhoras and kholas is a common practice in the study area. This particular case exemplifies how such an action has initiated a series of landslides that have affected the road communication, agricultural fields and threatened the fluvial environment of the river Marma, an important tributary to the river Balason (photo 9.2).

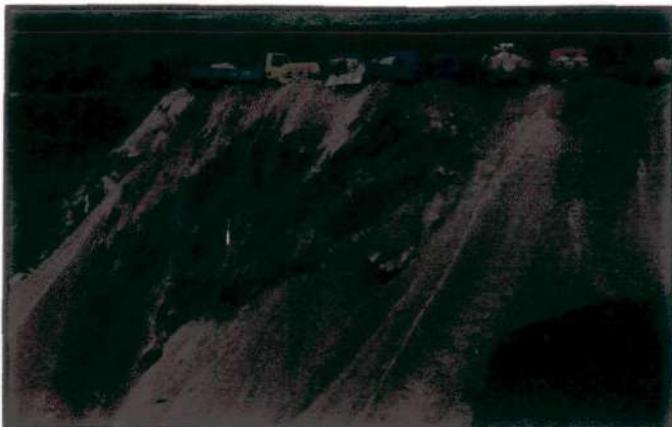
Photo 9.3 A dumping ground for construction refuse- a future hazard

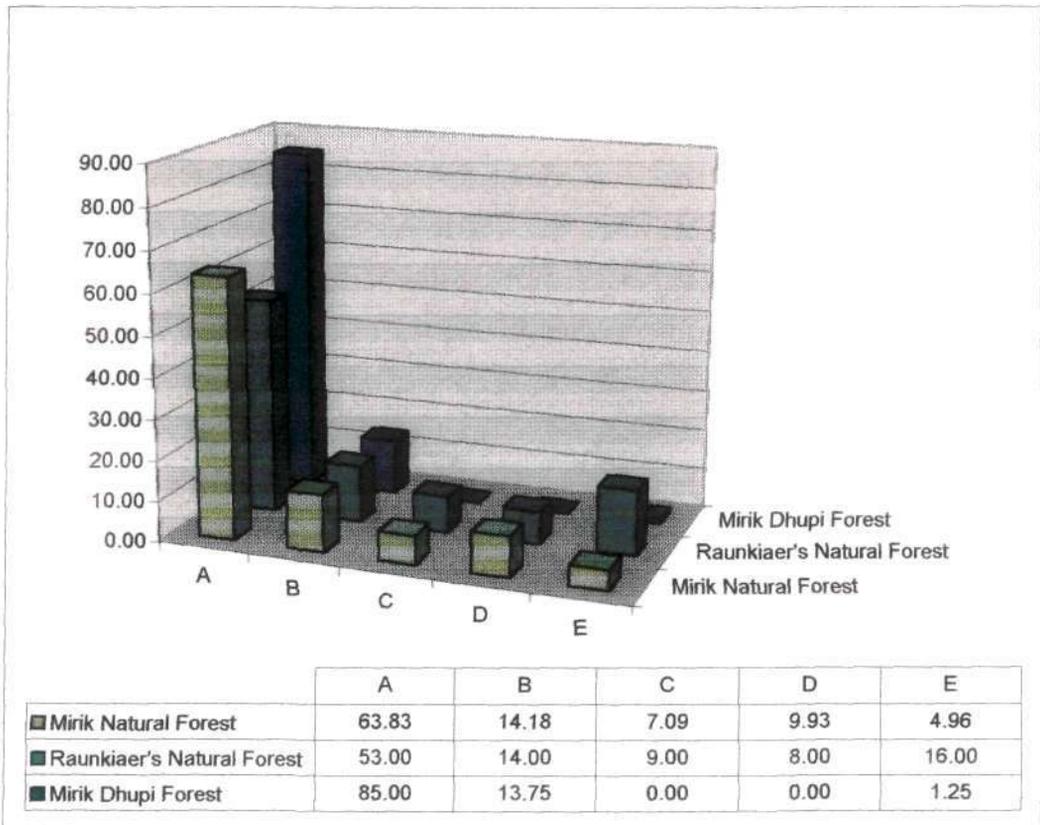
Figure 9.3

FREQUENCY CLASS DIAGRAM

A comparative analysis based upon Raunkiaer's Frequency Class of the two types of forests (figure 9.3) shows that the dhupi plantation deviates widely from that of Raunkiaer's normal forest thus, indicating that it constitutes biotically a highly disturbed site. The natural forest is close to the Raunkiaer's normal forest, but here too slight deviation can be observed, which shows that group with the highest relative frequency i.e. Class E of Raunkaer's Class is effected. This may be due to removal of some of the plants of commercial importance, grazing by domestic animals and removal of forest products and produce.

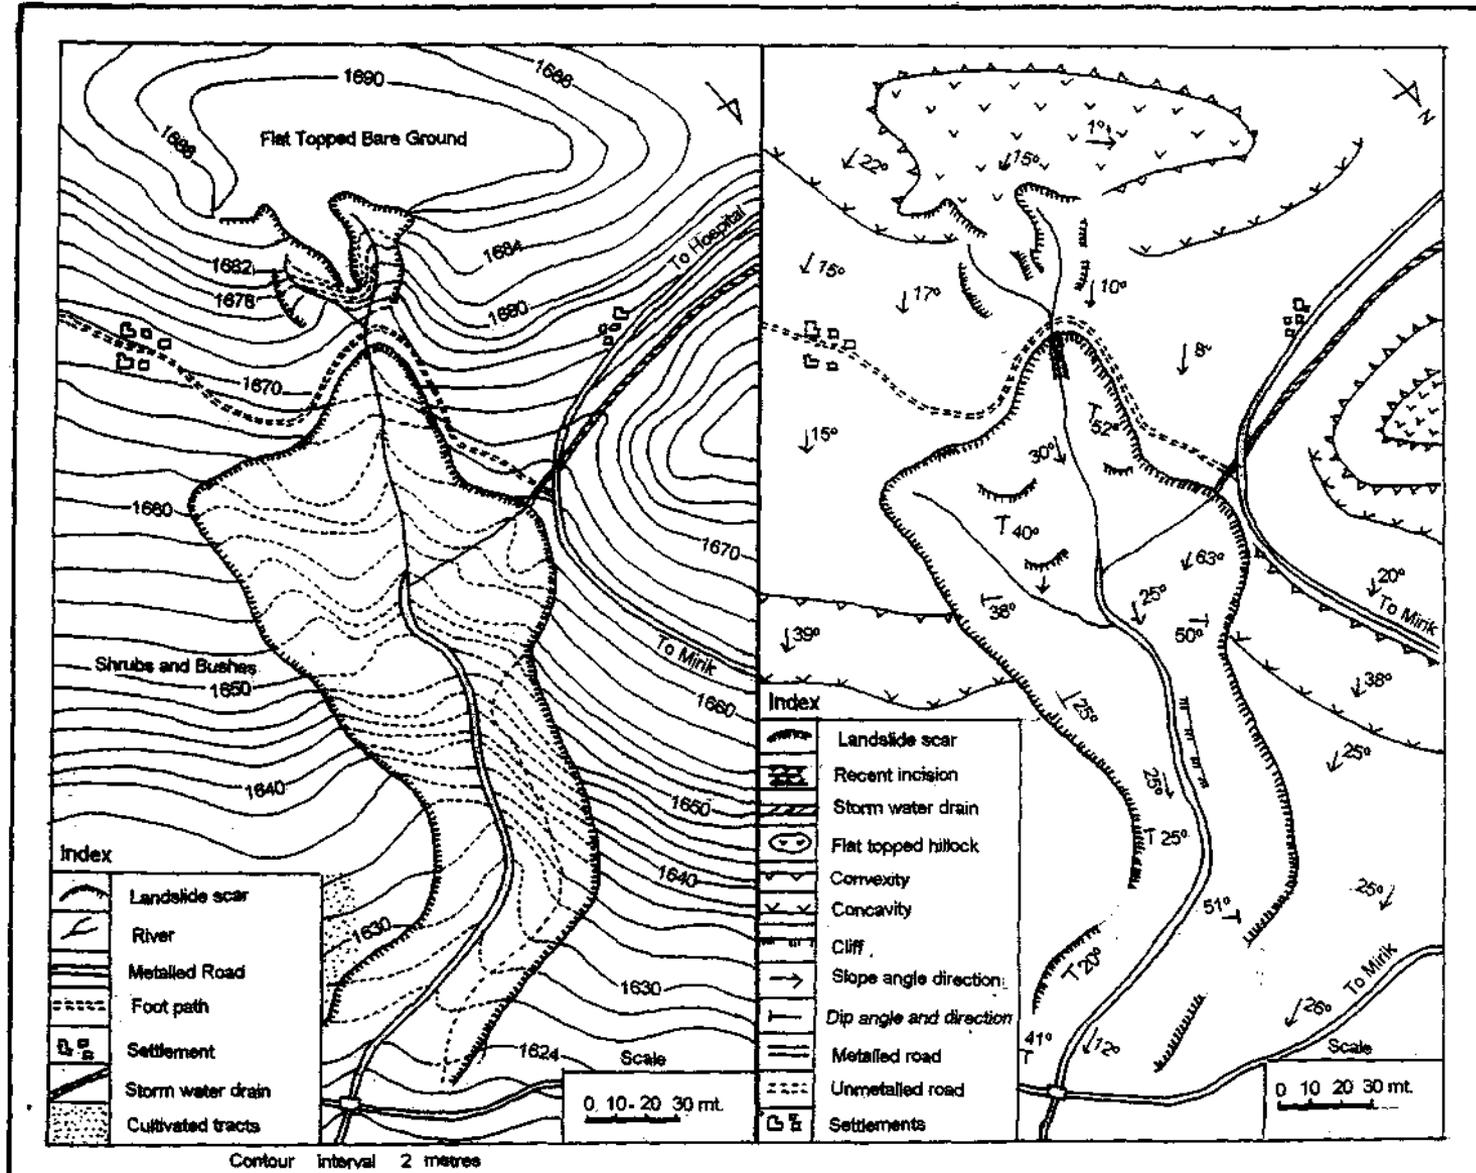
Figure 9.4

CONTOUR PLAN OF THE MIRIK LANDSLIDE

GEOLOGICAL AND GEOMORPHOLOGICAL SET UP OF THE MIRIK LANDSLIDE

communication and loss of agricultural areas along the banks of the jhora. Bhutia (2000) has excellently documented the causes and effects of landslide that has taken place during the monsoon of 1997 (figure 9.4). The follow-up study reveals how unscientific and irrational activities of man can cause irrevocable damage to the environment. The dumping of excavated materials into the source of Marma Khola has initiated landslides along the entire tract of the entire tract of the khola, causing a series of chain reaction leading ultimately into deterioration of the hydrological regime of the river Balason.
