Chapter V: Flood Hazards in Jalpaiguri

5.1 Introduction

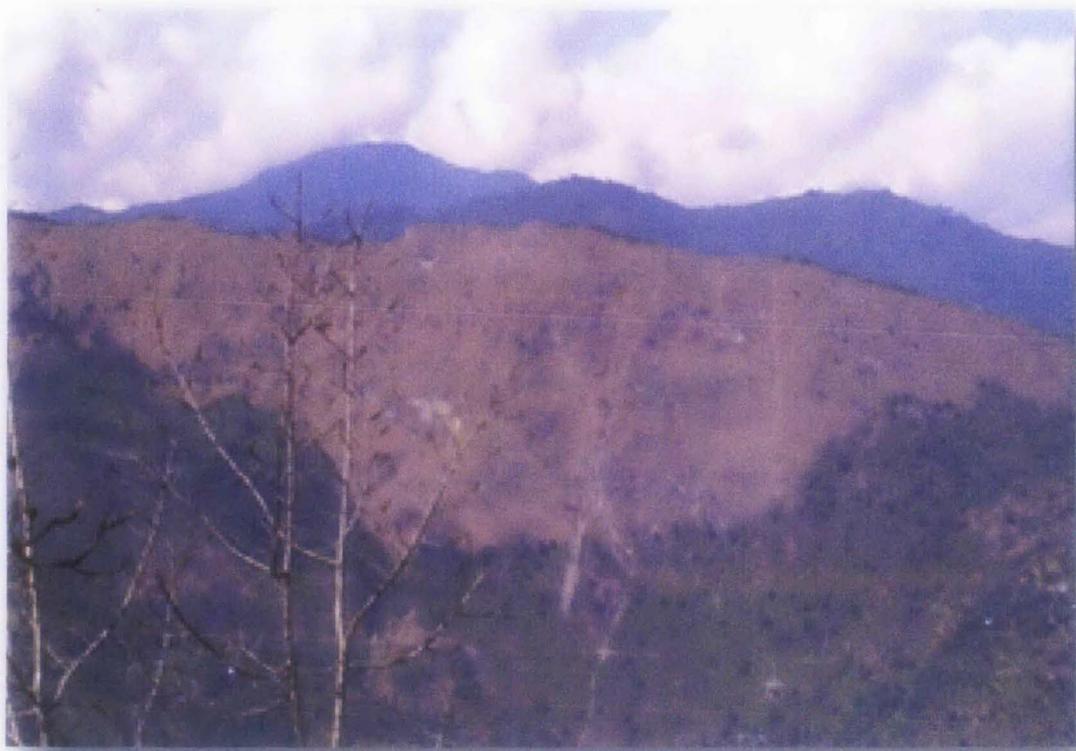
Photo 5.1 Deforested catchment in the Hills

The catchment area of these rivers has mostly been deforested and the clearings of the steep slopes have been used for the extension of settlement, agriculture, plantation and communication, disrupting the overall hill slope hydrological balance. As a result, during heavy and concentrated rainfall, innumerable landslides are caused transporting huge amount of sediment to the rivers (photo 5.3 & 5.4). Most of such landslides have never been treated scientifically with proper protective measures and as such those are in the habit of expanding their territories during monsoon (photo 5.1 & 5.2). This often added more and more silt to the rivers, which are incapable of transporting the loads efficiently under the existing hydrological conditions, especially areas beyond the foothill zone (Sarkar, S., 1996; Sarkar S., 2008).

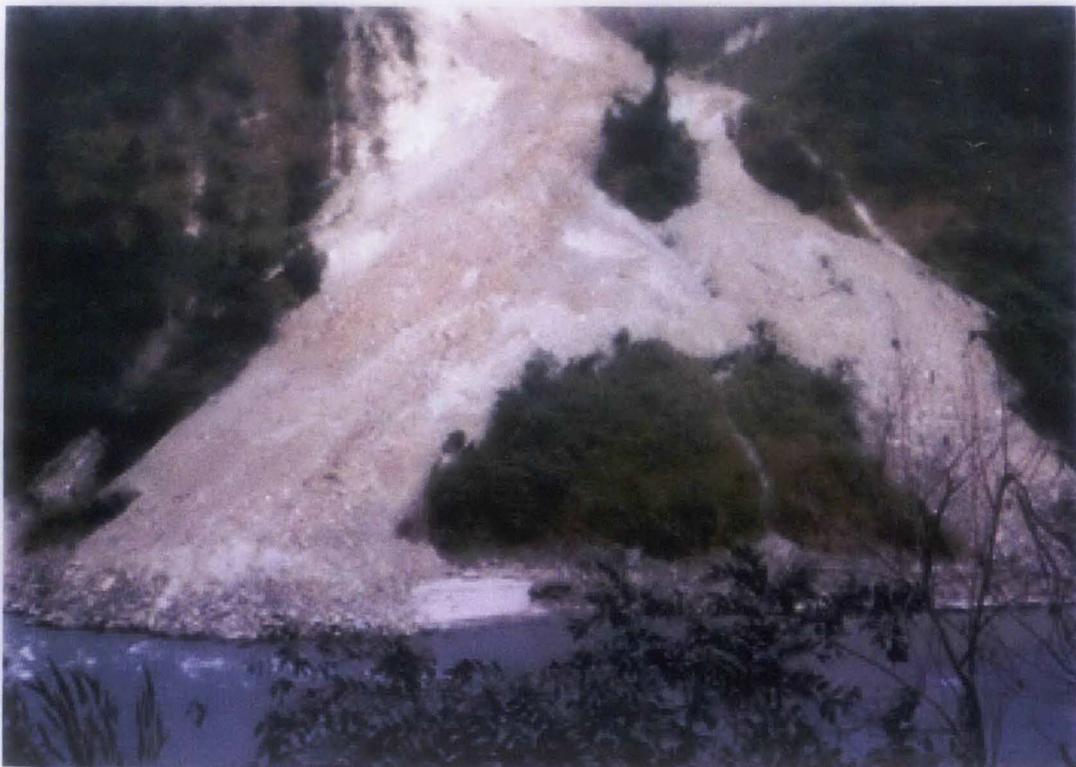
Photo 5.2 Landslide along the Tista Valley

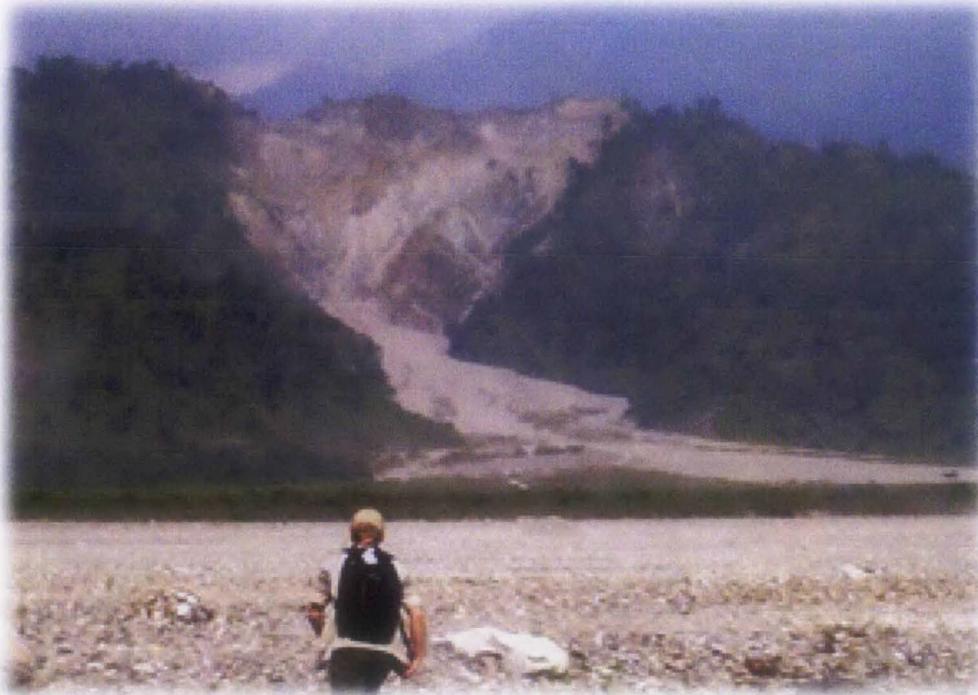
Photo 5.3 Deep seated landslides along Bhutanese border caused massive deposition in Pana-Gabur Basra valley.

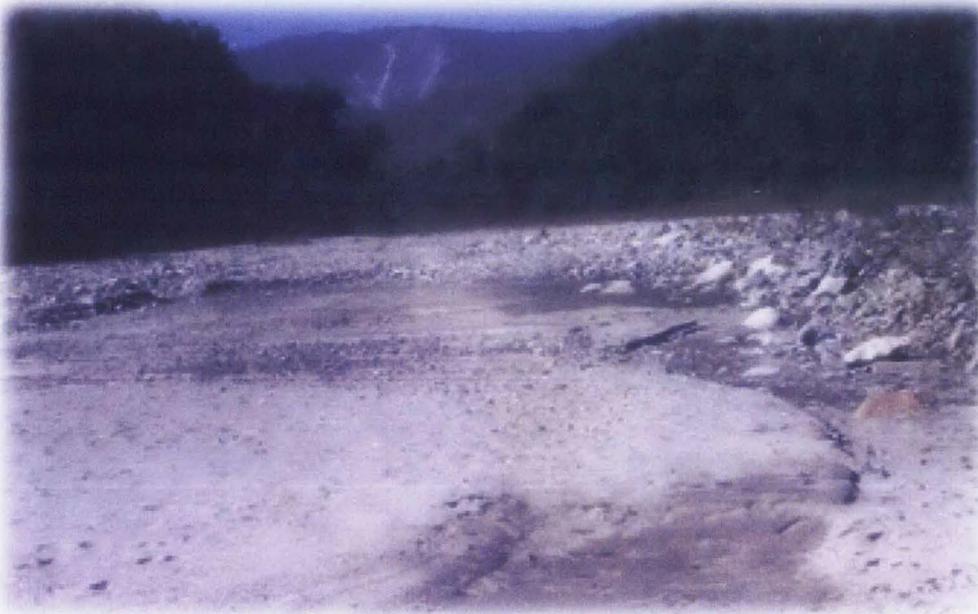
Photo 5.4 Parminder landslide in Lish catchment caused huge deposits in the valley
