## CHAPTER – 4

### Nature and Extent of Environmental Degradation in Darjeeling Hills

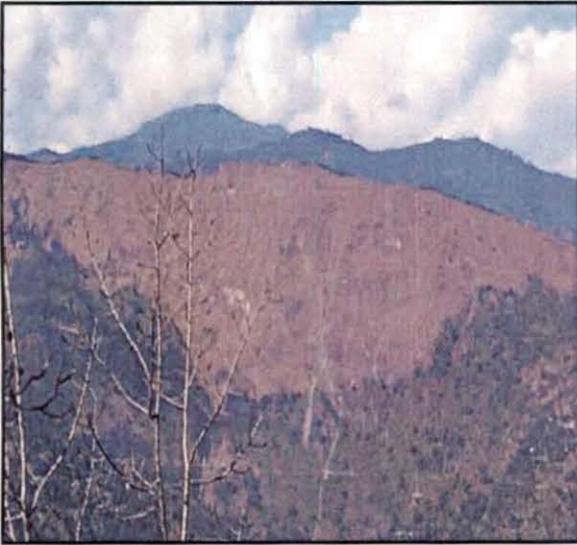
*Photo 4.1 Near complete deforestation near Sikkim Darjeeling border.*

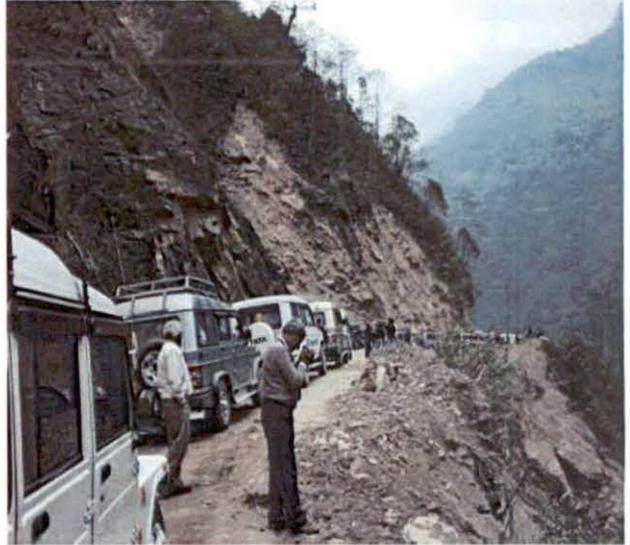
*Photo 4.2. Disruption of traffic: common scenario of roads of Darjeeling hill during monsoon months.*

Evidences show that during 1950s, disastrous landslides, huge amount of debris were deposited below Hill Cart Road, along the main Paglajhora. Subsequently, the underground channel drains through joints of the existing bedrocks. Due to enlargement of underground passage through continuous fluvial erosion the basal support of the road is lost and thereby subsiding the Hill Cart road (photo 4.2).

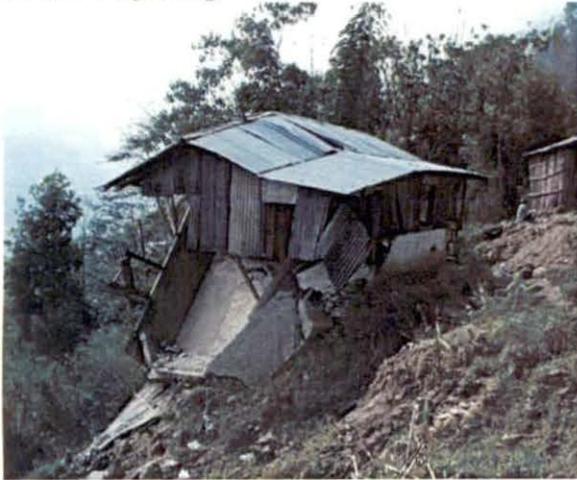
*Figure 4.3. Victim of landslide near Kurseong, During the 2009 landslide.*

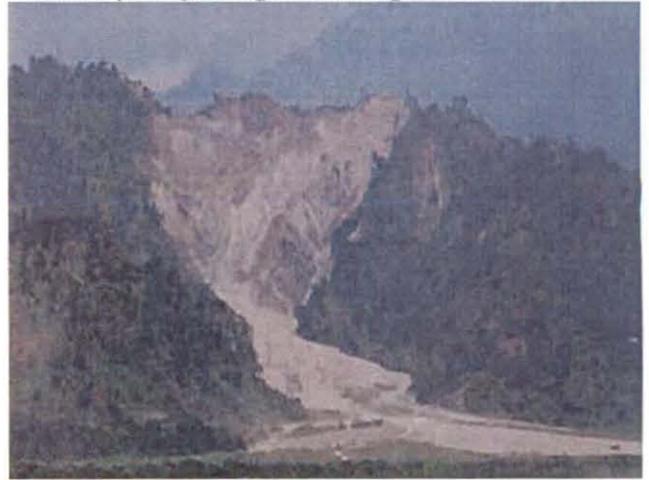
*Photo 4.4. Gigantic landslide along southern margin of the Himalaya.*

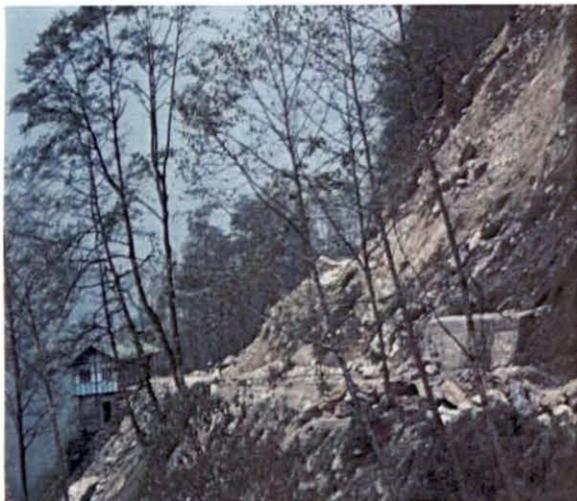
*Photo 4.5. Debris slides near Kurseong*

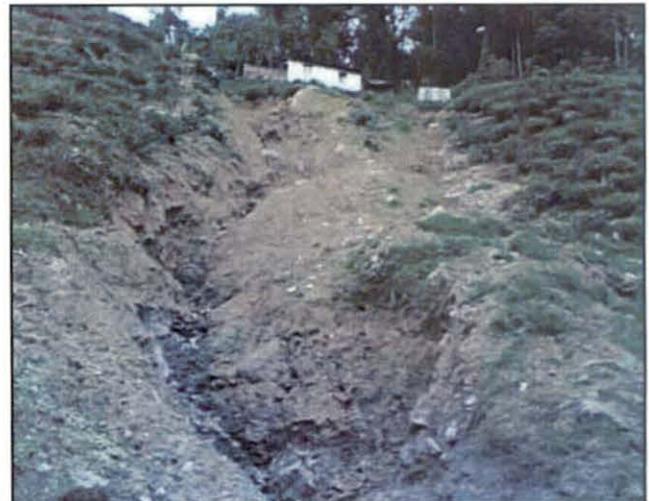
*Photo 4.6 Slumping in Goomti Tea Garden, Kurseong*

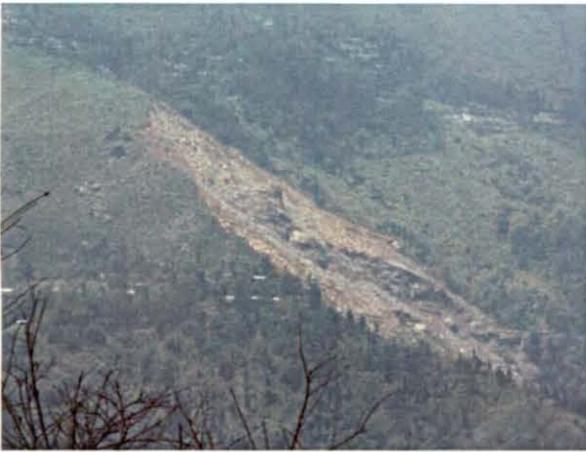
*Photo 4.7. The Lower Paglajhora Landslide, 2010*

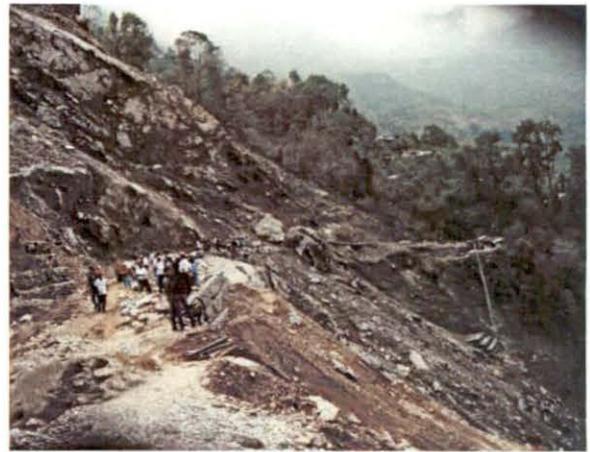
*Photo 4.8. NH-55 and Railway washed down at 17th Mile, hiking is the only option for local people in 2010*

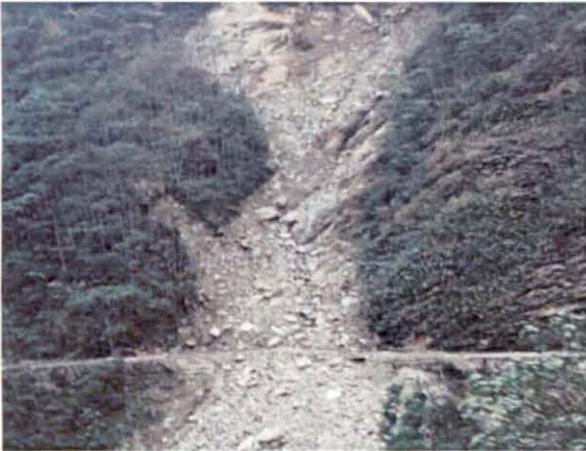
*Photo 4.9 Photo 4.1. Debris slide: common form of Landslides in Darjeeling Hills.*

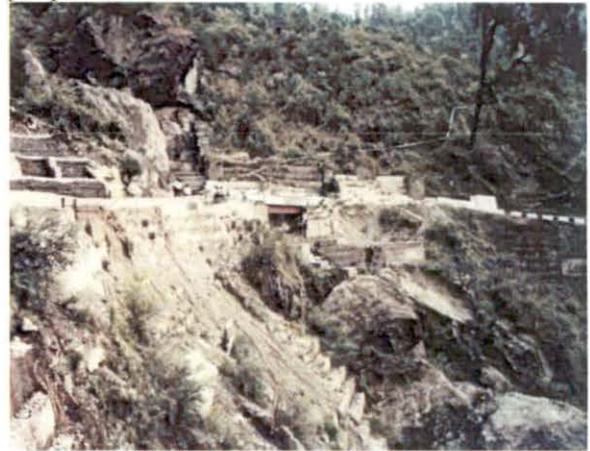
*Photo 4.10 The Paglajhora slump in 1998*

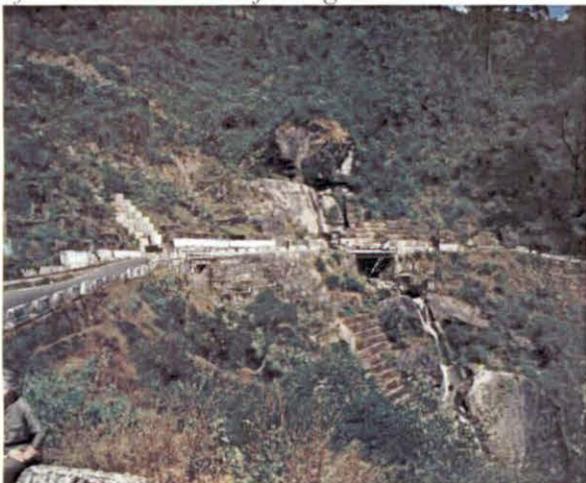
*Photo 4.11 Slumping of lower Paglajhora*

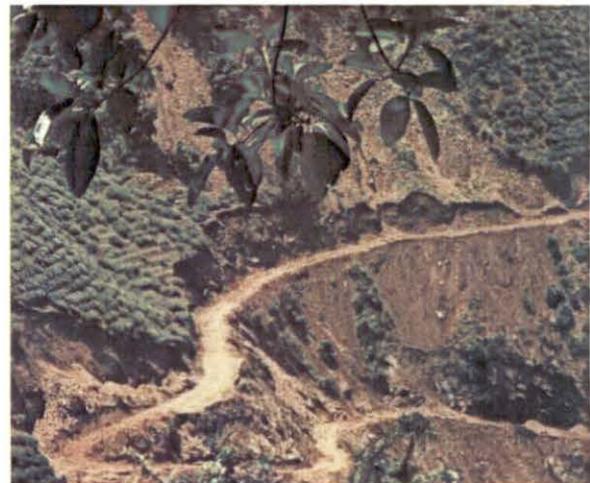
*Photo 4.12. Tea Garden road induced soil erosion, Tindharia*

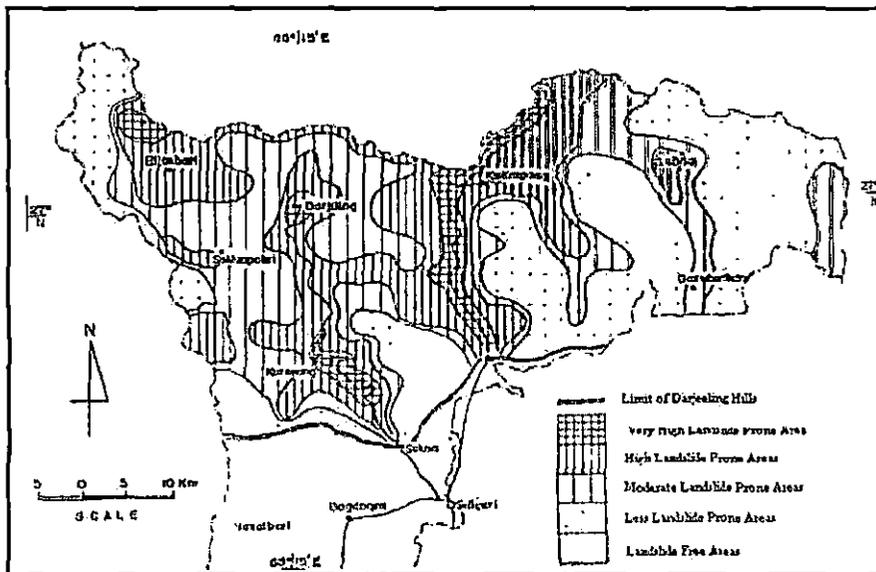
Figure 4.1: Landslide prone areas in Darjeeling hills (Source: Sarkar, 1999).

The map as represented in figure 4.1 shows some striking features such as some tracts of the study area, especially along the Tindharia-Paglajhora, Pankhabari, Rimbik-Lodhama, stretches along the river Tista, Bijanbari, in and around Darjeeling, Kurseong, Mahanadi, Ghum, Sonada, Sukhiapokri, etc., exhibit very high susceptibility. The ridges lower hills and the north facing slopes are showing moderate to moderately low susceptibility (figure 4.1).

to the old slides, which could become re-activated. The excavation position and depth, drainage diversion across the hill, loading of the upper slope and valley, cutting of basal support, unscientific construction and land-use, deforestation, legacies from the past slope movement, relief, drainage, slope materials, etc. have been accounted for in the “Check-list”. Sarkar (1999) has carried out such investigation through collection of direct field data from 65 sample sites as well as from secondary sources, and a map was prepared for identification of landslide-prone areas (figure 4.1).

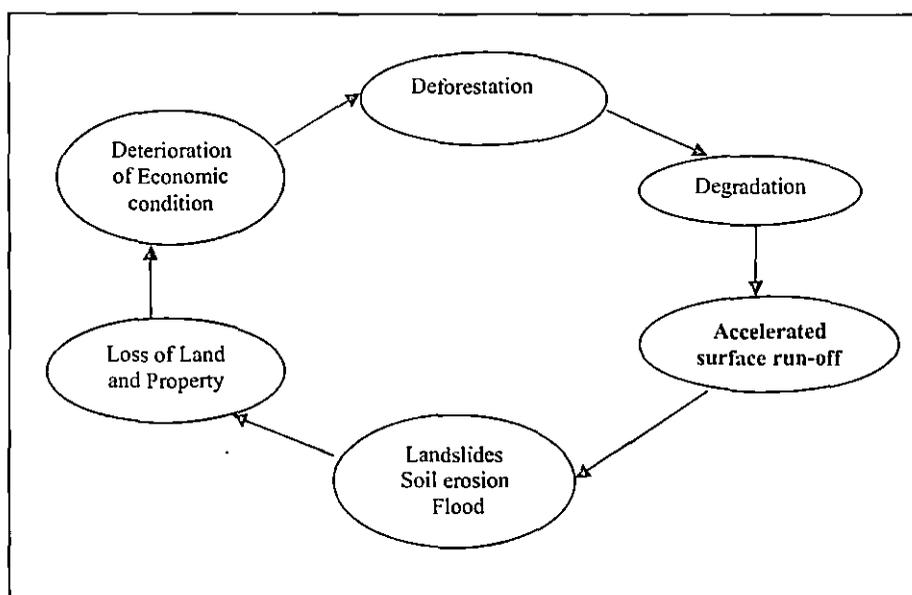
*Figure 4.3 Deforestation-Flood Vicious Cycle: A Case of the Darjeeling hills*
