3.1 Introduction:

3.2 Brief morphometric analysis of Sankosh River:

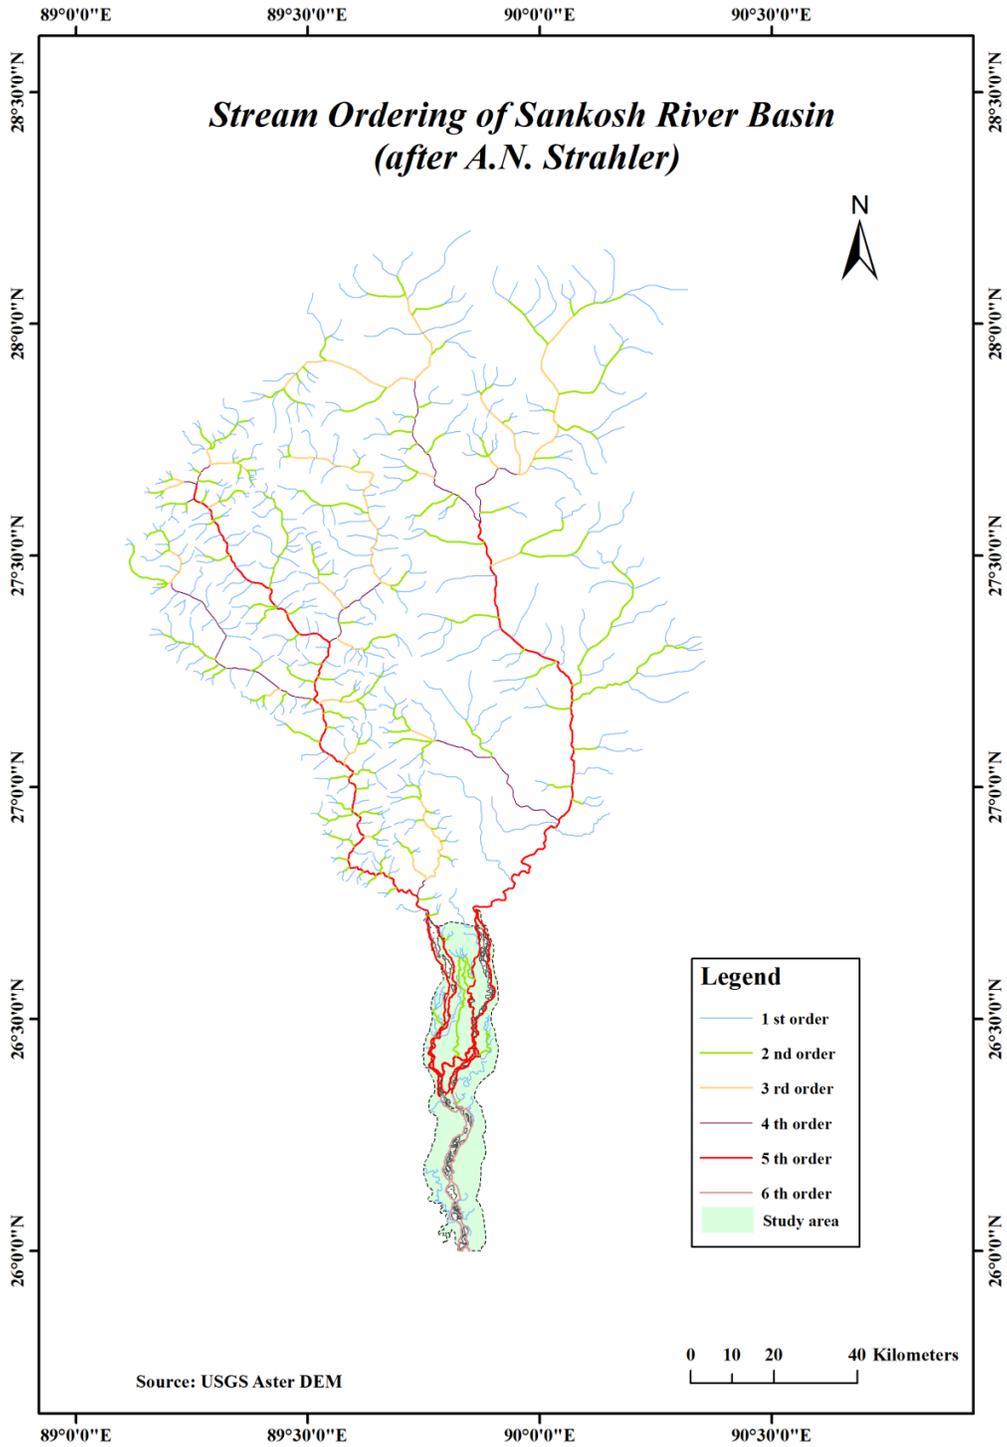
Map 3.1: Stream Ordering of Sankosh River Basin (after A.N. Strahler)

In a drainage basin, Stream ordering is considered the process of identification of links in a drainage network. The Strahler's method (1952, 1964) of stream ordering system has been adopted in determining stream order in the Sankosh river basin. The Stream order analysis reveals that the Sankosh river basin belongs to 6th order basin. It is mentioned that the whole basin area of Sankosh River has formed in different run-off zone on the basis of stream order. In the Sankosh River basin it is observed that the total number of 1st order River is 510 and 148, 26, 10, 2, 1 are 2nd, 3rd, 4th, 5th and 6th order respectively.

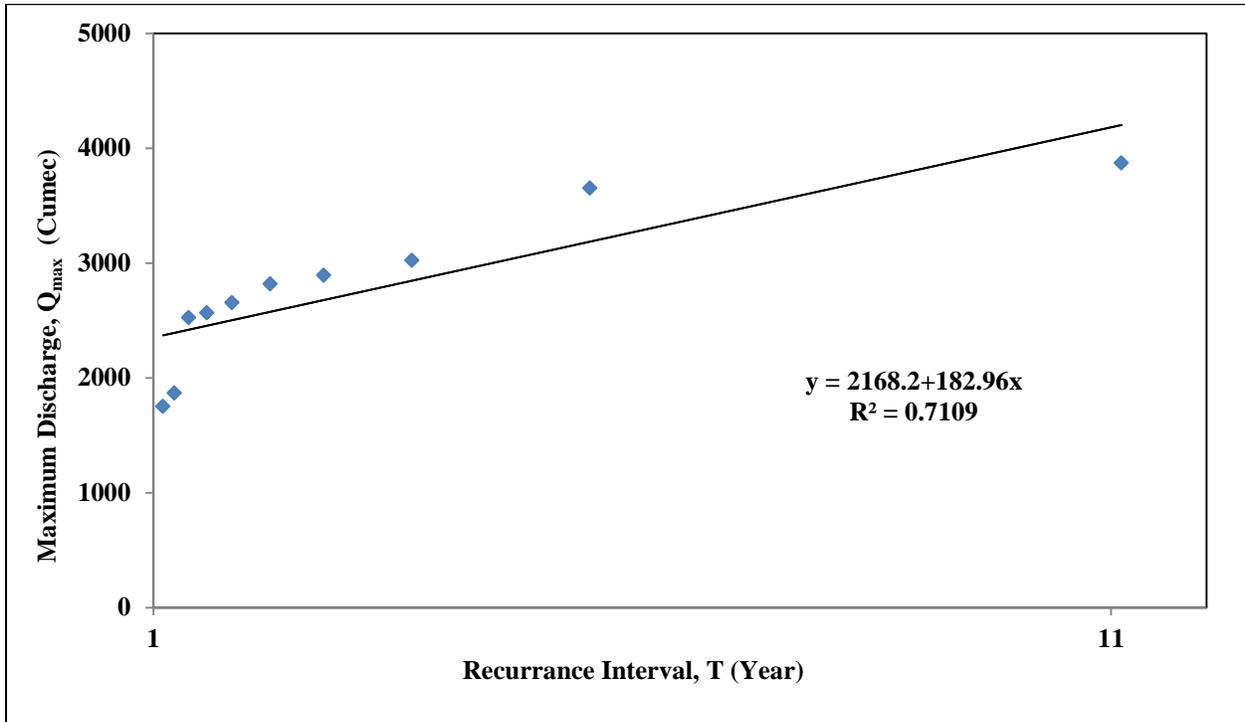
Figure 3.1 Flood Frequency Curve of Sankosh River for the Period of 1999-2008 at Gauge Station of Golokganj

From the above figure 3.1 and table 3.3, it is found that the peak discharge is highest in the year 2002 and the flood event of the same magnitude recurring within 11 years but the probability of flood of the same magnitude is found lowest. On the other hand, the peak discharge is found lowest in the year 2008 but the probability of flood occurrence is very high with the recurrence interval of one year.

Here, based on the discharge data (Table 3.3) for the period of 1999 to 2008 from CWC office, Jalpaiguri flood probability and recurrence interval has been calculated to know the overall conditions of the occurrences of floods and flood discharge in the study area.

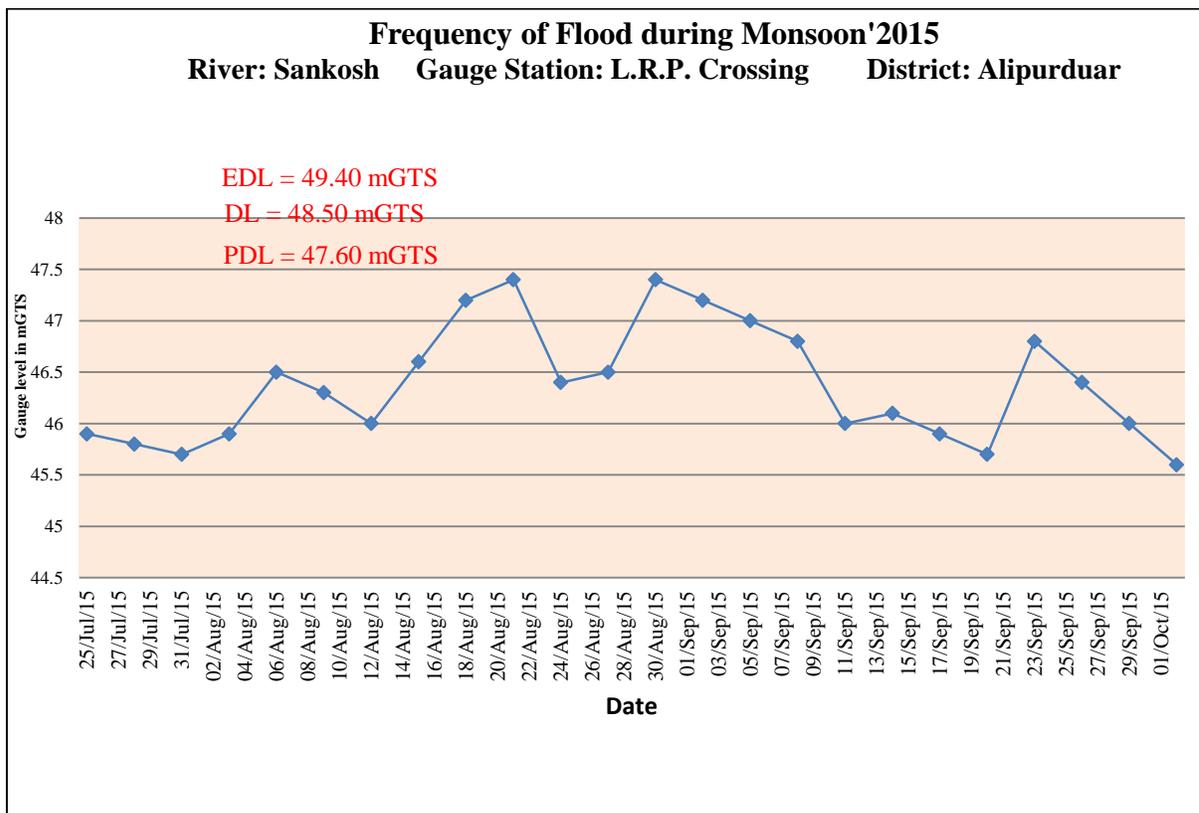
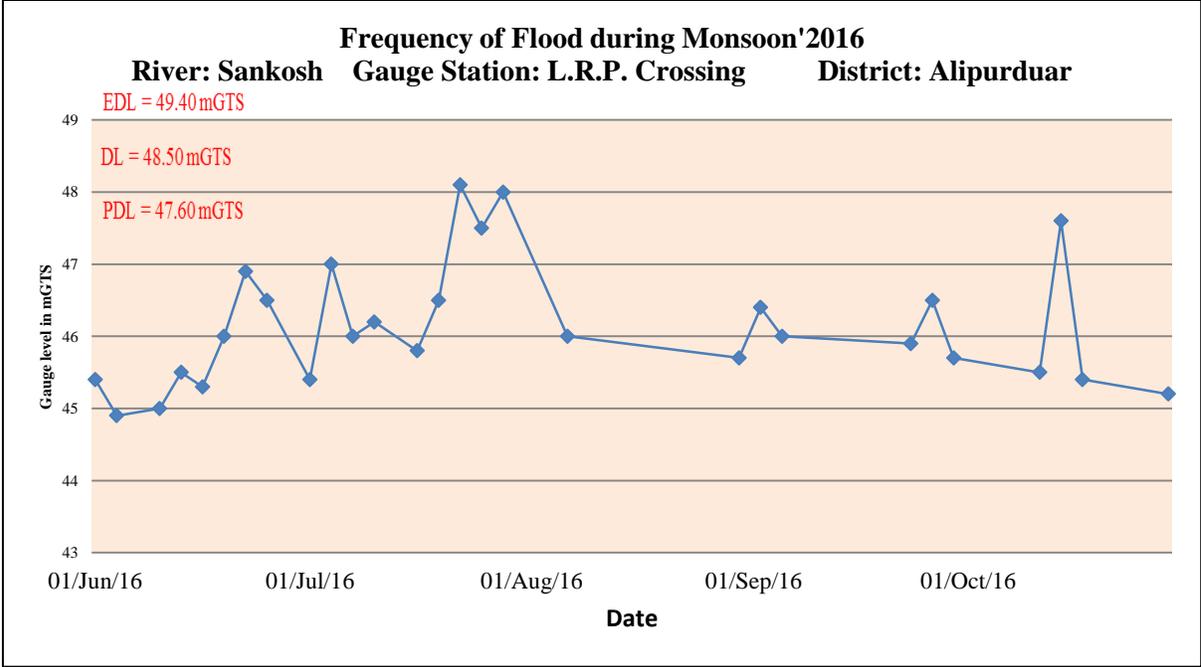
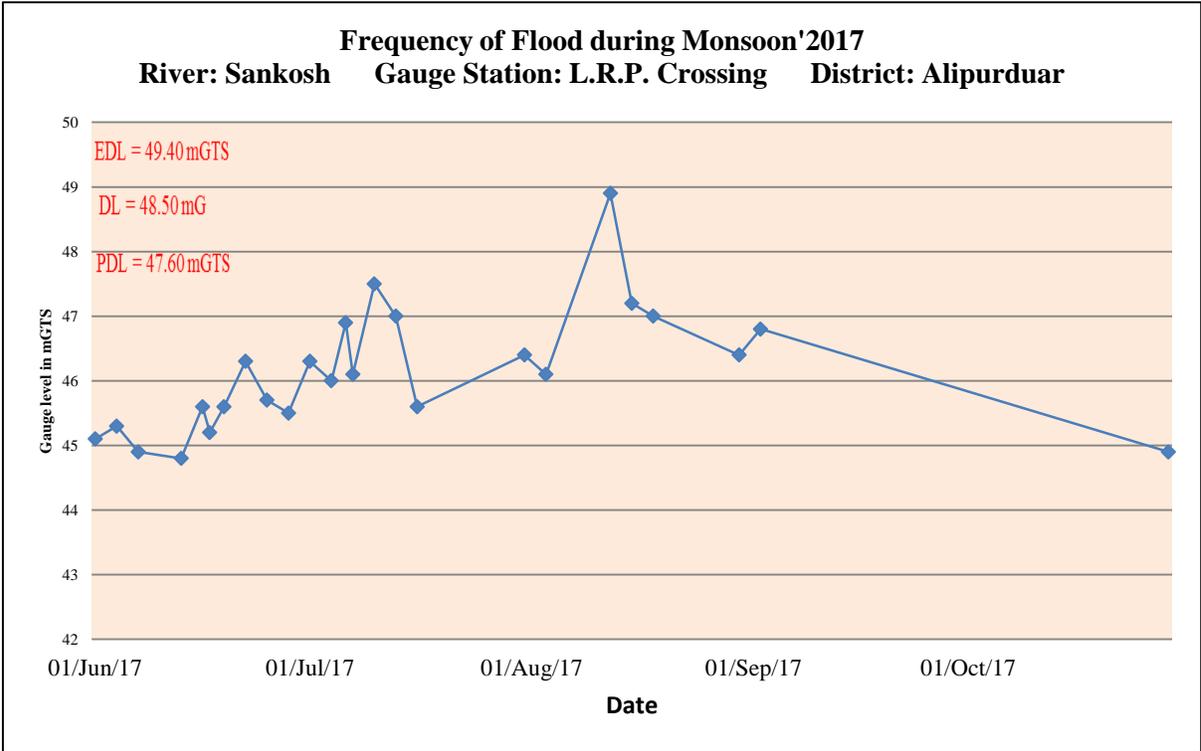
Figure 3.2: Frequency of Flood during Monsoon'2015

Figure 3.3: Frequency of Flood during Monsoon'2016

Figure 3.4: Frequency of Flood during Monsoon 2017

In the study area hydrograph of Sankosh river has been constructed for consecutive three years (i.e. from 2015 to 2017) from the collected data. From the constructed hydrographs it is observed that hydrographs are multi peaked in nature in the study area. So, it can be inferred that rain storm occurs before the run-off of the previous storm ceases. From the above figure it is found that the hydrographs for the year 2016 is skewed to the left which indicates that the peak occurs relatively quickly. On the other hand, in the year 2015, the hydrographs are skewed to the right and which reveals the longer lag occurring peak and remain one hydrograph of the year 2017 indicates the intermediate peak occurrence in the study area. In this regard, it is concluded that flood magnitude and frequency are responsible for the local changes in the flood plain slope relative to the channel belt slope and which initiate the processes of channel avulsion with respective time and location (Mackey and Bridge, 1995) in the study area.

Hydrograph (Figure 3.2, 3.3 & 3.4) is the plot of discharge against time during a rainstorm event. It is the slope of the flood wave at the location of any particular gauging station. Hydrograph at any gauging station is generally used to define the changing slope of the flood wave as it runs towards the downstream. In the study area, it is observed that the hydrograph is mostly depending on the intensity of rainfall and the characteristics of the basin area. Detailed analysis

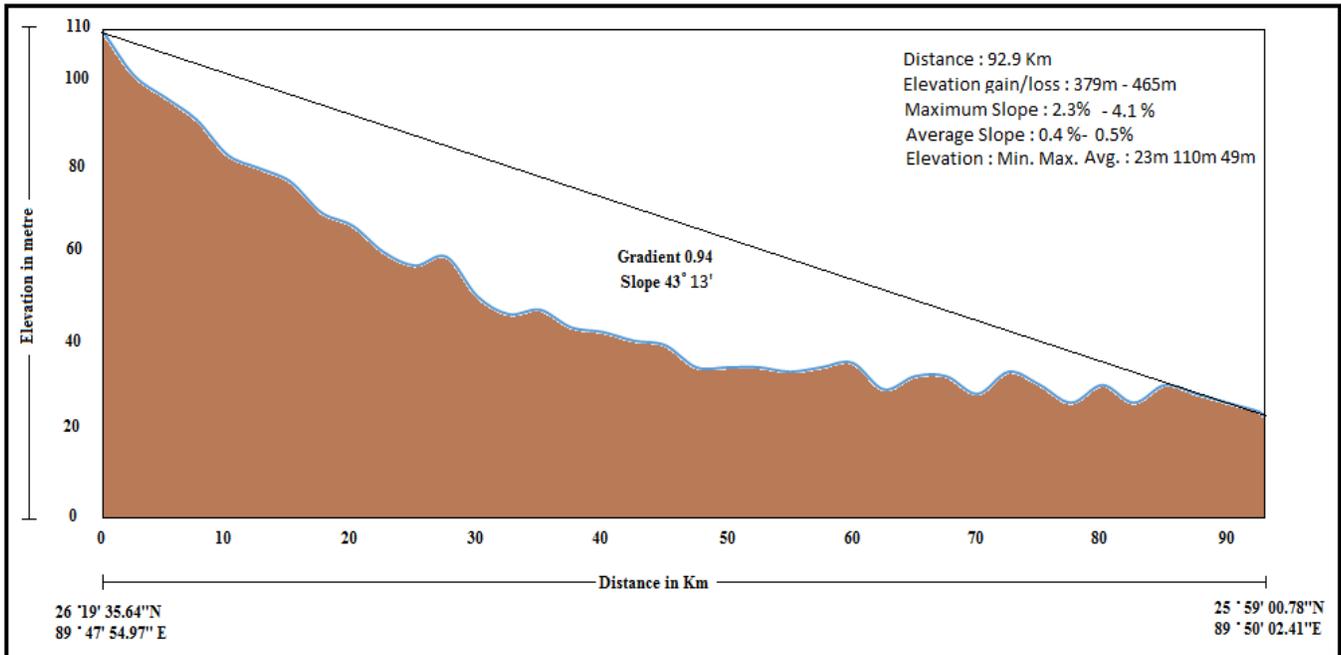
Figure 3.5: Long profile of Sankosh River from Indo-Bhutan border to Indo-Bangladesh Border

The alluvial section of the lower Sankosh river channel at fatal stage reveals a concave-upward slope along its downstream gradient (figure 3.5) with an elevation 110m above the mean sea level at 23m located a distance of about 92.9 km downstream the studied segment of Sankosh river while the elevation at 110m above mean sea level which is about 92.9km downstream of River Sankosh, Thus the river drops 92.9km along the studied reach. As a result, longitudinal zone of channel forms may be identified from the headwaters downstream to the river mouth.

It is observed that the profile is punctuated at different points where the river cuts through valley floors as indicated at about 4 km distance which is clearly influenced by human interference of the location of a barrage and sand mining activity respectively.

The gradual lowering of the channel gradient provides explanation of erosional and depositional work of the river along the meanders and braided section and the possible reason for the increase in fluvial landform within the study area. Features like ripples and pools sequence are evidenced at the concave and convex section of these meanders which are characterized by braids between 70 km to 80 km downstream distance. These types of features are formed by pattern scour and deposition at bankful discharge where the ripples tend to occur at inflection points and pools at bends.

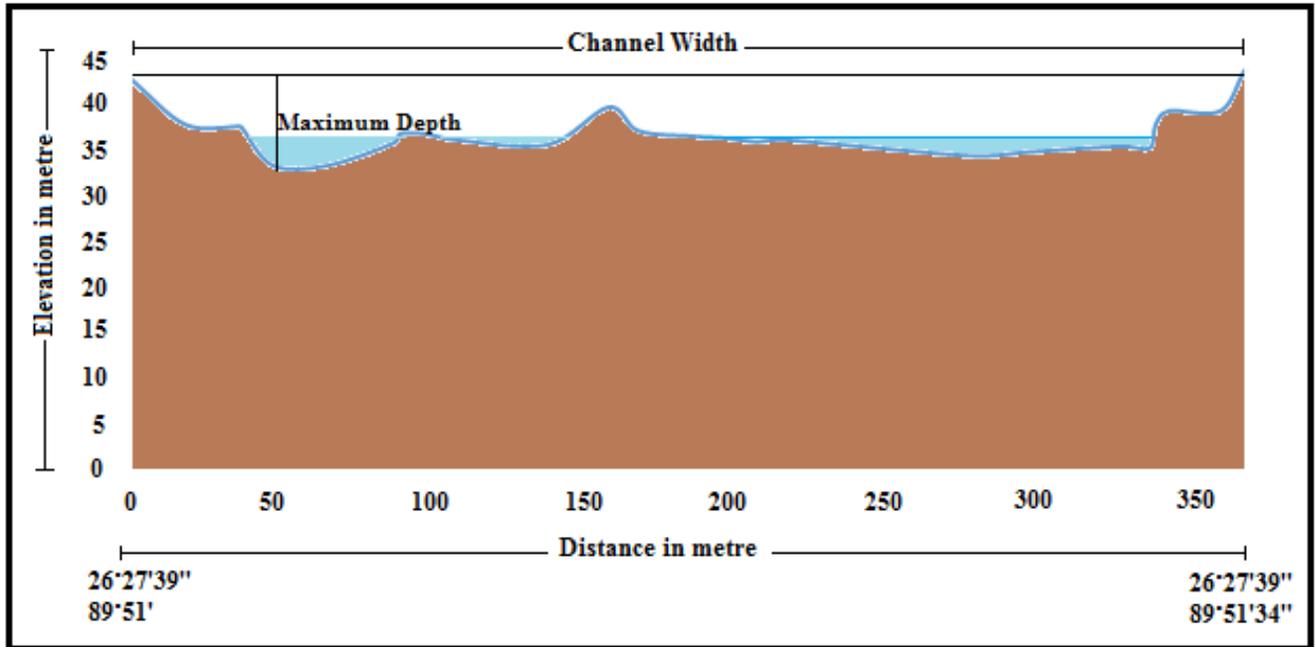
Figure 3.6: Cross Profile at Upstream Gauge Station at Barobisha

The cross-profiles (Figure 3.6, 3.7 & 3.8) of the River Sankosh at the three reaches is distinctive due to braiding and bed load meandering is featured by a number of wetted perimeter separated by sand bars, mud-flats or mid islands, which repel the water flow against the side walls of the channels causing erosion and avulsion.

Moreover, discharge can often be measured automatically giving a continuous record (i.e. hydrograph) of the changing level or direct discharge of the river. In the study area it is observed that the cross-sectional area (Figure 3.6) fluctuates with the change in water level or river stage. Further it is also mentioned that with known cross-sectional area, the discharge can be derived by measurement of the water level at different selected gauge station in the study area.

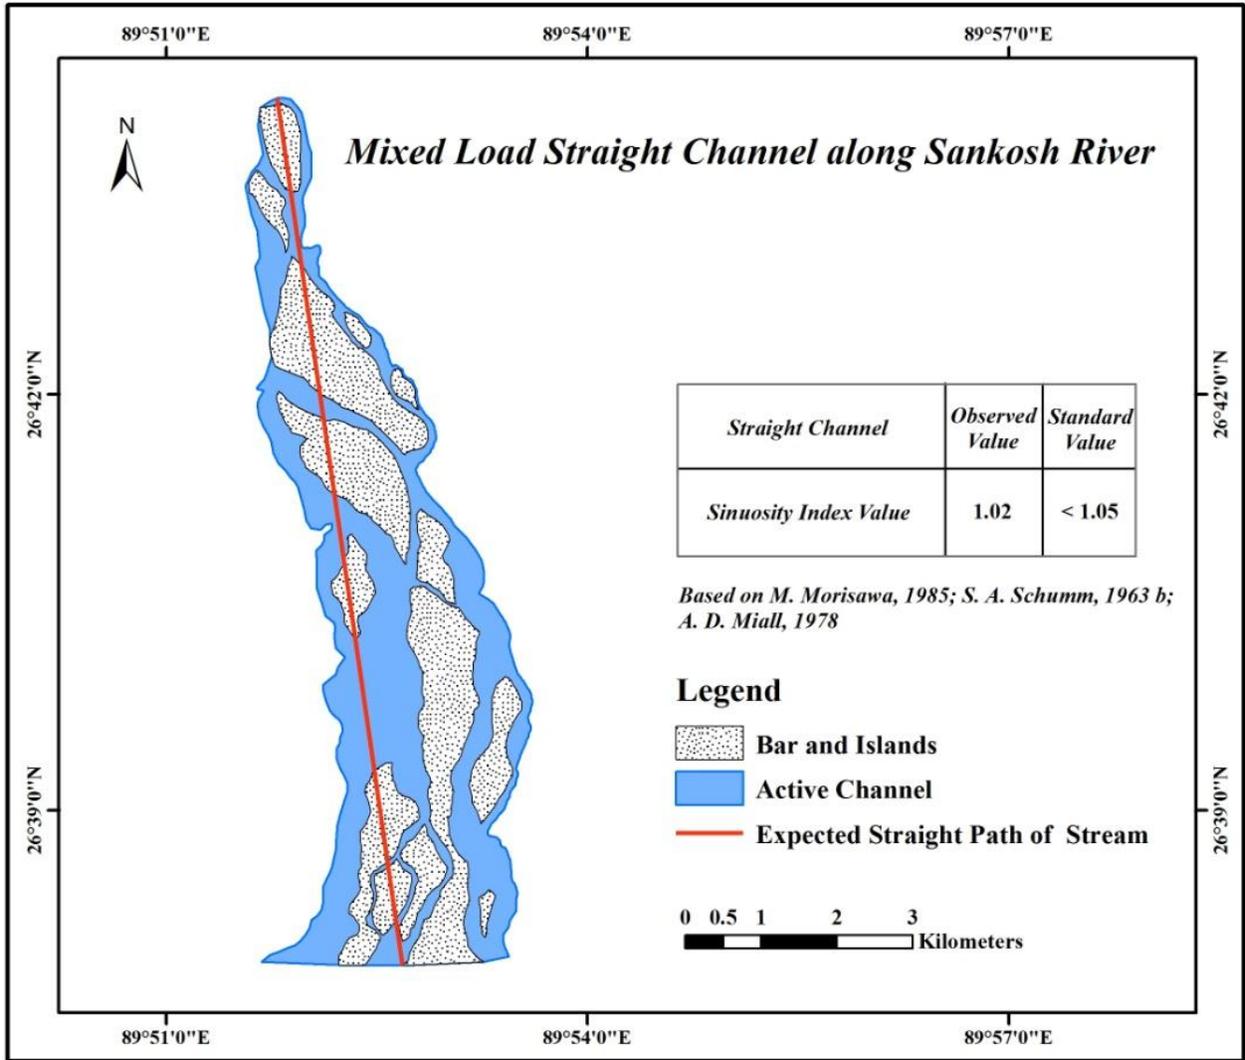
Map 3.2 Mixed Load Straight Channel along Sankosh River

The channel is straight and it is usual for the thalweg, or line of maximum depth, to wander back and forth from near one bank to other (Wolman, Leopold, Miller 1963) which in our study is found at the northern part of the study area and Sinuosity index is less than 1.05 because of high degree of slope (Map 2.6) which is responsible for higher velocity in the channel flow.

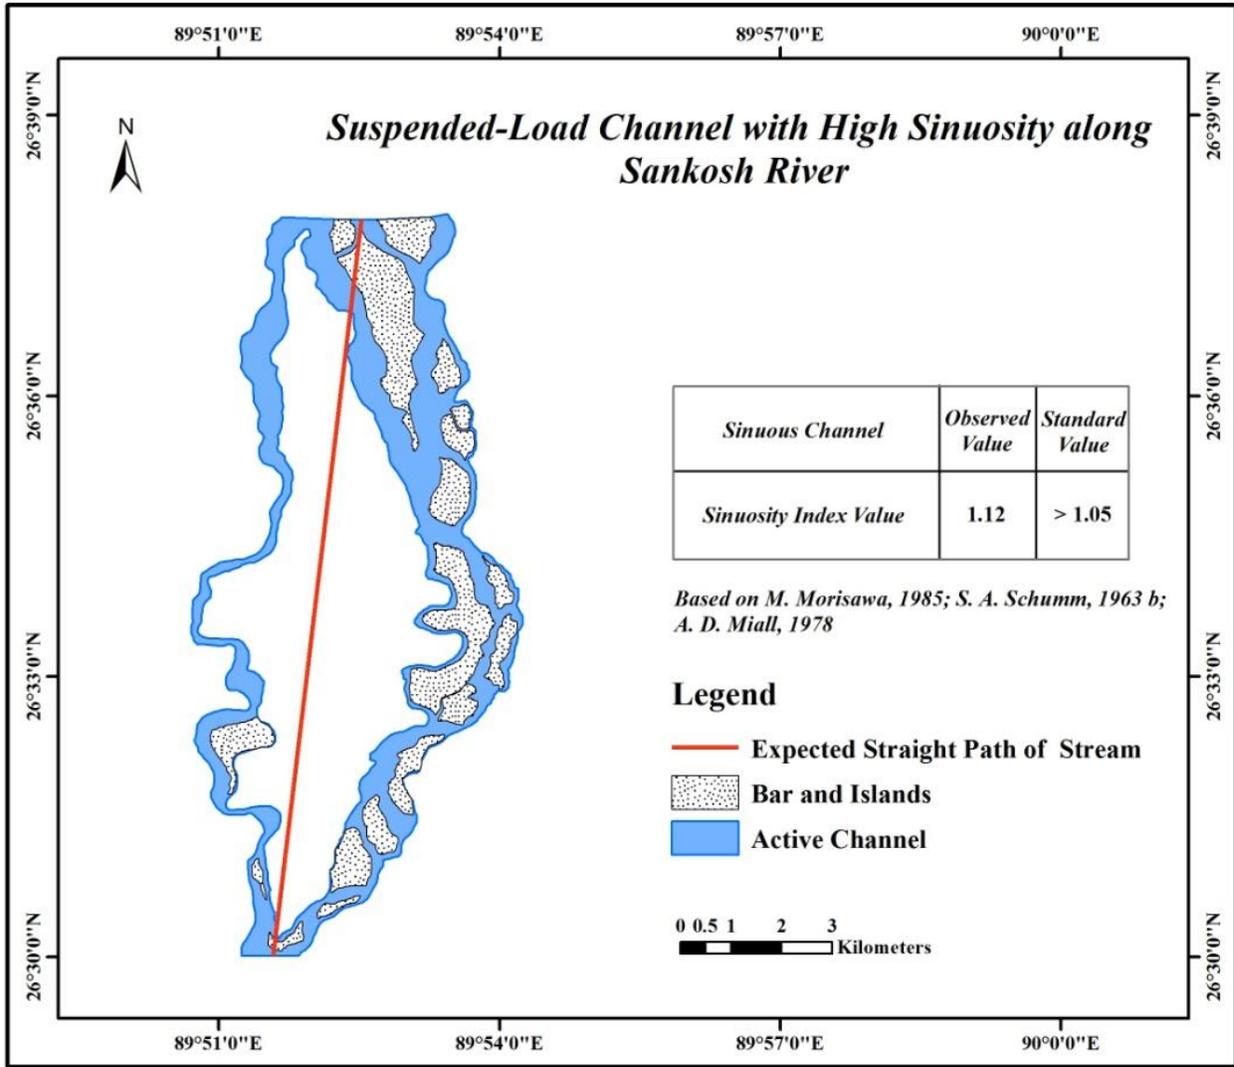
Map 3.3: Suspended-Load channel with High Sinuosity along Sankosh River.

An alluvial channel when Sinuosity index is between 1.05 and 1.5 is called sinuous channel, is found in the lower portion of straight pattern of River Sankosh.

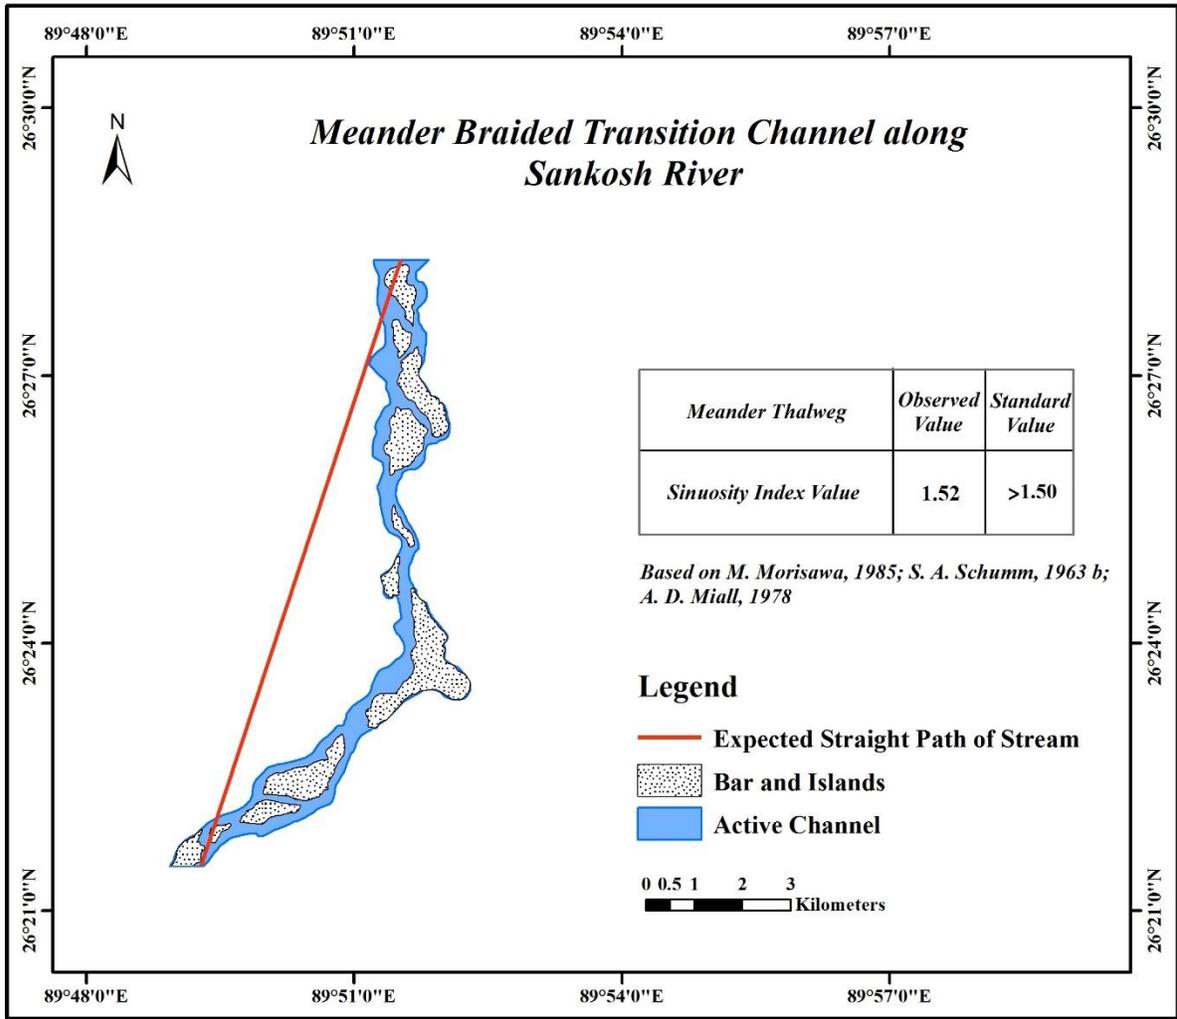
Map 3.4: Meander-Braided Transition Channel along Sankosh River

An alluvial channel pattern having sinuosity index more than 1.5 is called meandering channel and it is characterized by pools at the bends and rifles at the crossovers of the main stream and is found at midsection of the study area with high curvature.

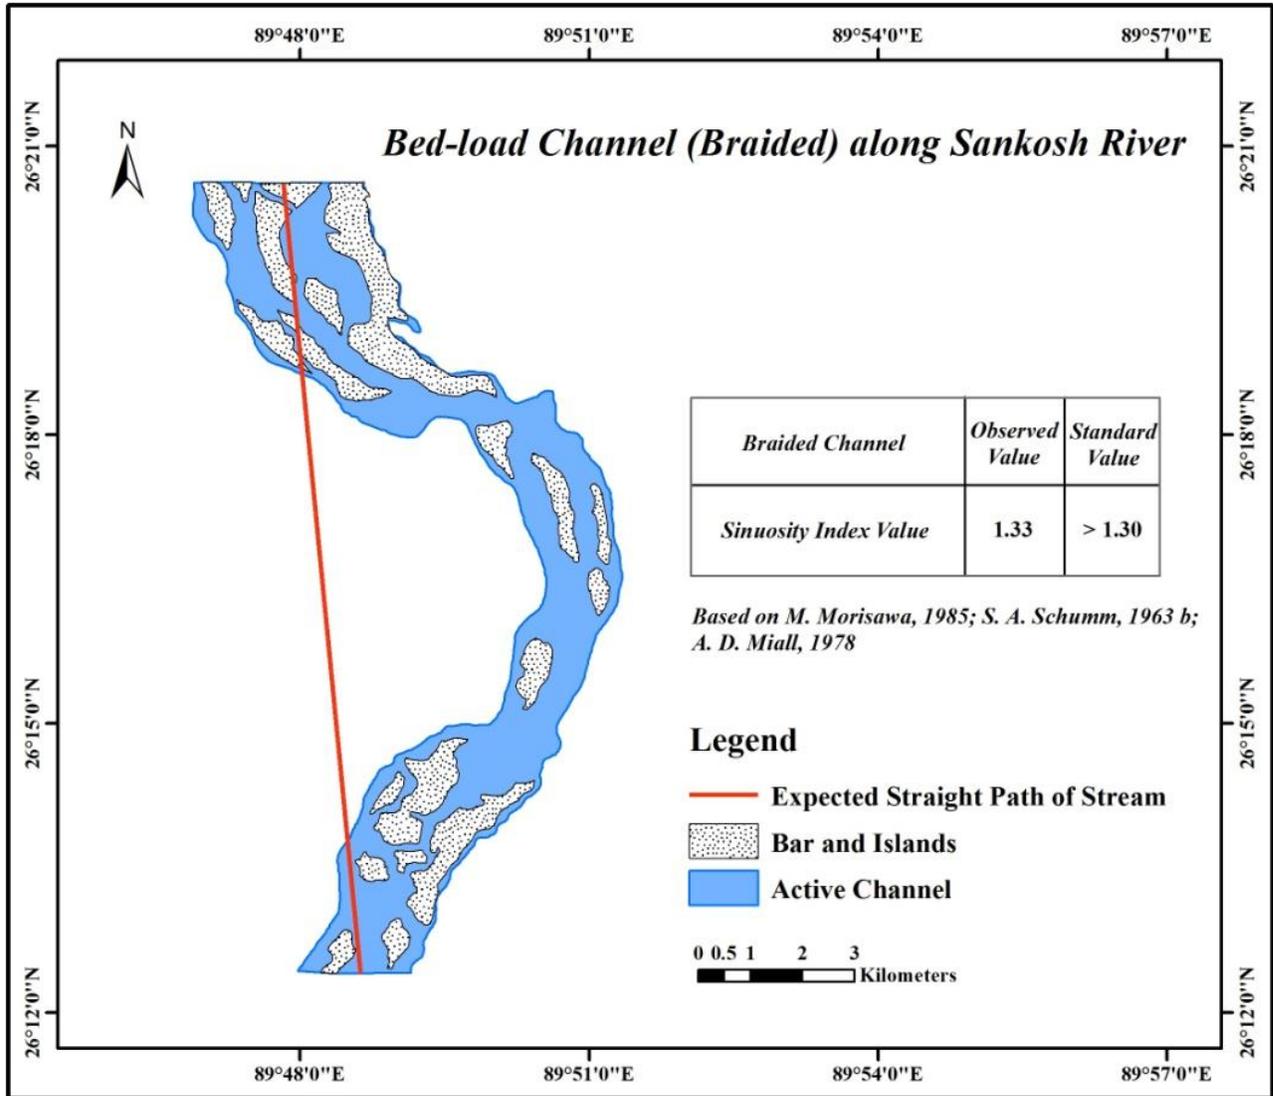
Map 3.5: Bed-Load channel (Braided) along Sankosh River

The separate channels of a braided stream are divided by islands or bars. Bars which divide the stream into separate channels at flow are often submerged at high flow (Wolman, Leopold, Miller 1963). In this study braided channel is a very common feature and is found in the entire Sankosh river basin.

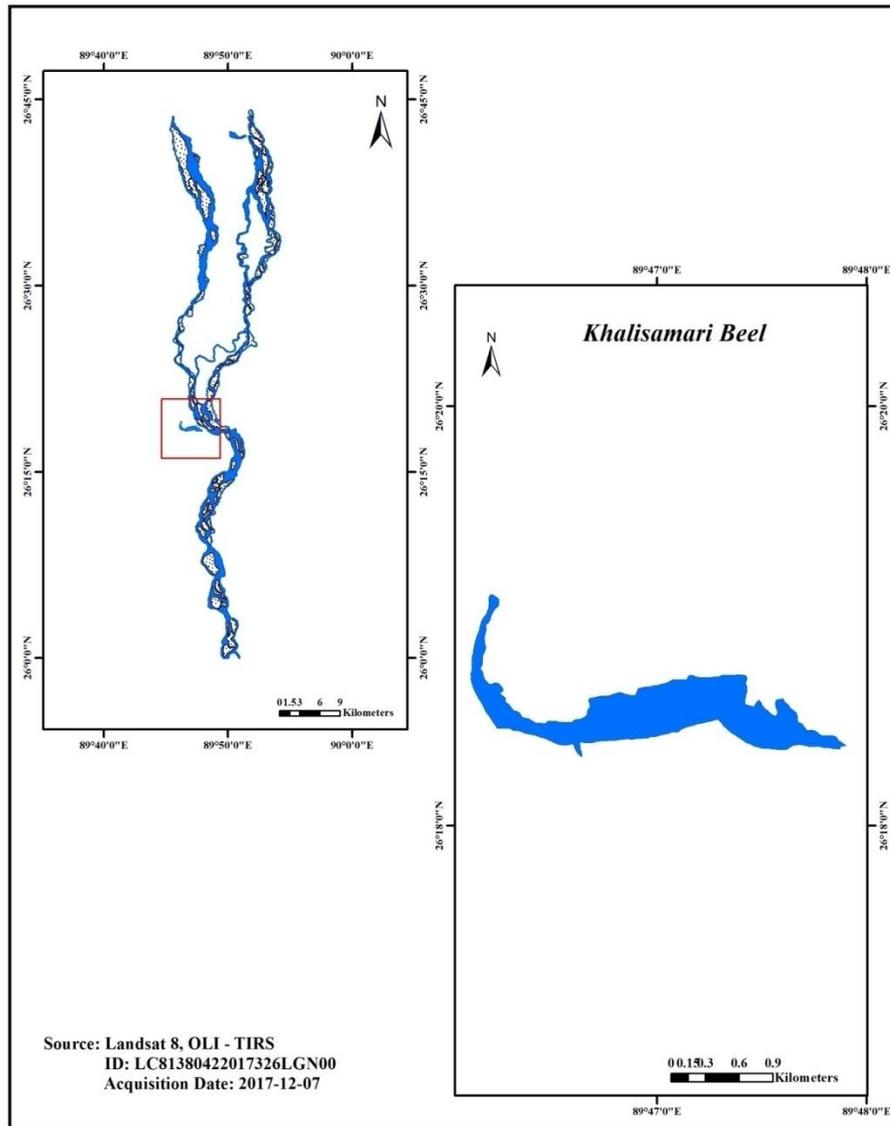
Map 3.6: Location Map of Khalisamari Beel

Khalisamari Beel (Map 3.6) is located at Chagalia village of Dhubri district of Assam. At present Khalishamari Beel is an abandoned channel of Sankosh River. This abandoned channel was a main channel of Sankosh river in the past which disconnected by the process of chute cut-off for long time. This abandoned channel occupies about 70 acres of land and exhibits a ground elevation of about 32 m from mean sea level. The length of this abandoned channel is around 8

km from Chotto Guma to Kaimari village. The depth of water of this abandoned channel is about 5m to 6m in rainy season and 3m to 4m in dry season and is affected by floods in the rainy season. In the earlier times, this Khalishamari beel was owned by the king of Gouripur.

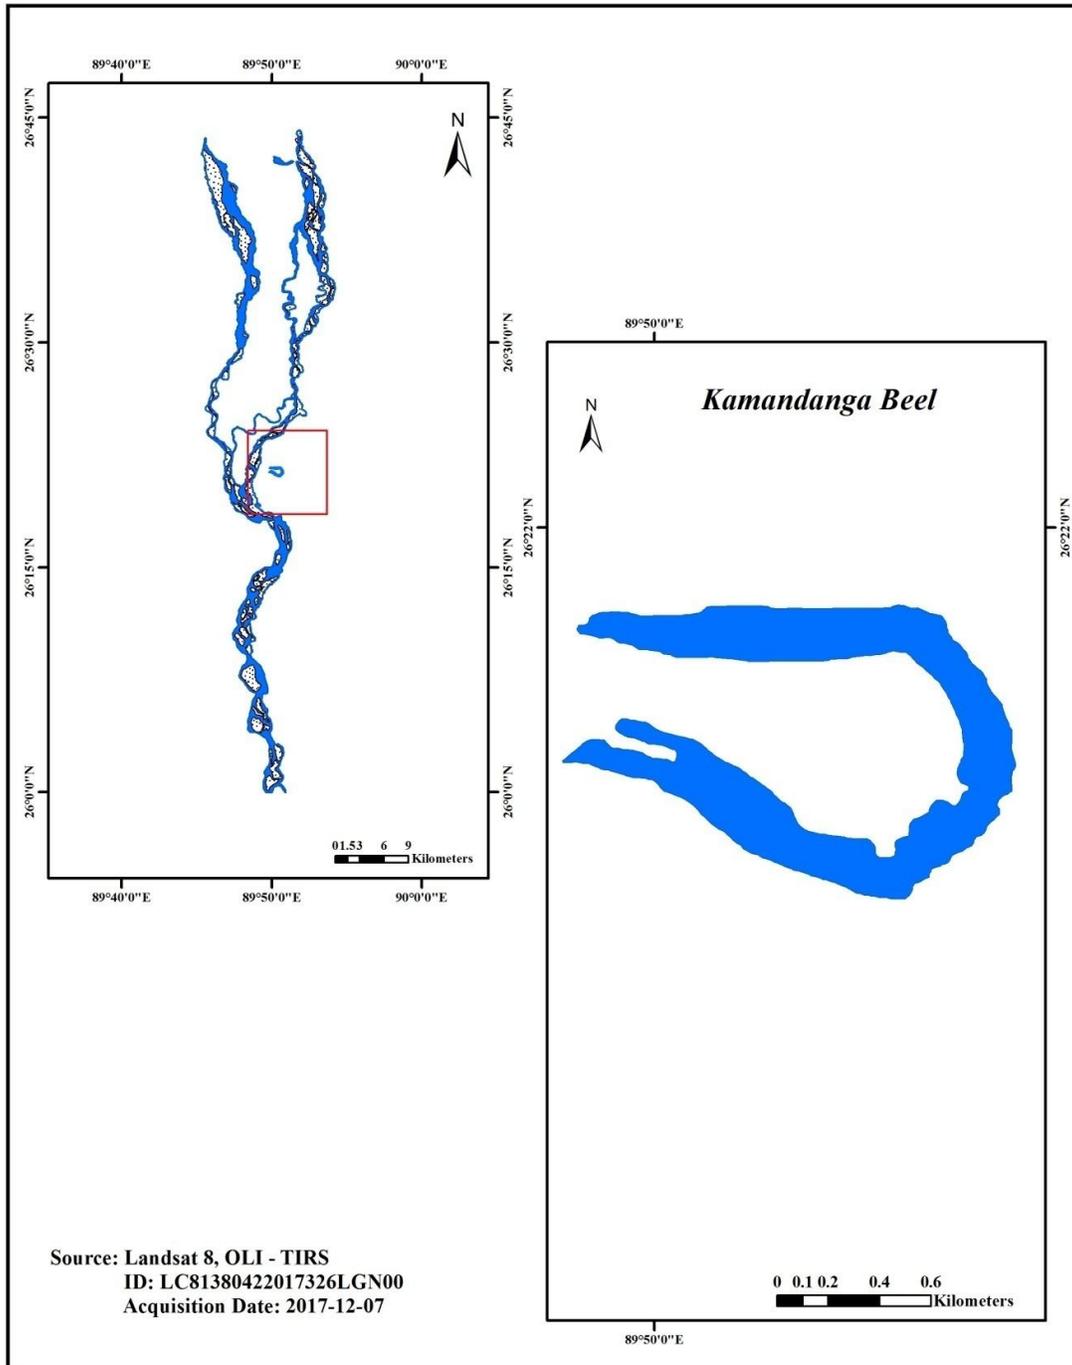
Map 3.7: Location Map of Kamandanga Beel

Kamandanga Beel (Map 3.7) is located at Pokalagi village and Kamandanga village of Dhubri district of Assam. Geographically it is situated in the left bank of Sankosh River at 26° 12' latitude and 89° 50' longitude. It is an important abandoned channel and its geographical area is about 188 bigha. Its length is 1.5km to 2.0km with 200m to 300m width. The water depth of this abandoned channel is 4m to 6m in rainy season and 3m to 4m in dry season. This Kamandanga Beel is socio-economically very sound. Water of this beel is used for irrigation and agricultural purpose, fishery and other household purpose of the people of the village. It is also mentioned that this beel is controlled by Govt. Of Assam and a legal tender is opened every year for fishery.

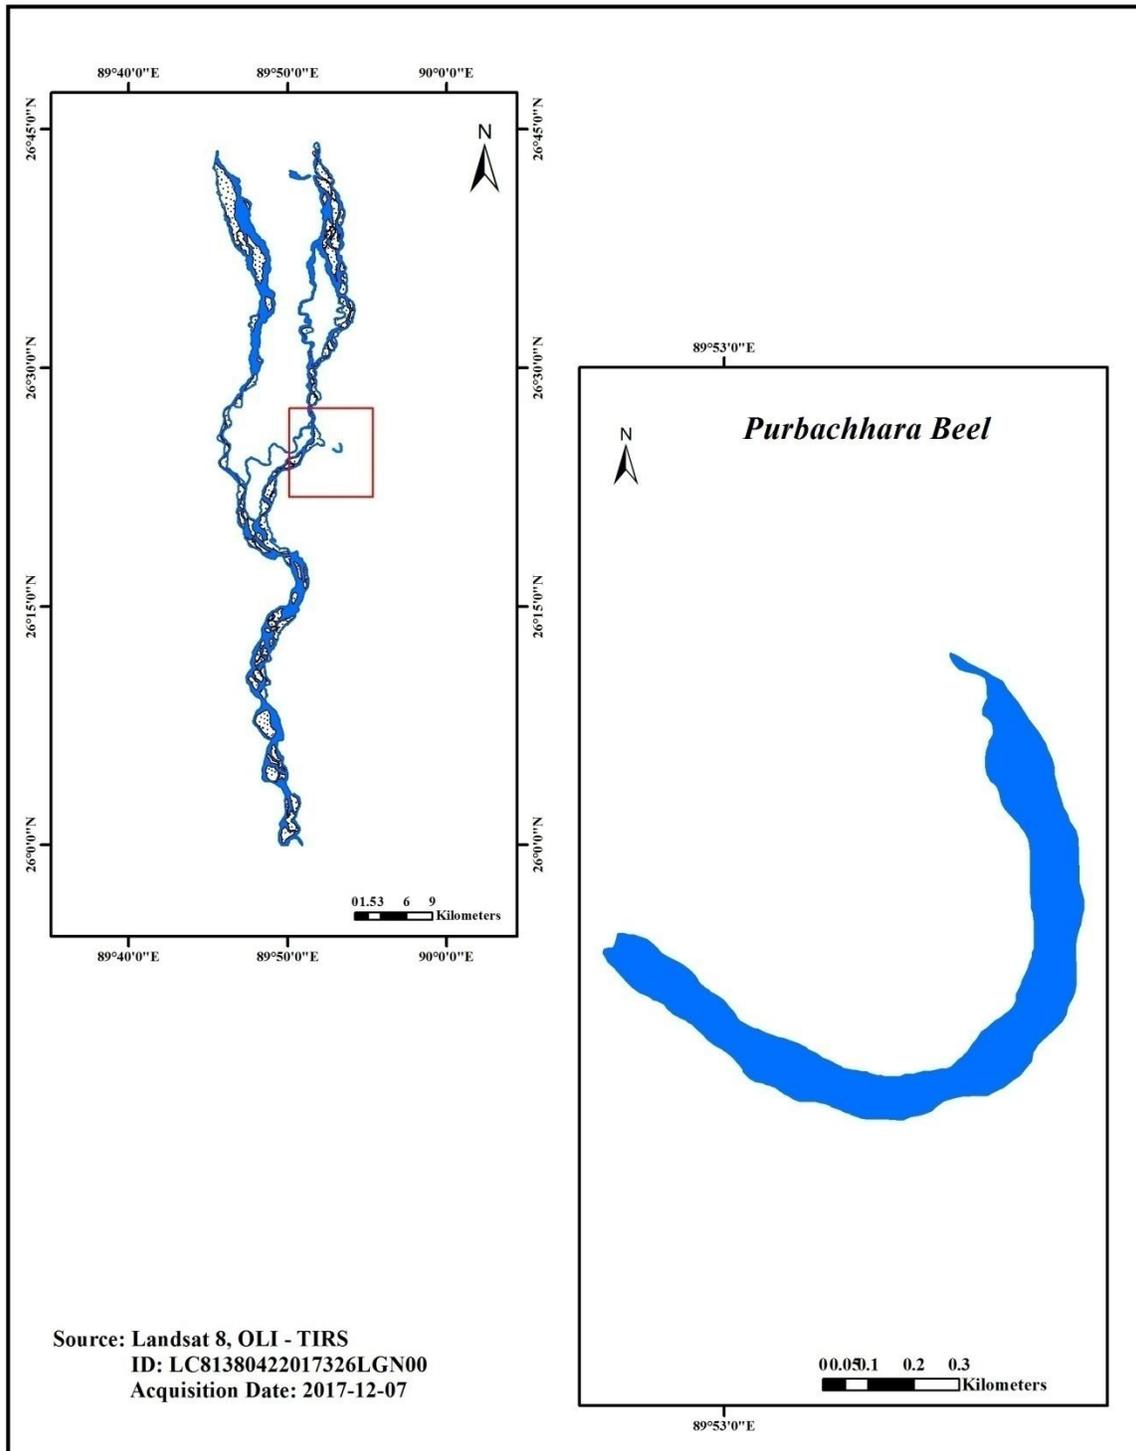
Map 3.8: Location Map of Purba chhara

A semi-circular, curved shaped perennial abandoned channel formed by meander cut-off named Purbachara (Map 3.8) is located at Schoolghutu village of Kokrajhar district of Assam. Geographically it is located in the left bank of Sankosh river at 26° 21' latitude and 89° 53' longitude. The length of this channel is about 1km to 1.5km and water level is about 2m to 3m in dry season and 3m to 4m in rainy season, Socio-economically this abandoned channel is more important and used for agricultural and other purposes by the local people.

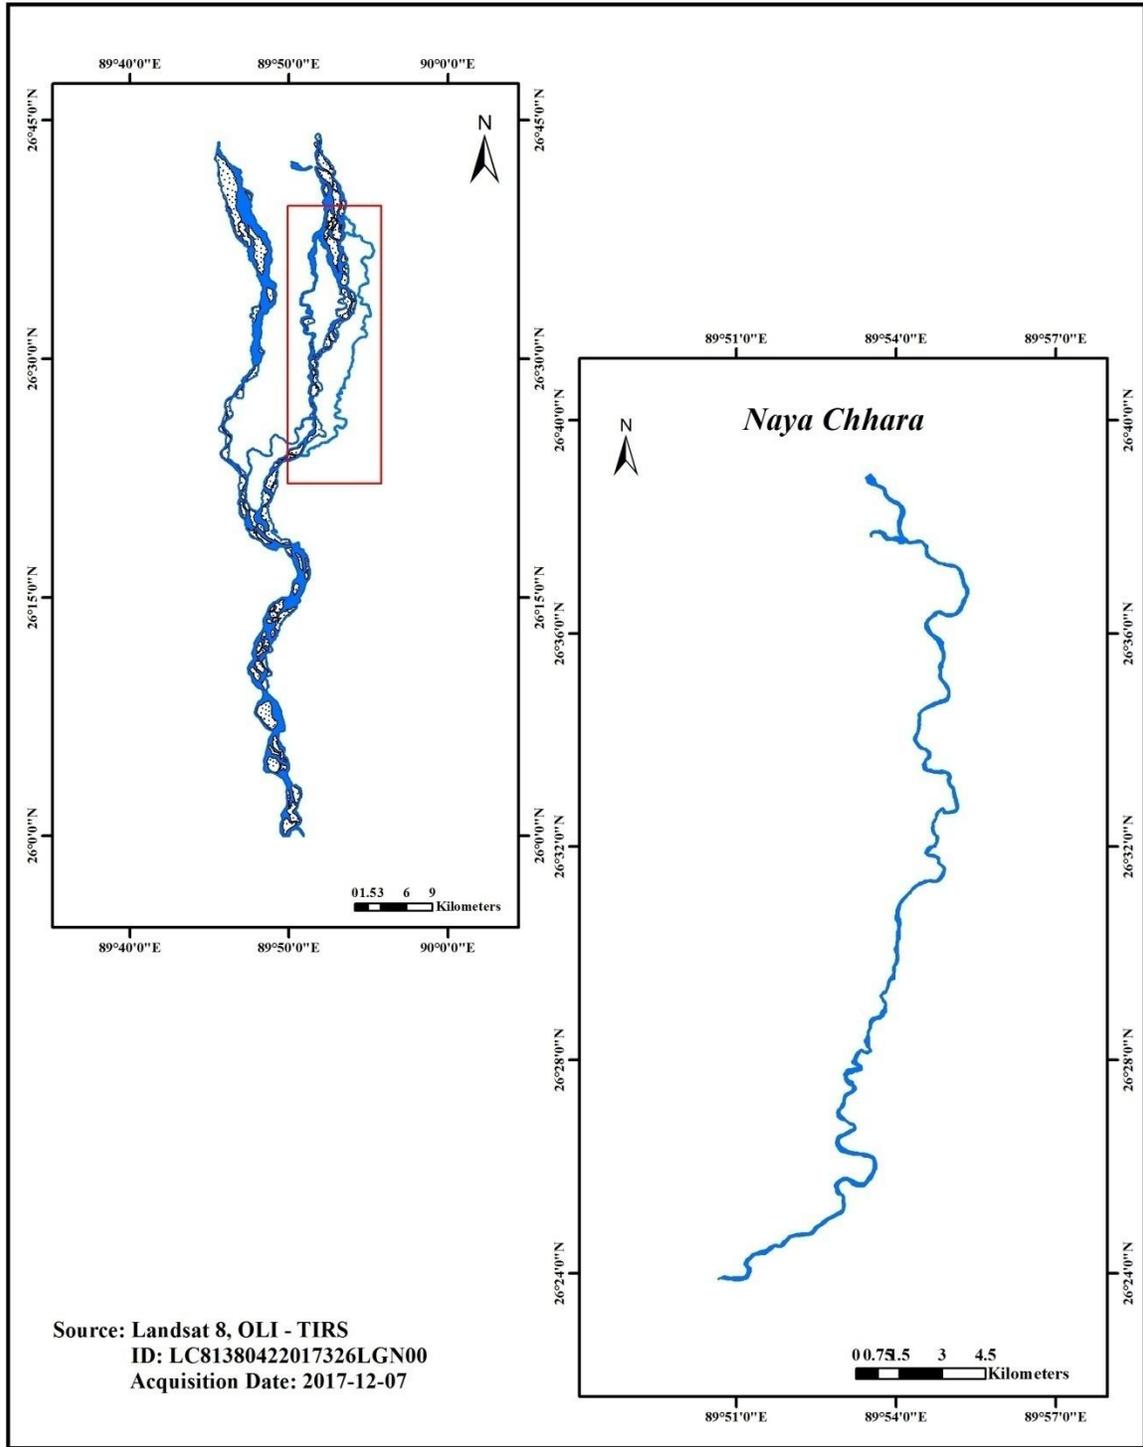
Map 3.9: Location Map of Naya Chhara

An avulsed channel Nayachhara (Map 3.9) of Sankosh river is found at the Fulkumari village of okrajhar district of Assam in the left bank of the main channel. Due to siltation and dense forest cover, this avulsed channel disconnected with the main river and now flows a few km to the south direction and again meets the main channel of the river Sankosh at Majherdabri village of Cooch Behar district of West Bengal. Numerous meander formations are found in this avulsed channel and it has great importance to local people residing in the surrounding areas of the abandoned channel.

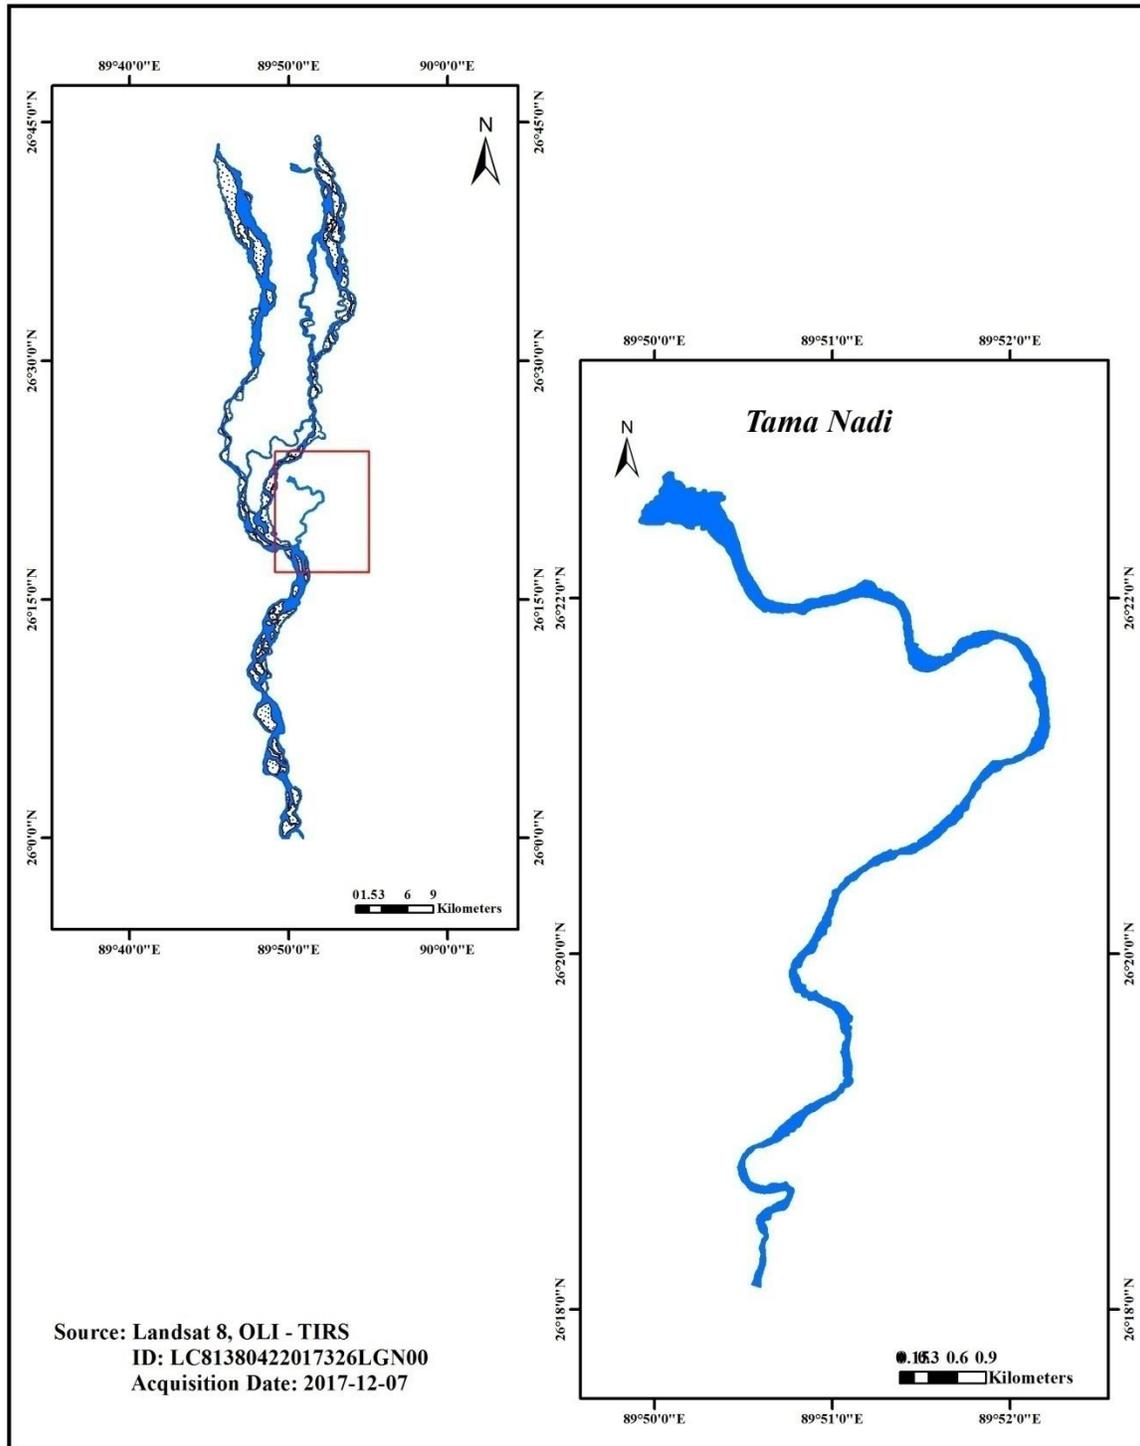
Map 3.10: Location Map of Tama Nadi

A locally avulsed abandoned channel is found in the middle stream reach of Sankosh River of the study area. It has been observed that Tamanadi (Map 3.10) has formed due to channel infilling at the entrance. The total length of this avulsed abandoned channel is about 13 km. It is noticed that the entrance portion of this avulsed channel forms an extensive flood plain and some portion is occupied by local dwellers for settlement and use of surrounding land for agriculture, livestock grazing and other economic activities.
