3.1 Introduction:

3.2 Brief morphometric analysis of Sankosh River:

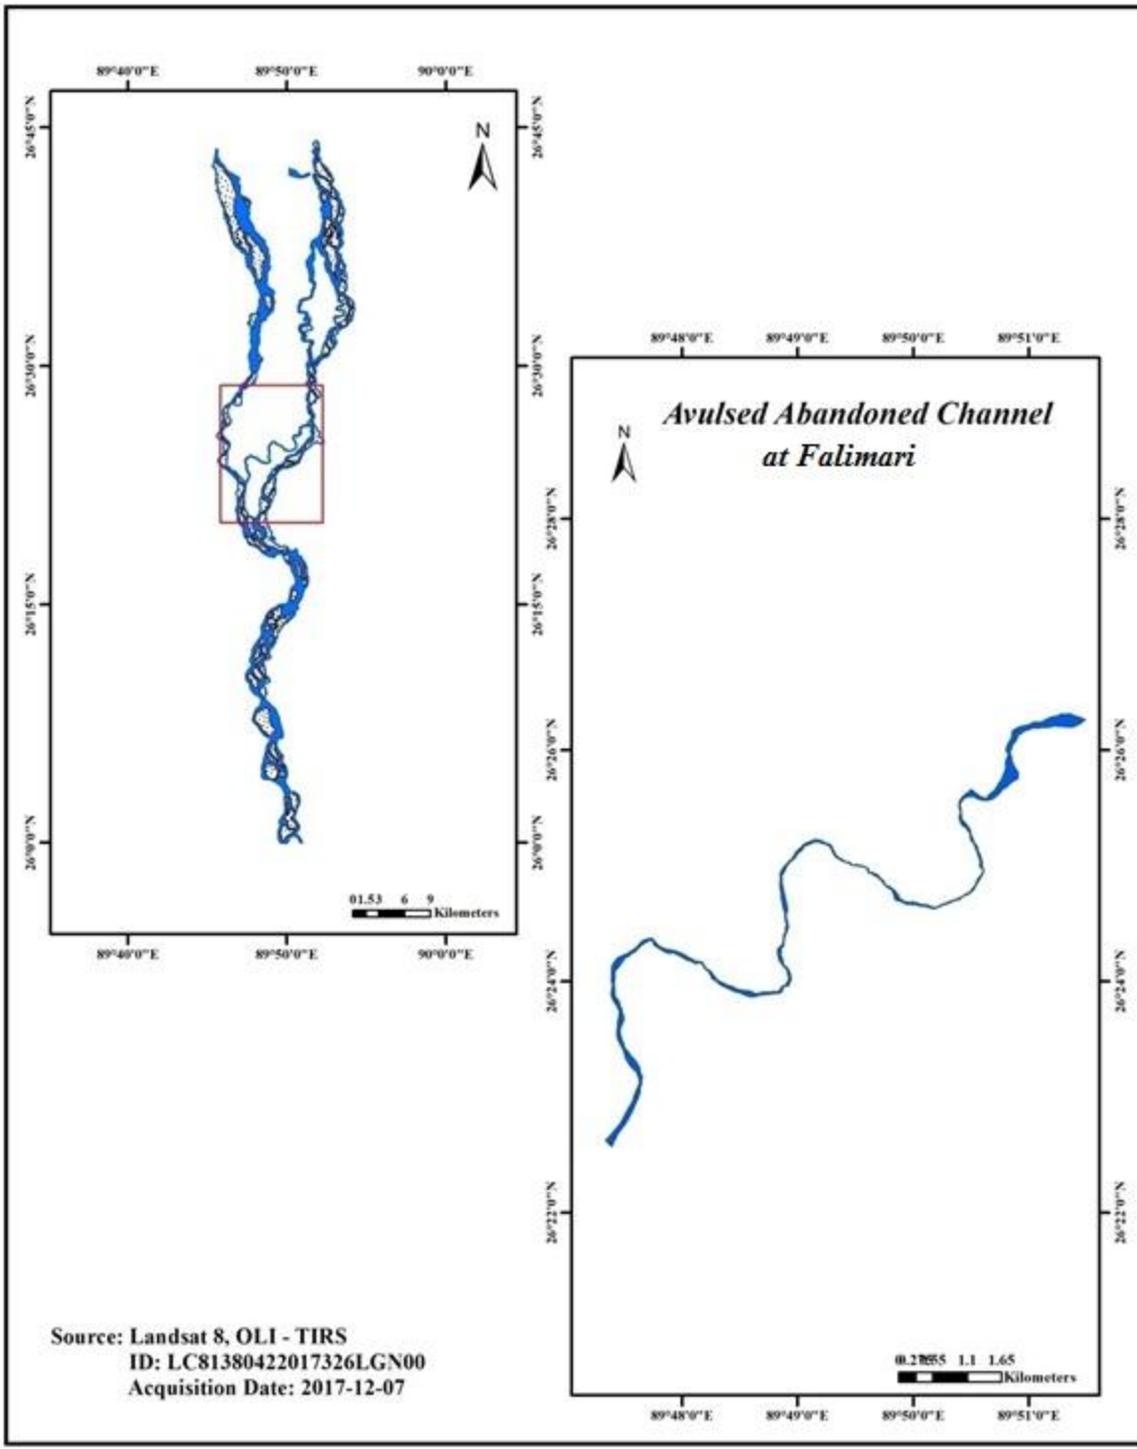
Map 3.11: Location Map of Avulsed Abandoned Channel at Falimari

A partial avulsed abandoned channel (Map 3.11) is found in the middle course of the Sankosh River at Majerdabri, Falimari village of Cooch Behar district of West Bengal. The left flow of Sankosh River was called Gadadhar at that time and on the other hand right flow of Sankosh was the main flow of Sankosh River. This abandoned channel avulsed from the main channel of the Sankosh River due to overbank flow, channel in filling factors and joined to the river Raidak-II at Jaldhoya village of Cooch Behar district. The length of this abandoned channel is about 12.8km and width is about 200 m. Jorai Nadi also meets this channel and jointly flows about 16.2km and to meet Raidak-II river. Some areas of this upper portion of avulsed abandoned channel is filled by sediments and at the same time human settlement has taken over some sections. No water flow is found in dry season, only in rainy or flood season water flow is found. Nowadays it has become a source of fertile land for agriculture.

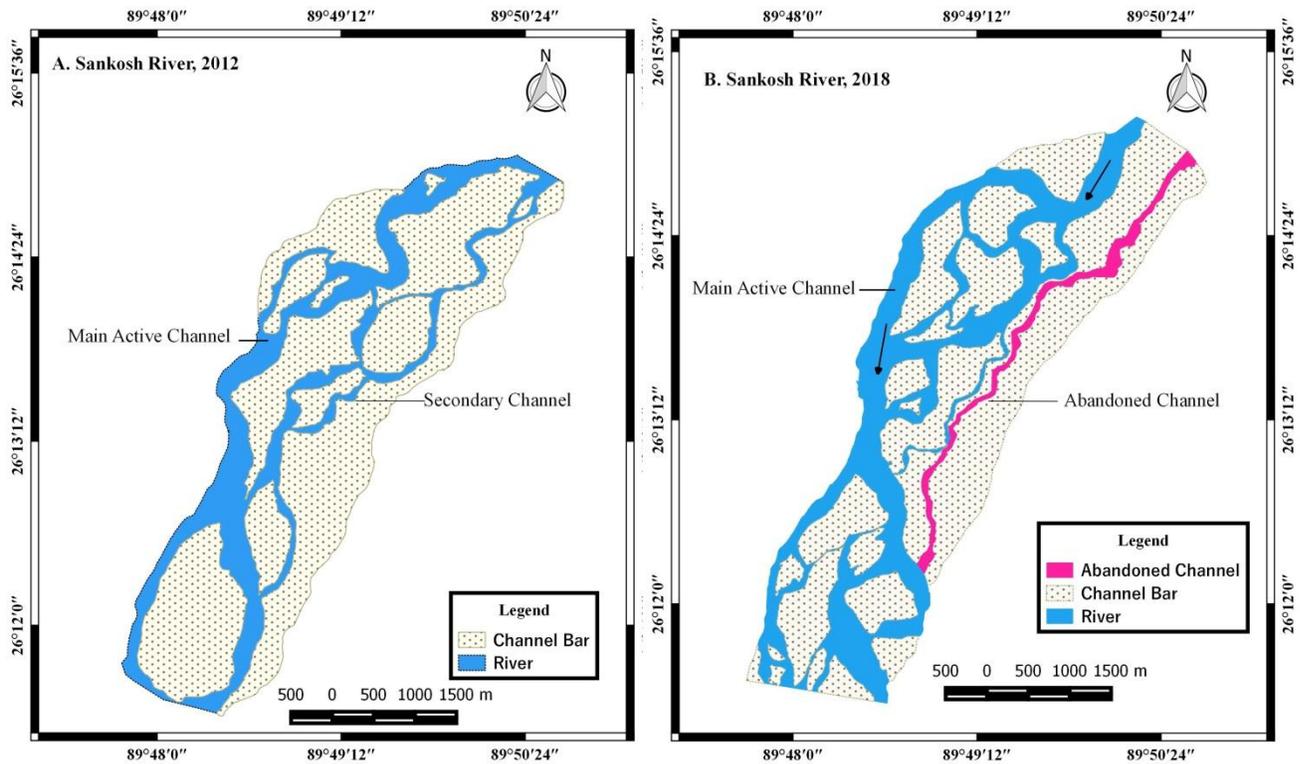
Map 3.12: Channel braiding and abandonment at Tamarhat in the year 2012 to 2018.

From the map 3.12, it is observed that Sankosh River at the lower reach in the study area has formed a braided pattern in the year 2012. In this pattern the main active channel is divided into

a number of secondary channels and as a result, a mid-channel bar has formed on the channel bed. Continuous deposition of sediment has increased the shape and size of the bar and at the same time the shifting of thalweg has also been observed here. In 2018, this braided pattern has changed due to rapid shifting of bed materials and continuous shifting of the position of the main active channel (Leopold et. al., 1964) of the River Sankosh. In this way, the secondary channels of this braided pattern are becoming abandoned day by day.
