CHAPTER VII

EARLIER STRATEGIES OR MEASURES IN CONSERVATION OF SOIL AND WATER

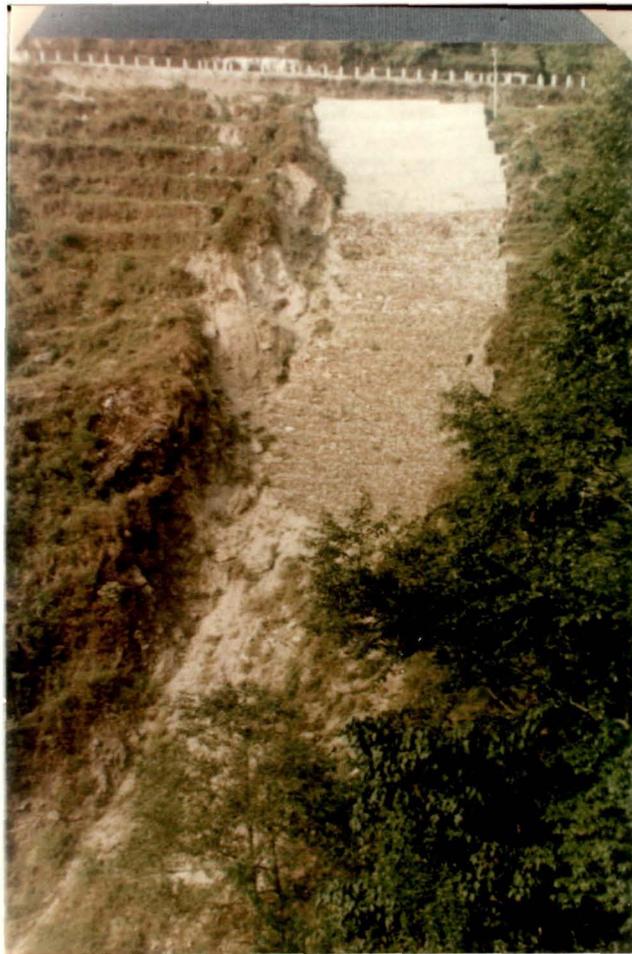
Large number of retaining and breast walls have been constructed for protection of road benches in the study area . Besides roads , protection to homestead lands , bridle paths , buildings and other structures , too , has been given by the protection walls . The terrain in the study area being quite steep and rugged coupled with high rainfall (in terms of quantity as well as intensity) , it is impossible to build any large structure without retaining or breast wall . In most cases, these gravity structures depend solely on their weights to resist the thrust of the back fill . This is because often bed rock is not economical to find to anchor the foundation of such structures . This makes them quite vulnerable to overturning and sliding (Plate 11).

PLATE 11: RETAINING WALL ABOUT TO SLIDE
(GOETHAL'S RESUME FOREST)

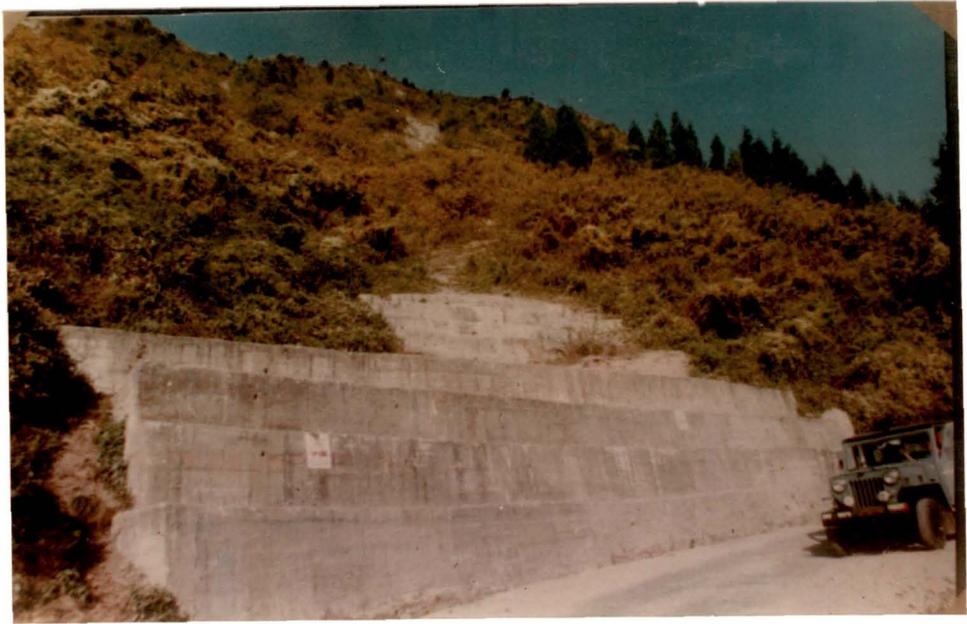
It is seen that materials likely to slip are not removed and slopes not trimmed and flattened before constructing the retaining walls . In some instances , absence of inadequacy of weepholes is the cause of failure (Plate 12). The fact that under poor drainage conditions , the tendency of backfill to slip is very much increased when the material gets saturated with water is often ignored .

PLATE 12 : A MASSIVE RETAINING WALL WITH
SCANTY WEEPHOLES (DILARAM)

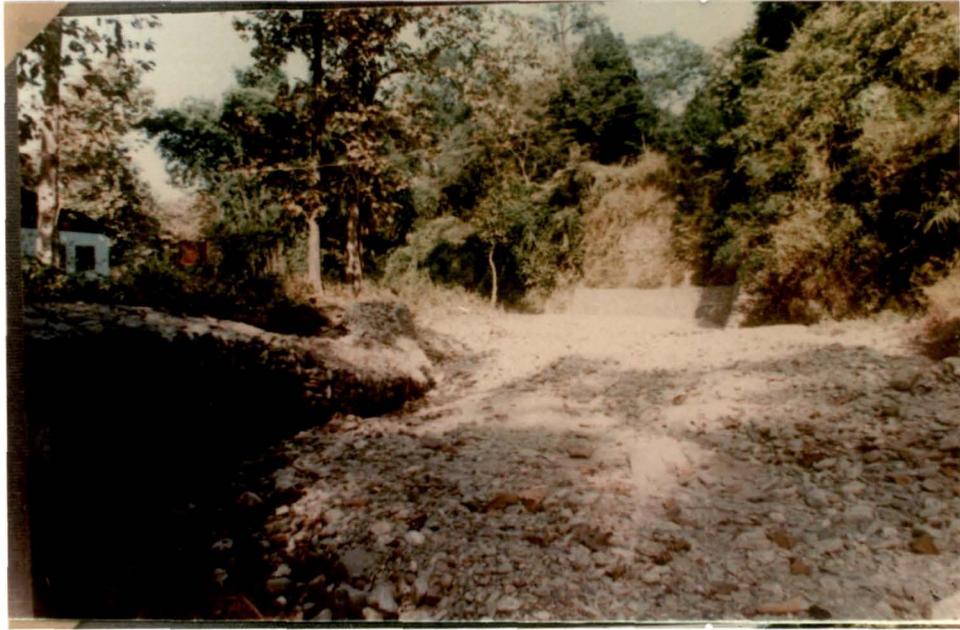
given even on the straight stretches . These structures are not protected by retards against scouring by the flow . This results in scouring of foundations of these gravity structures leading to their failure (Plate 13) . Sometimes rooting of groynes inside bank is not properly done resulting in dislodgement of the structure . If retards and groynes are not placed as per the hydraulic requirements of bank protection , streams scour banks behind their roots resulting in failure . At some places , retards have been made in such a way that they interfere with the channel itself . The fact that the retards must be erected as elements of an integral system providing a smooth line of flow along their heads , is often overlooked . It is not difficult to find existence of flow in between two retards . This is highly undesirable . This defeats the entire purpose and renders total expenditure wasteful . That the retards should usually slope downwards from their roots to head , is often neglected .

PLATE 13 : SCOURING OF FOUNDATION AND
FAILURE OF TRAINING WALL
