**STUDY OF SOIL EROSION PROBLEMS IN EASTERN
BALASON CATCHMENT**

THESIS SUBMITTED FOR THE DEGREE OF DOCTOR OF PHILOSOPHY
(Sc.) IN GEOGRAPHY & APPLIED GEOGRAPHY
UNIVERSITY OF NORTH BENGAL

By
Mr. Sheelwant Patel, IFS

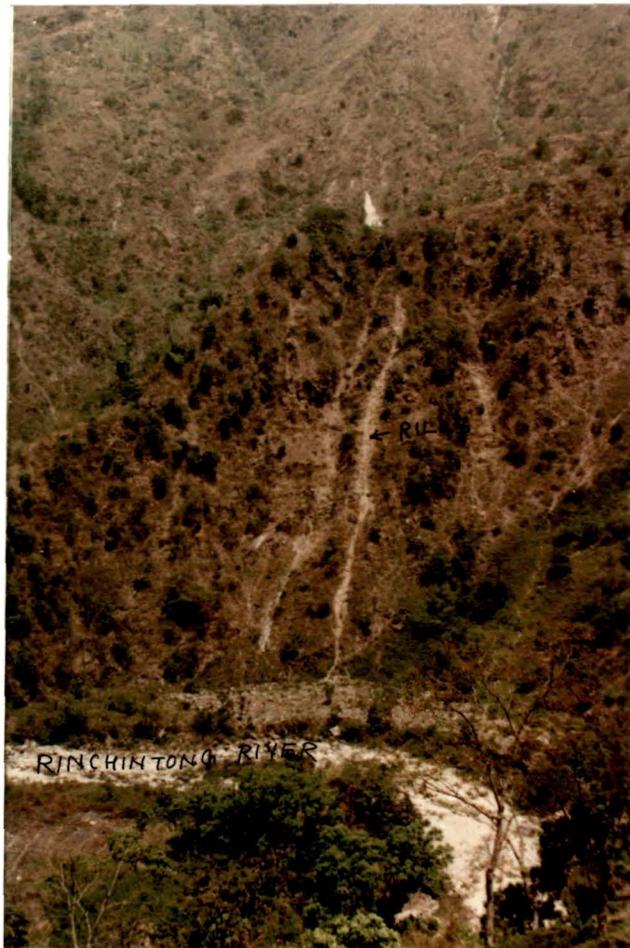
PLATE 3 : RILL EROSION IN
OVERGRAZED TREELANDS
(SINGLE T. G.)

Although rill erosion is often overlooked , it is this one which erodes the soils the most (Schwab, 1971) . In the study area rill erosion is seen in fallow lands and degraded forest areas. Rill erosion is seen in the overgrazed wooded lands of Nahar tea garden (Plate 3). Banks of Ghatta jhora show rill erosion of its upper reaches. Extensive rilling is seen on the steeper slopes of Pachim and Gorabari basti. Rilling has also been seen in Nahar, Oaks and Chhota Ringtong tea gardens. Invariably, rills are located on steeper slopes having very little vegetation. Rilling has also been seen in Avongrove tea garden and Nagari spur. Pubong and Tomsong tea gardens also show rilling in areas having low density of tea bushes. Govt. forests of Mahaldram and Senchal show rill erosion. Rills develop fast in overgrazed forests. Dhupi plantations contain very little ground flora. Rills develop faster in Dhupi plantations. In Senchal forests, the areas located above Rongbull and Sonada are the worst affected. Ghoom-Simana reserve forest also shows rill erosion in and around Lepchajagat and Sukiapokhari.

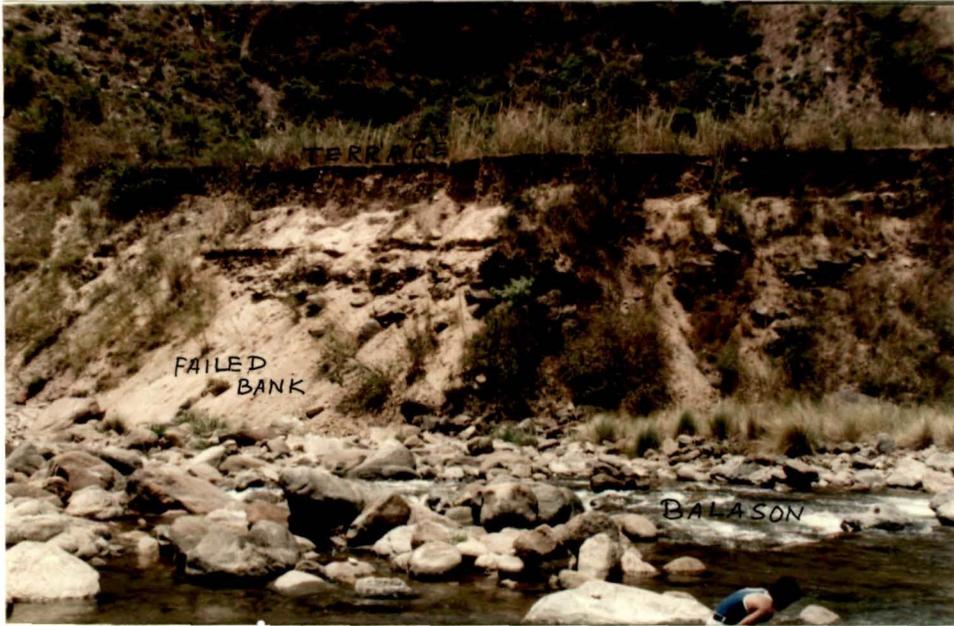
PLATE 5: SEVERE STREAM BANK EROSION
(BALASON RIVER)

Besides gullying, another important soil degradation process is stream bank erosion. The stream bank erosion is yet another form of fluvial erosion. The scouring, gouging and under cutting of banks and mud flows are major processes of bank deterioration. The stream bank erosion differs from the gully erosion in that the former applies to the lower end tributaries and to the streams that have continuous flow and relatively flat gradient (Michael et al, 1981). As the velocity and volume of discharge increases, flow of stream becomes turbulent and vertical eddies develop. These eddies scour deep holes in the river bed (Ray, 1954). The swirling water cuts on the outer side and deposits its sediment load on the inner side where velocity is lower. This generates a debris bar on the inner side of the bending stream which pushes the stream further outwards initiating fresh under cutting and tumbling down of vertical slices from the bank. The debris is quickly removed by the stream and the stage is further set for fresh under cutting (Plate 5). The process continues so long the velocity of the flowing water continues to be erosive. It often so happens that area lost on one bank is recovered on the other. The quality

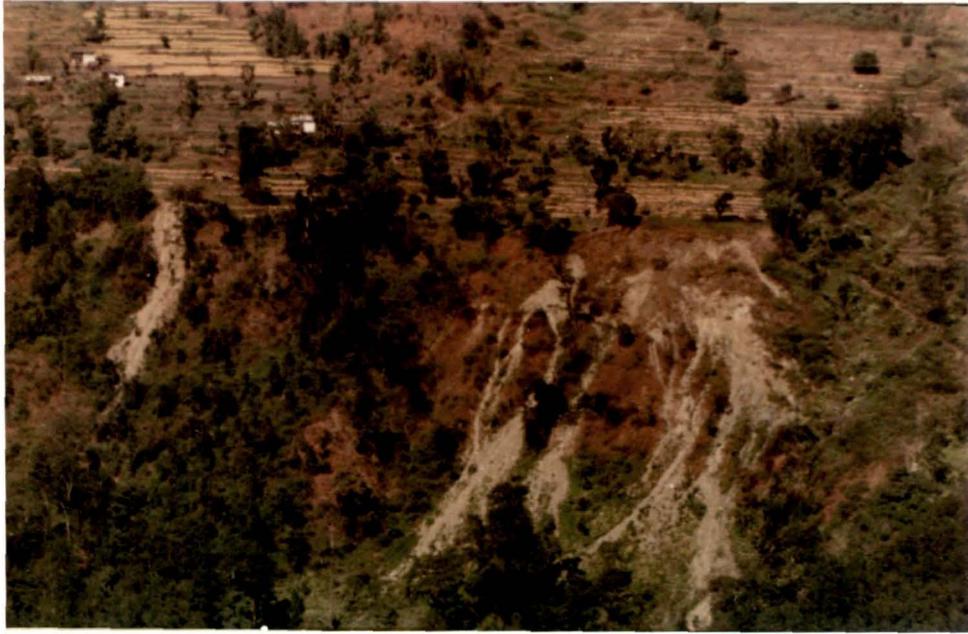
*PLATE 6 : PADDY CULTIVATION BY IMPOUNDING
WATER LEADING TO LANDSLIDE*

Weak geological formations constitute one of the biggest factors responsible for failure of slopes . In general , the clays , clay shales , over consolidated clays and phyllitic formations are invariably associated with most of the areas showing instability of slopes. Seismological factors , too , contribute by setting in long term instability in intensely uplifting young mountain ranges like Himalayas . The hydrological factors are , however , most important causative factors in Himalayas , especially in north eastern part of it . Excessive wetting of soil weakens them and brings about increased pore pressure leading to instability . Paddy cultivation by impounding water often leads to landslides (Plate 6). About 100 mm to 200 mm precipitation in 24 hours is usually sufficient to cause failure in Darjeeling Himalayas (Starkel , 1972). Accumulated amount of rainfall from 350 to 400 mm during a spell of rain brings about disasters (Haruyama, 1980). Higher the accumulated amount of preceding rainfall, lower is the required threshold intensity of rainfall for a given degree of sliding (Fukuoka, 1980). Closer the water table to the surface , higher are the chances of slope failure (Aoyama et al , 1980) . Excessive moisture increases unit weight and decreases shear strength of soils . For some soils water entering into the voids dissolved the binding material causing instability . In fine grained cohesionless soils saturation eliminates surface tension holding soil particles together and ,

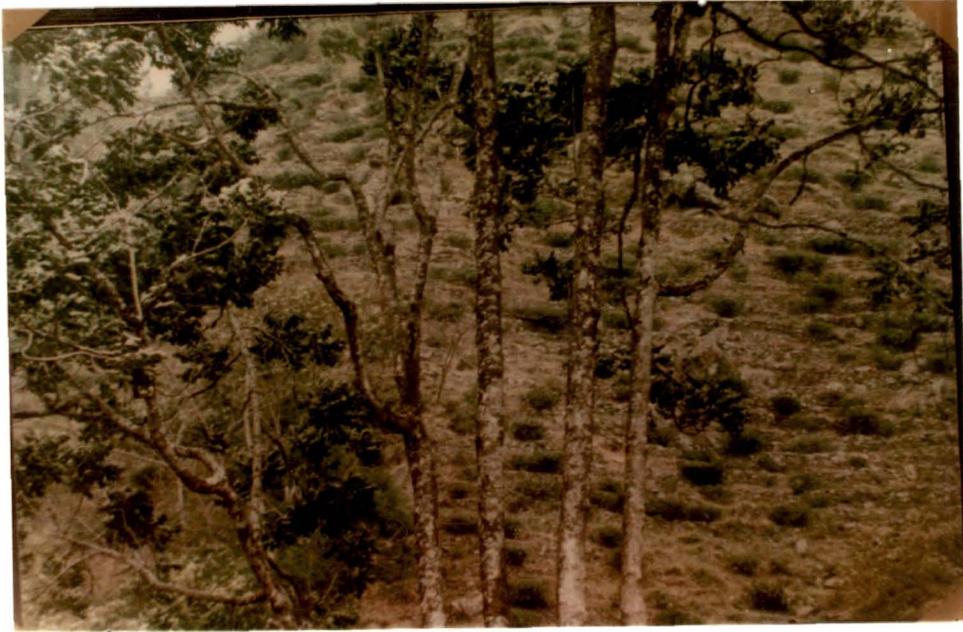
PLATE 7: POORLY MAINTAINED TERRACES IN TEA GARDEN
(SINGLE TEA ESTATE)

It is seen that several tea gardens have raised tea crops without proper terracing of land. In other cases , even if terraces are made , they are very poorly maintained as in Singel tea garden (Plate 7) and do not provide any protection to soil against run off . Invariably in such tracts the tea bushes are extremely sickly and have very low yields . In some others (Ambootia tea garden) , it is seen that extensive soil working has been done to raise a new plantation without any terracing (Plate 8) . Though the slope is not steep and area is protected from

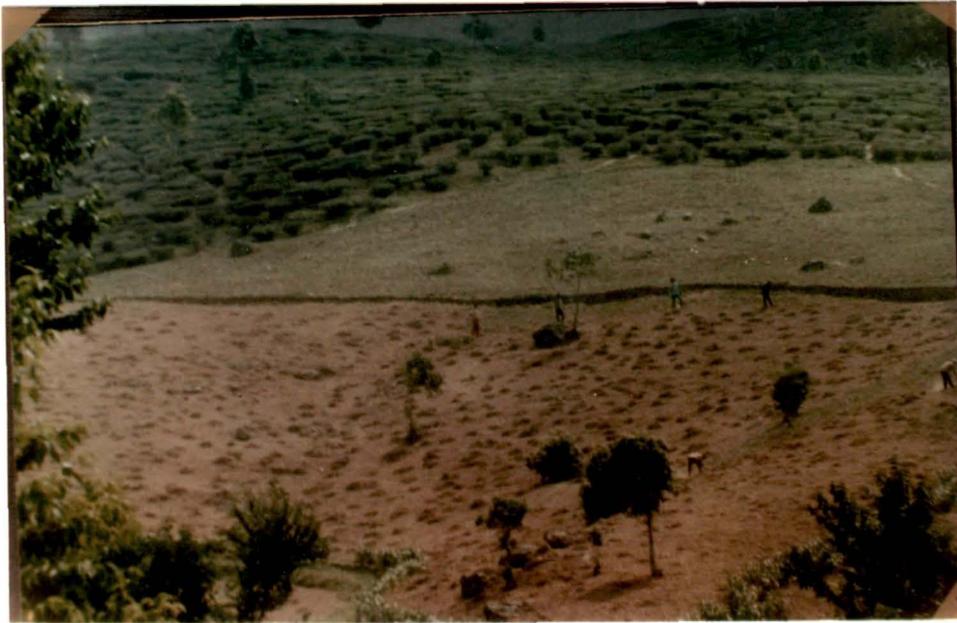
PLATE 8: SOIL WORKING ON SLOPING LAND IN TEA GARDENS
(AMBOOTIA TEA GARDEN)

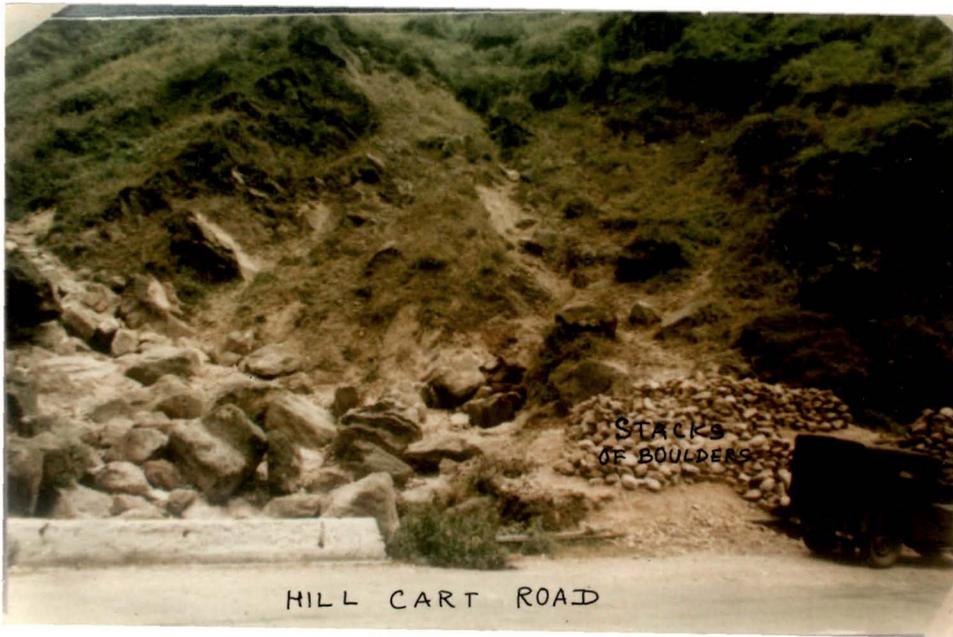
PLATE 9 : UNAUTHORISED QUARRYING ALONG
HILL CART ROAD
STACKS OF BOULDERS SEEN

Specific localities where unauthorised quarrying is seen in the study area are large in number . The jhora near Phazi catchpit , meeting river Rinchintong on its left bank , (200 mt down stream from Dilaram factory) is subjected to quarrying . The stretch of Hill Cart road between Gorabari to Rinchintong has several sites of unauthorised quarrying . At the time of survey during November 1993 , about 200 cub. mt. of boulders were seen stacked along the Hill Cart road in this stretch . A site , 100 mt down the road from Dilaram bazaar , is subjected to intensive quarrying . A jhora crossing Hill Cart road , 200 mt north of Tung railway station , too , is subjected to intensive quarrying . So is the case of Chaitapani jhora draining the stretch between Goethal's memorial school and St. Mary's Hill (Plate 9) . On a site 100 mt down the Hill Cart road from Sonada bazaar , a precipitous uphill slope along the road is being quarried dangerously . The Sonā Hollow Block Industry , located on the left bank of Rinchintong jhora on Hill Cart road has been quarrying sand over several decades without any apparent check adding enhanced sediment load in the stream . Near Cedar basti and Pachang bazaar , a few sites of unauthorised quarrying are seen . The list is the least exhaustive . Because of paucity of time and resources , detailed survey could not be undertaken . However , it is believed that unauthorised quarrying has taken very serious dimensions in the study area . There are innumerable spots where

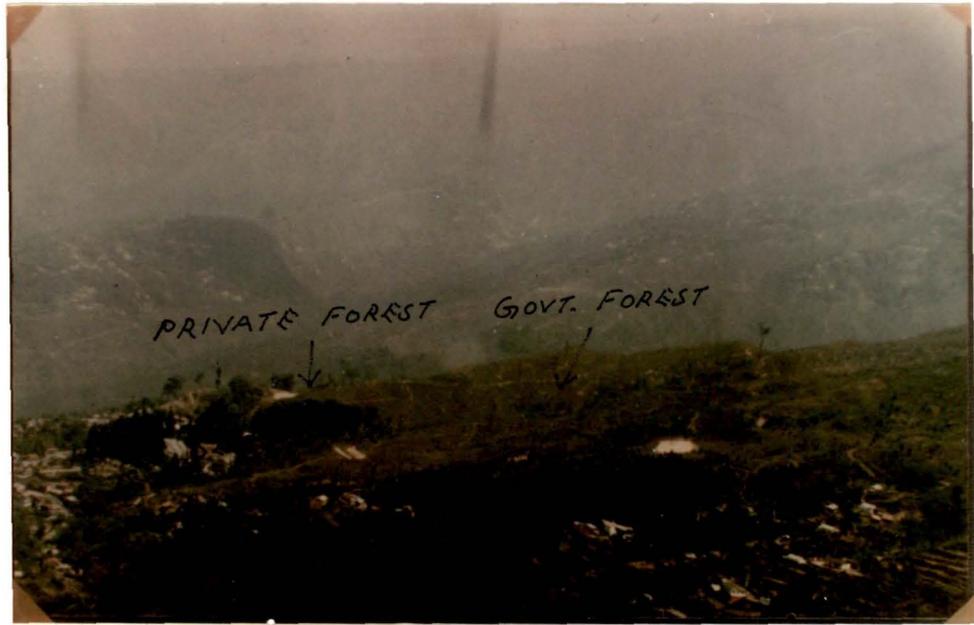
PLATE 10: EXTENSIVE DEFORESTATION ABOVE
SEPOYDHURA

Deforestation, as is obvious, brings about a number of pedological, hydrological and environmental degradation. Removal or thinning out of canopy, exposes the soil beneath to the full erosivity of rain storms. This sets in various soil eroding processes and mechanisms active. So long top soil contains some organic matter, soil particles are not easily splashed by the impact of rain drops. The organic matter, however, does not last long. Organic molecules with low molecular weight are first to depart. Others follow soon. Soluble salts and soil nutrients are leached down far quickly than the organic matter. In situations of splash erosion, fine soil particles block the pore spaces making soil impervious. Even there

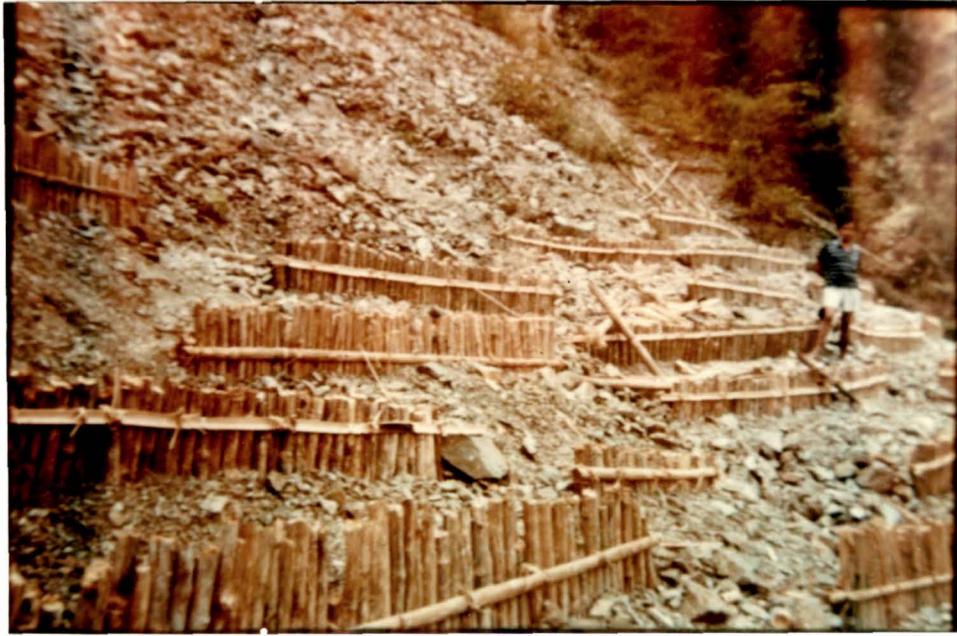
PLATE 14 : PALISADES ERECTED WITH LOCAL
WOOD MATERIALS (SENCHAL R.F.)

Palisades and wattlings are two important modes of soil conservation in controlling gullies, landslips and slides. The structure is erected mostly with locally available materials. Palisades are usually applied on slopes steeper than 30 degrees. Hard wood bullies 10 cm in diameter and 1.7 to 2.0 mt long are fixed vertically along contour, are spaced 50 cm apart and are fixed 80 to 110 cm below the ground 90 cm being above it (Govt. of West Bengal, 1995 A). Posts should be fixed touching one another (Plate 14) on steeper slopes having moving debris (Fig. 8.11). Usually seven such posts should be fixed making a 3 mt long palisade as a single unit. The above ground parts of posts are woven with brushwood material or with splitted bamboo.

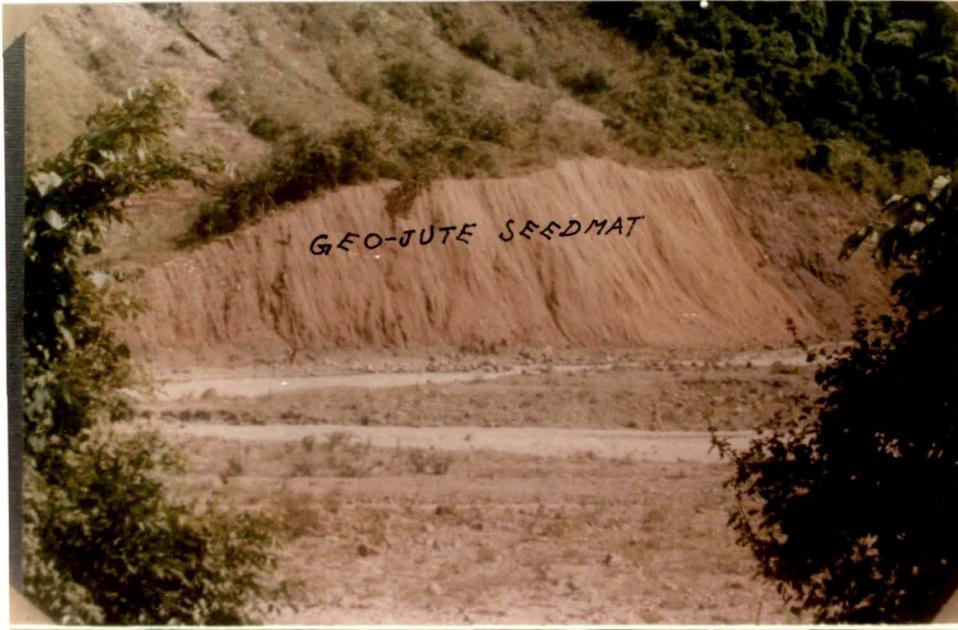
PLATE 15: APPLICATION OF GEOTEXTILES AS SEEDMAT

Geojute mat can also be used for seeding of the slopes . Geojute , woven from thick , widely spaced yarns are used for this purpose . It is typically made from thick open woven jute , is about 5 mm thick , has apertures about 15 mm x 15 mm size and weighs about 500 gms / sq. mt. Geojute can either be applied on the surface of slope or can be buried under 2 - 3 cm of soil (Plate 15) .

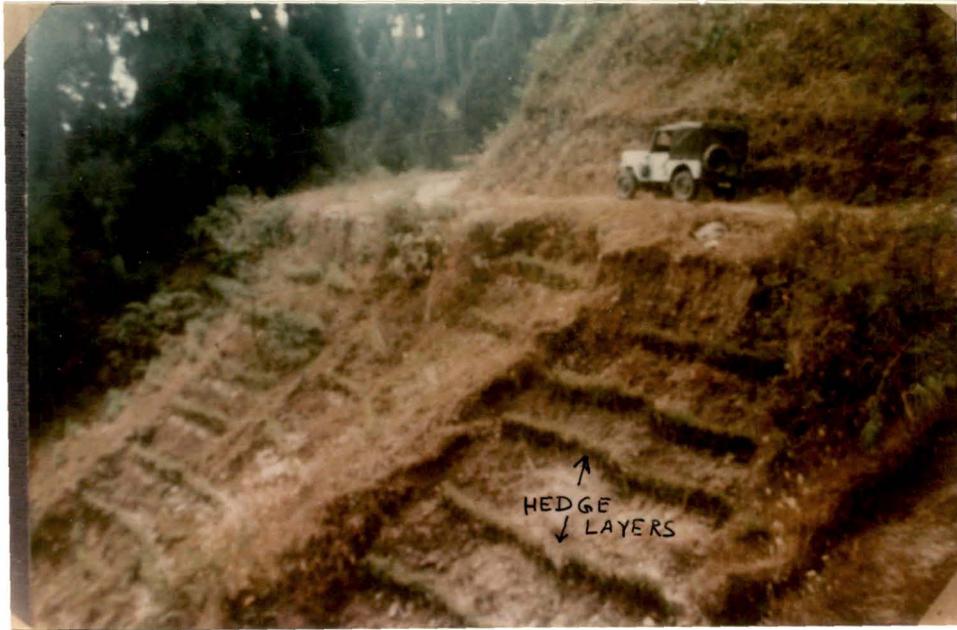
PLATE 16: HEDGE LAYER CONSTRUCTION IN STUDY
AREA (DARJEELING FOREST)

For hedge layer construction small terraces or berm are formed with depth of at least 50 to 70 cm . The terrace platform should have an angle of inclination (sloping up) of at least 10° to the outside (Fig. 8.15 b). Rooted plants are placed close together with their roots inside so that approximately one third of the entire plant length extends over the edge of the terrace (Plate 16). The terrace is then covered with soil that has been dug out from the terrace above . Manuring may be necessary. Rooted woody plants that are resistant to rockfall and coverage by debris and which have ability to produce adventitious root system are required . Two to four year old transplants and very fast growing varieties of two year old seedlings should be used , if possible . The ratio of roots and shoots is very important . The stronger the root system , better is the plant development . Depending on species , approximately 5 to 20 plants are needed per running meter of hedge layer construction . These should be constructed during dormant season of plant growth . In the study area , however , dry season is quite limited and this system can be used through out the year with winters being the most effective .
