Chapter - V

GEOMORPHOLOGY AND URBAN ACTIVITIES

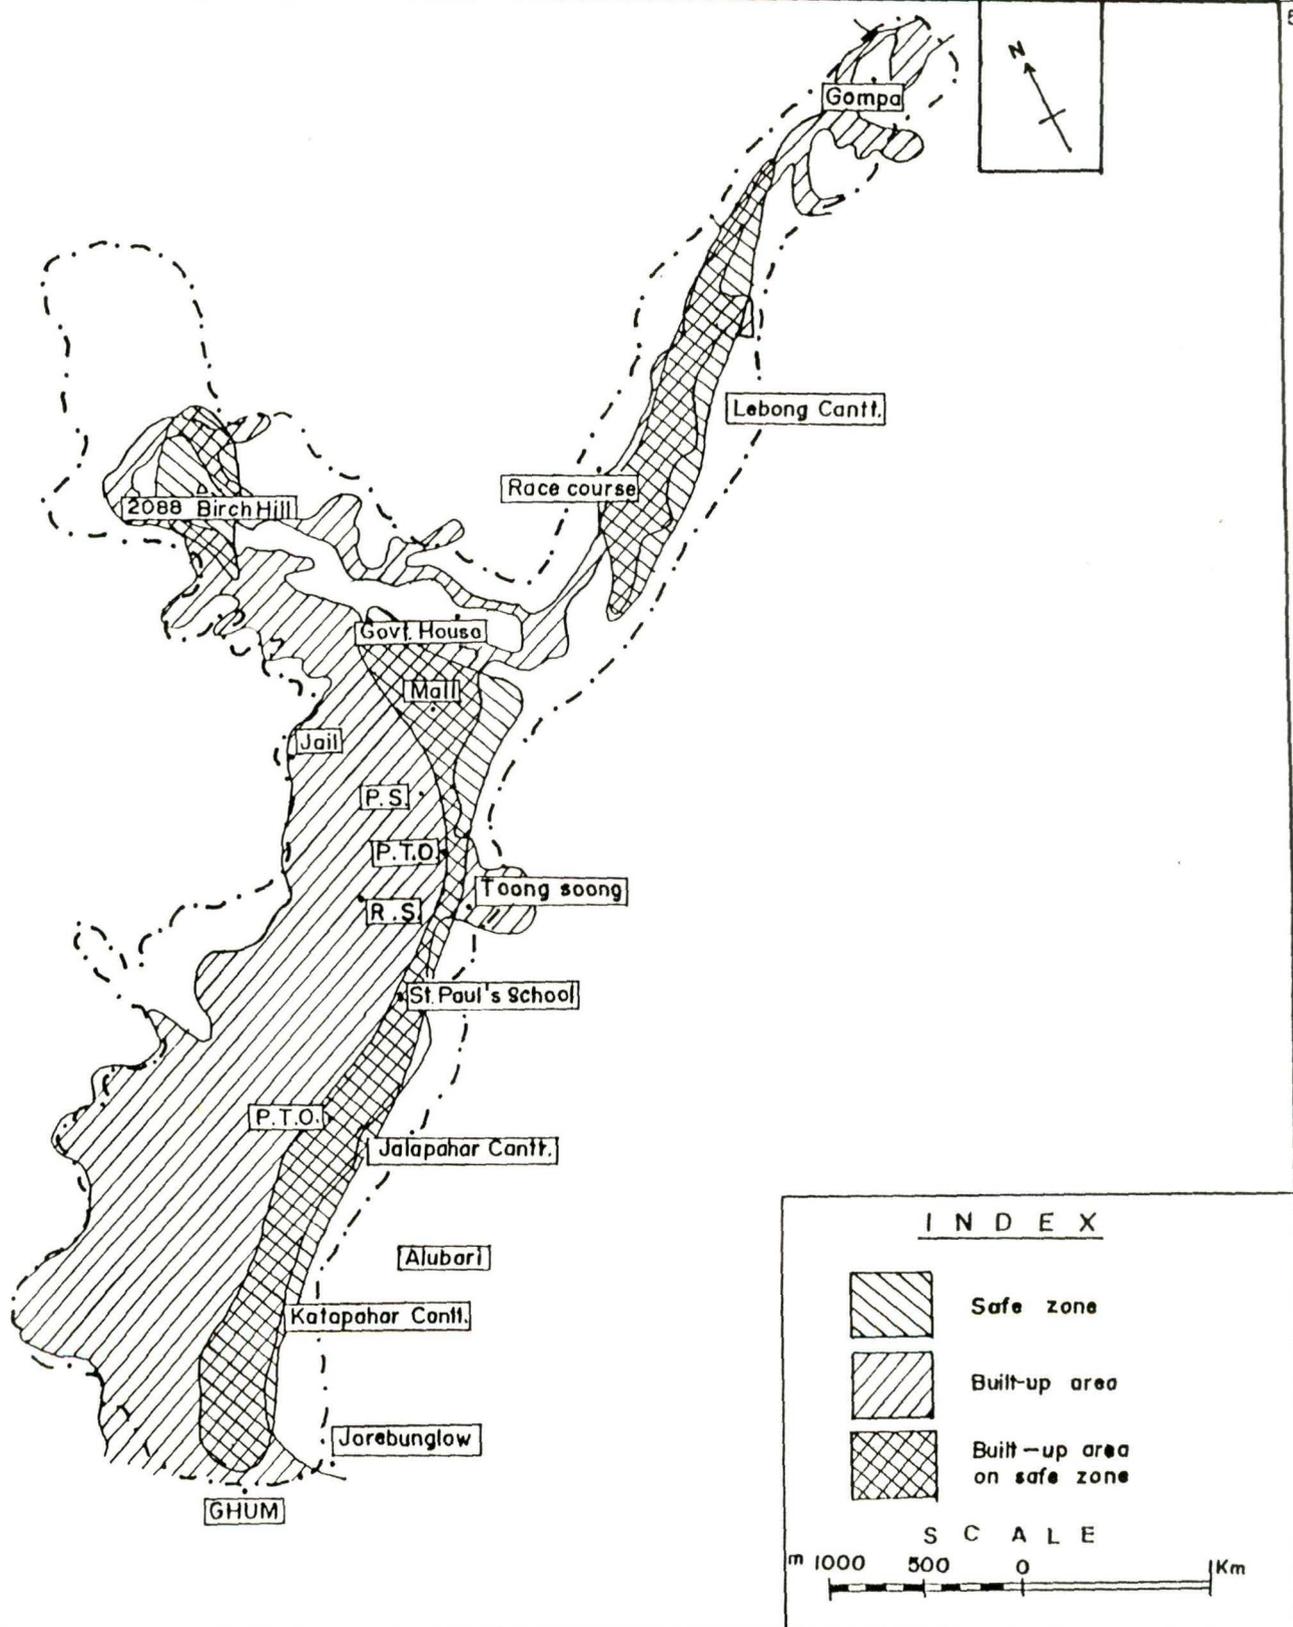
Fig-5.1

SAFE ZONE MAP OF DARJILING TOWN

Except the narrow tracts along the Ghum-Jalapahar-Birch Hill-Lebong ridges and the Jalapahar-Birch Hill saddle, the rest of the town have a moderate to severe limitations for urban growth (Fig.5.1).

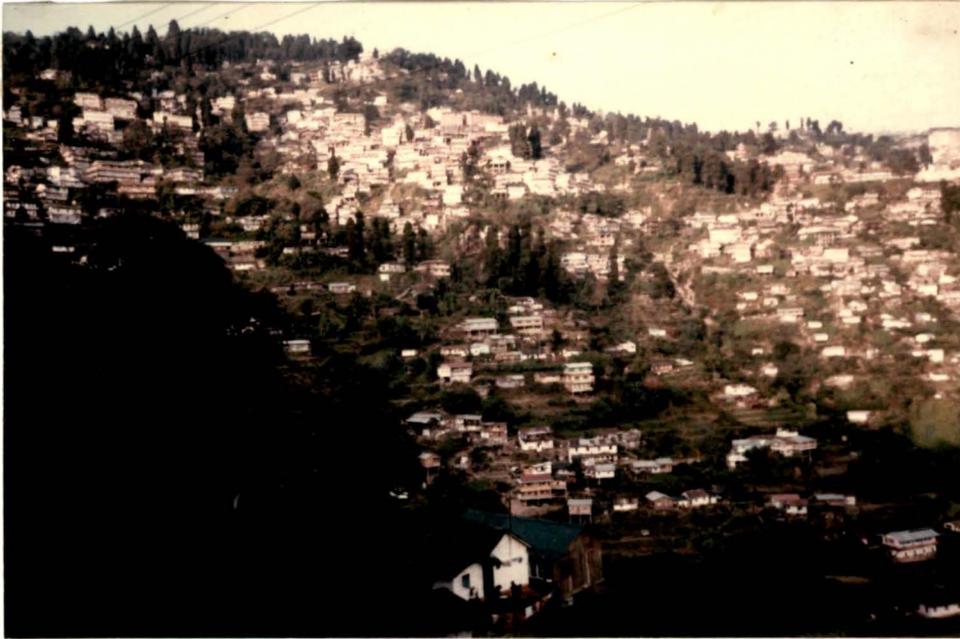
5.1

Building of houses on terraced slopes following
cut-and-fill process.

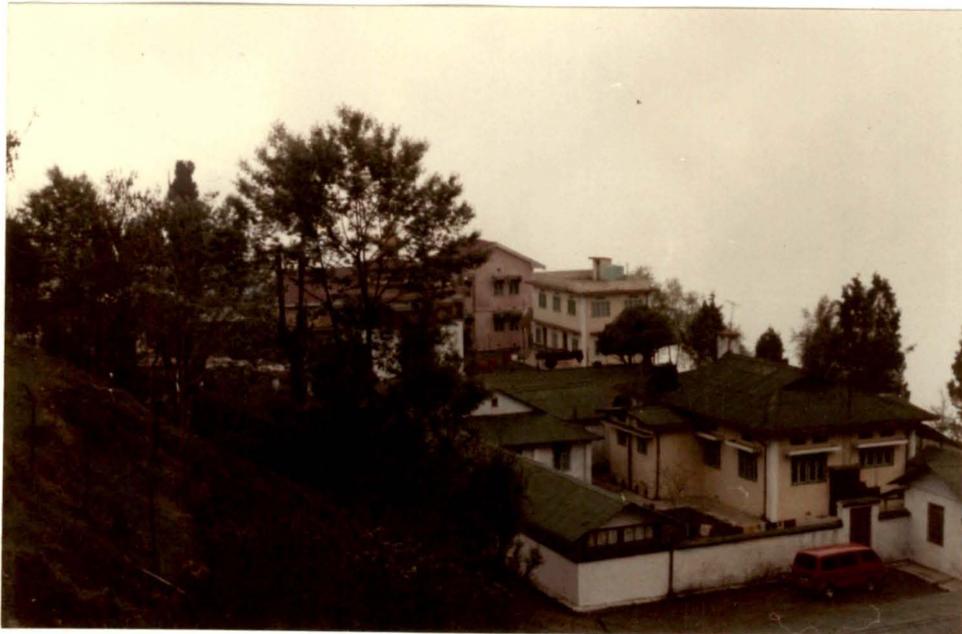
5.2

Extension of Bell-View Hotel disregarding
the landslip scar at the back.

a slope covered with *Cryptomaria Japonica* had been cleared in 1980 for the extension of the Bell-View Hotel. As the soil below such vegetation is always acidic, with the completion of the ground floor of the Hotel building during monsoon with a rainfall of 50 mm within 24 hrs, the whole slope together with the building collapsed on the 25th August 1980 (Photo 5.2) (Fig. 5.2).

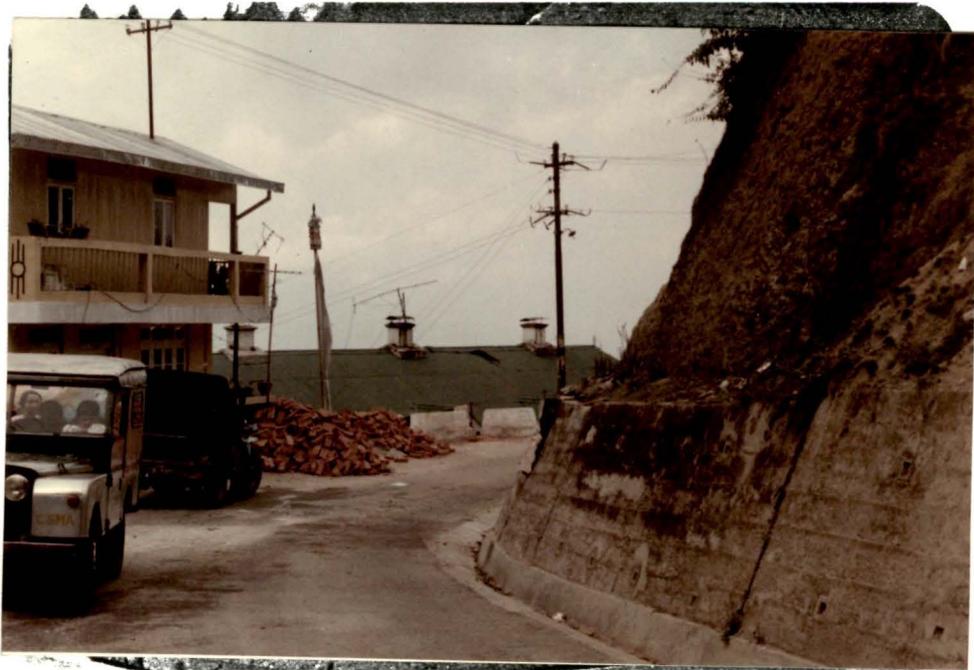
5.5

Slope cut for widening of road.

very creation of the town, its attendant urban structures i.e. buildings, roads, railways, playgrounds^{invite} etc. the obliteration of some of the natural topography (Photo 5.5).

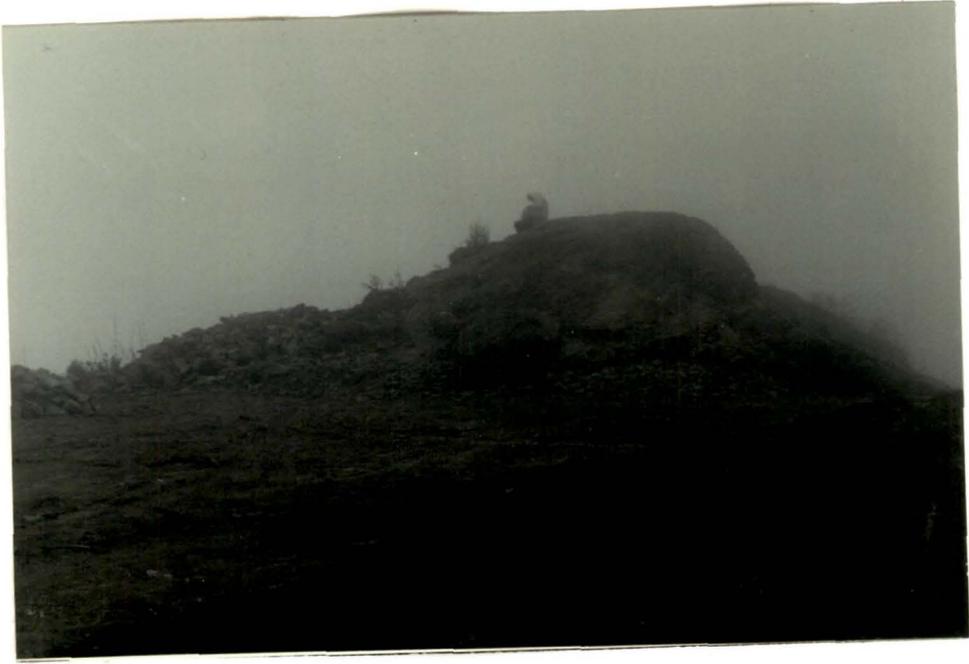
5.6

Ground levelled for air-strip at Tiger Hill

By cut-and-fill process.

This project is one of the most ambitious plan for the Tourist promotion and development of the DGHC (Photo 5.6). The project is yet to get its final clearance from various governmental agencies. Yet the 1993 Tea and Tourist Festival (October 21st-23rd 1993) revealed a tale of environmental degradation.

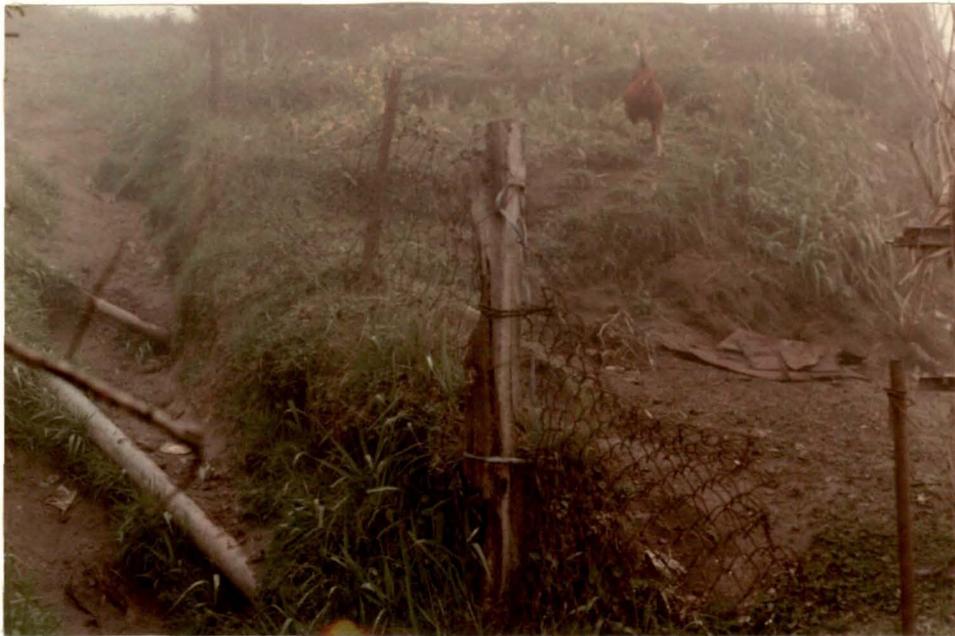
5.7

St. Paul's School Tennis Court.

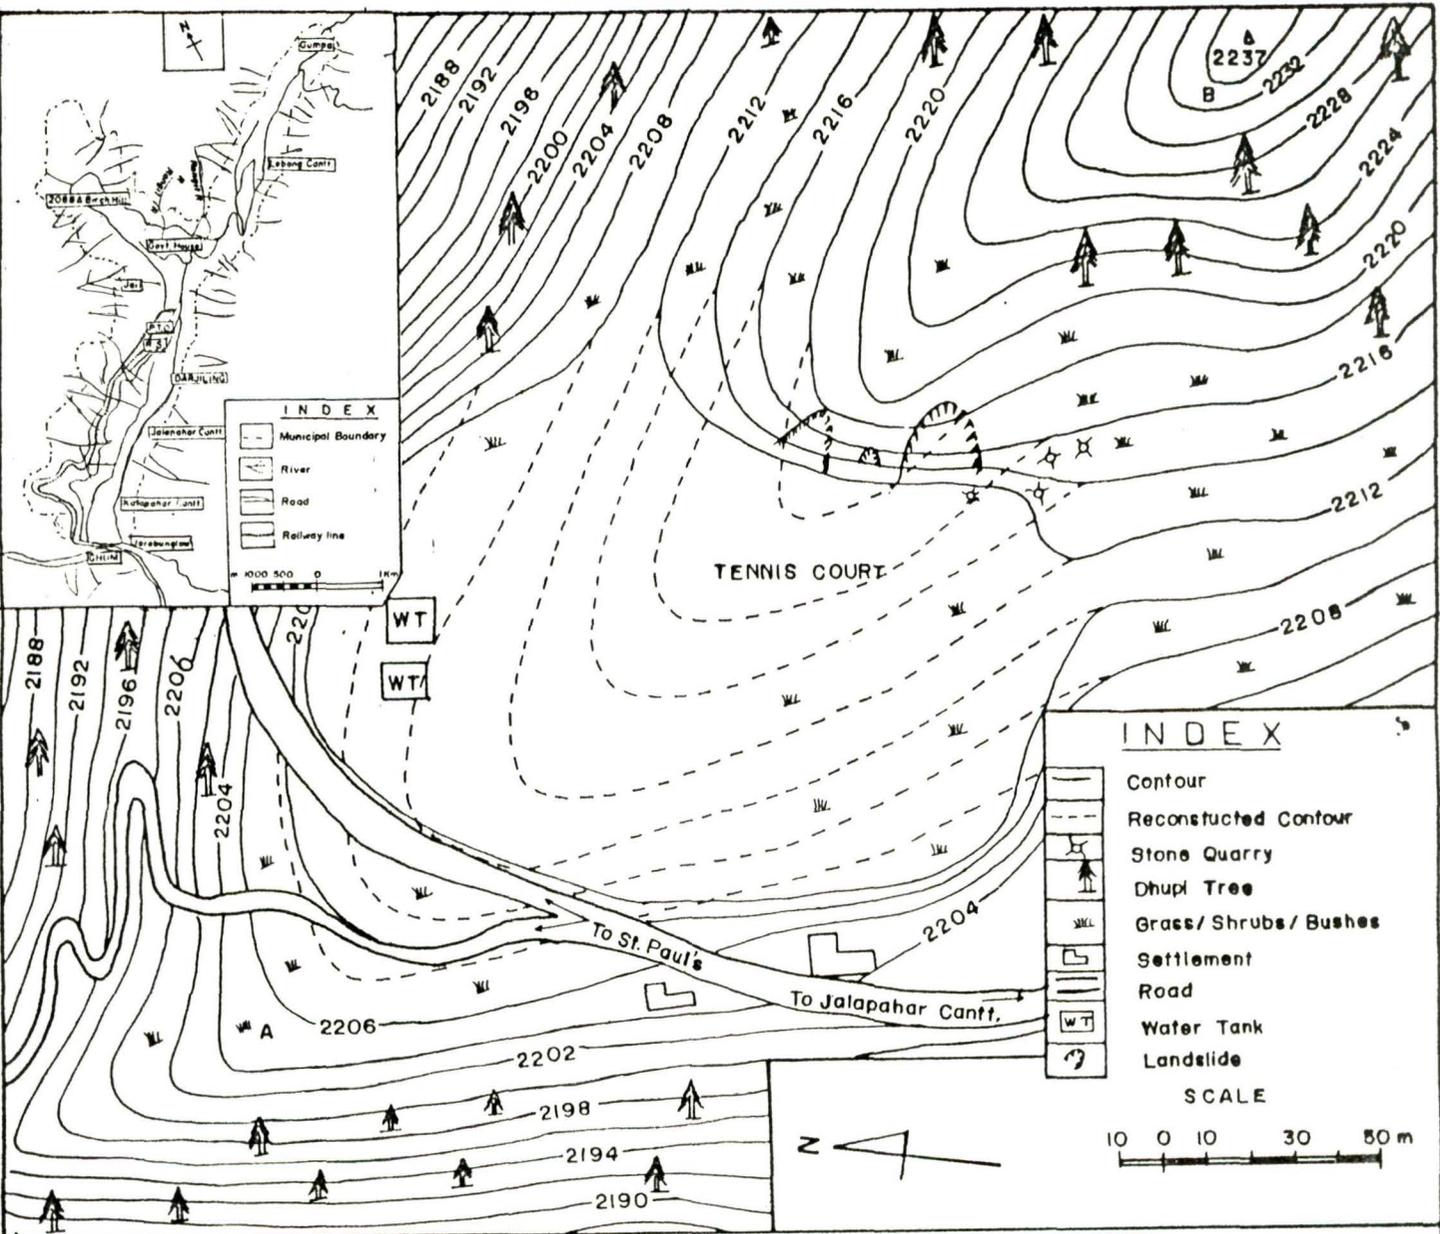
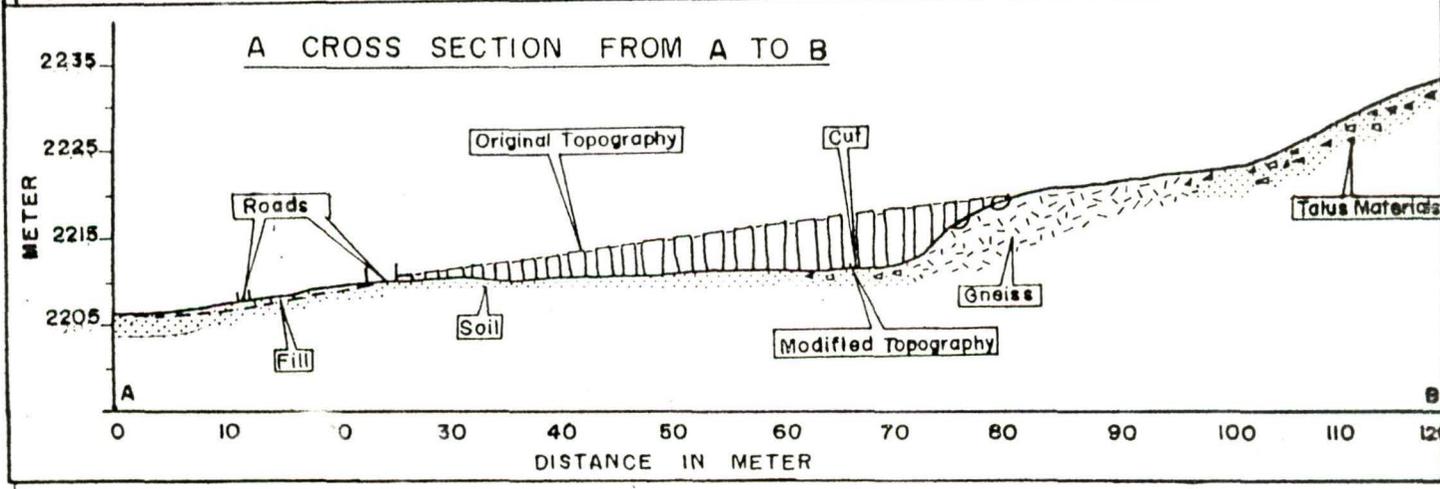
FIG - 5.3.

CONTOUR PLAN AND CROSS-SECTION OF A MAN MODIFIED LANDFORM NEAR ST. PAUL'S SCHOOL DARJILING

In order to have an idea about the rate and magnitude of cut-and-fill performed by the early developer, the investigator of the present study has tried to reconstruct the pre-urban landform and the present landscape of the study area (Fig.5.4). A study of this map (Fig.5.4) gives a good information about the magnitude of removal and accumulation and its impact on the environment. As it has been already mentioned that the Jalapahar ridge is one of the safest zone of the town, the original slope along the ridge was 8-10° towards NNW. A massive cut-and-fill was performed for the construction of a 150 x 100 m. (15000 sq. m.) tennis court along this ridge (Fig.5.4). Over steepening of slope becomes inevitable having a magnitude of 45-55°. This over steepening of slope eventually invites a decrease in shearing resistance and ultimately culminates into a series of small landslips along the cut wall, during the subsequent years.
