CHAPTER VII

EFFECT OF ENVIRONMENTAL DEGRADATION IN RAYENG BASIN

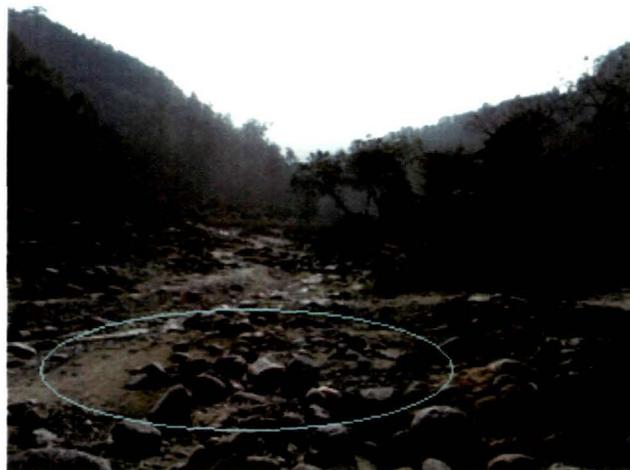
Plate 7.0 Deposition of boulders behind remains of a bridge at Rambh Bazar.

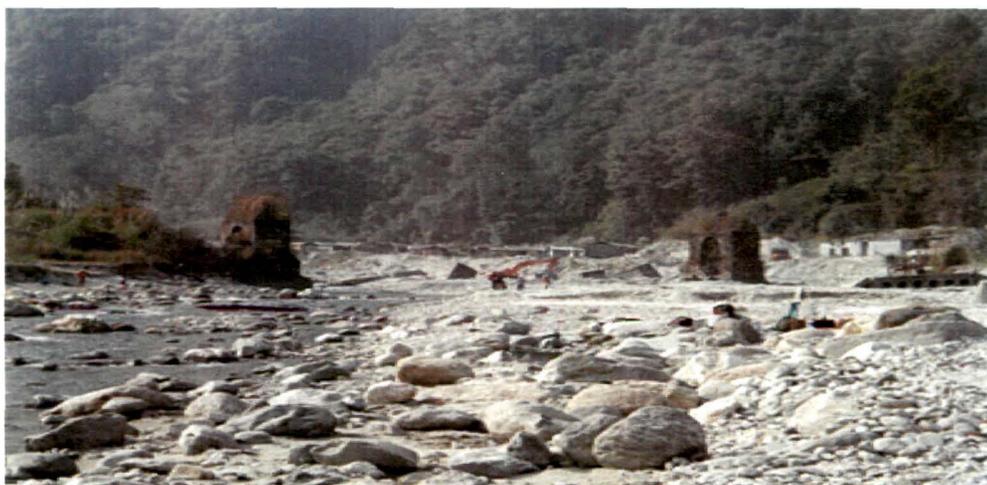
Plate 7.1 Remnant of an old bridge hindered the transporting capacity of Rayeng near the confluence.

their cohesiveness as they become saturation at the times of high water, as long as the water level remains high hydrostatic pressure may support the bank loose or gravels tend to fall into the Rayeng River. Thus erosion is rapid and large quantities of bed loads are immediately available. This favors channels widening instead of deepening, so that shallow channels are formed, such channels may be short lived, since sandbars, gravel shoals channel bars, point bars are developed. Cross section areas of almost in every study year, denoting disturbances in transportation of sediment loads. Artificial channel diversion and construction of bridge on the Rayeng River have disturbed the natural width of the river. Residue of the bridge has seriously hindered the transporting capacity of the Rayeng River. Huge amount of silts, clays and boulders have deposited on channel bed above the residue of the bridge due to artificial obstruction. Temporary construction of Tista Lower Dam Project in the river bed near the confluence has altered the natural characteristic of the channel. Aggradations and sedimentation of Rayeng River beds triggers off a series of sequence effects. Surplus supply of sediments owing to accelerated rate of soil erosion makes the river filled to capacity and slothful, with the result sediments are deposited in the valley floor and river bed. Constant deposition of sediments in the river bed and their resultant steady rise upward bring in the changes in the river regime. Continuous aggradations of river valley causes flattening of the valley and braiding of river channel mainly in the lower hill. Rise in the river bed due to continuous siltation reduce the water accommodation capacity of river valley on the one hand, and reduce the channel gradient on the other hand. As the filling of river valley due to continuous sedimentation goes on unabated, the valley become shallower in the lower hill (Plates 7.1 & 7.2).

- a) Alteration of natural condition such as artificial channel diversion, reduction of width of the channel for the constructional works. During the study years (2008-2011) it is observed in the field that gigantic constructional works were going on in bed of the channel of Rayeng River at the confluence of Tista River. Thus natural channel of the Rayeng was changed.
- b) Disturbances in discharge hindered transporting capacity of the stream. A residue of a bridge is situated just few hundred metre away from the confluence of Rayeng River with Tista River. It is observed from the study of sediment load transportation that the residue of the bridge has disturbed the normal discharge of the river.

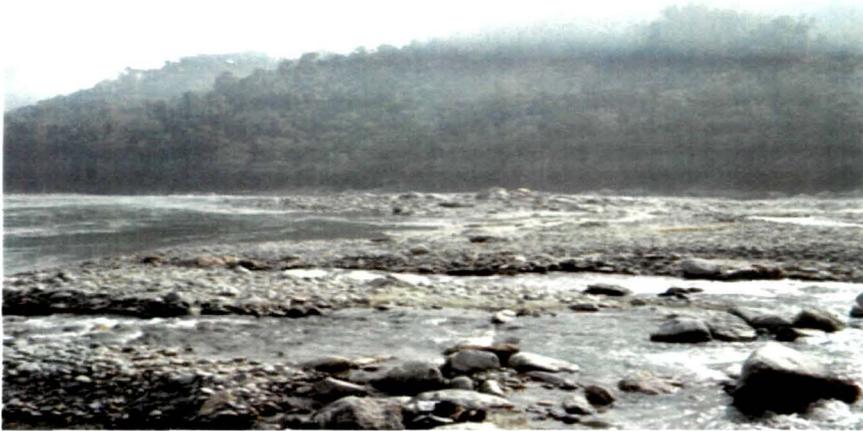
Figure 7.2 Huge siltation in bed of Rayeng River in the lower valley part.

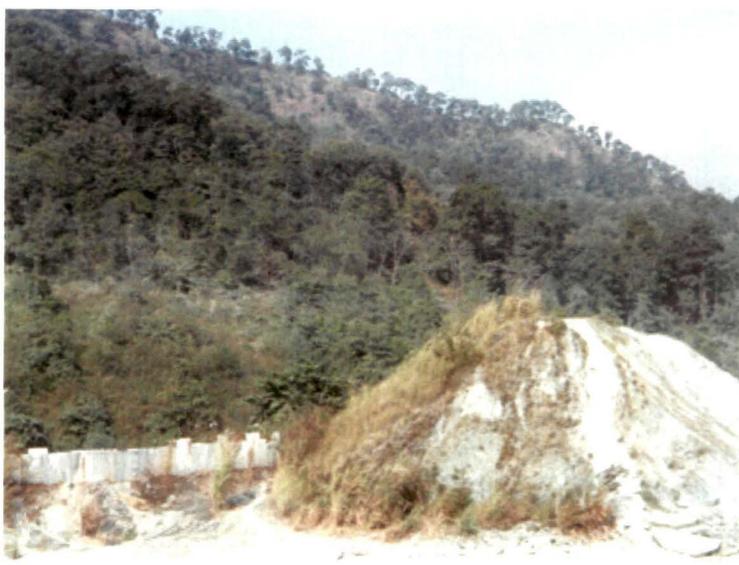
Plate 7.2 Vegetal covers are reduced due to forest clearance at Lower Mamring Kashmahal.

- 1) Natural flow of the channel has been altered.
- 2) Vegetal communities have been reduced (plate 7.2).
- 3) Soil erosion and landslides have increased

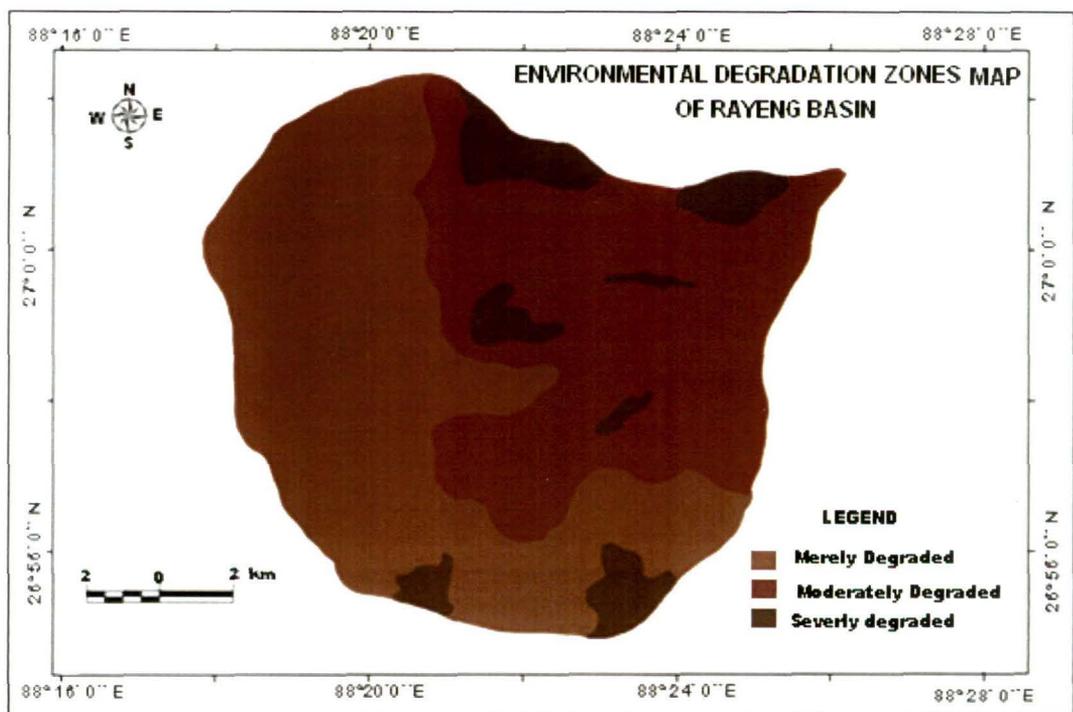
Figure 7.0 Scenario of environmental degradation.

Land use pattern of Rayeng Basin has modified the hydrological regime of the basin. Deforestation in the basin area and introduction of plantation crops in hill areas replacing the natural vegetation reduces the storage capacity of soil and resulted to surface soil erosion in the watershed and sedimentation in Rayeng River. Consequently channel becomes shallower which has altered the flow regime in Rayeng River. Deforestation, agricultural malpractices in the uplands and excessive exploitation of natural resources has increased the rate of erosion, and mass wasting and sedimentation in downstream areas posed serious and constant threats to the overall stability of river regime (Figure.7.0)

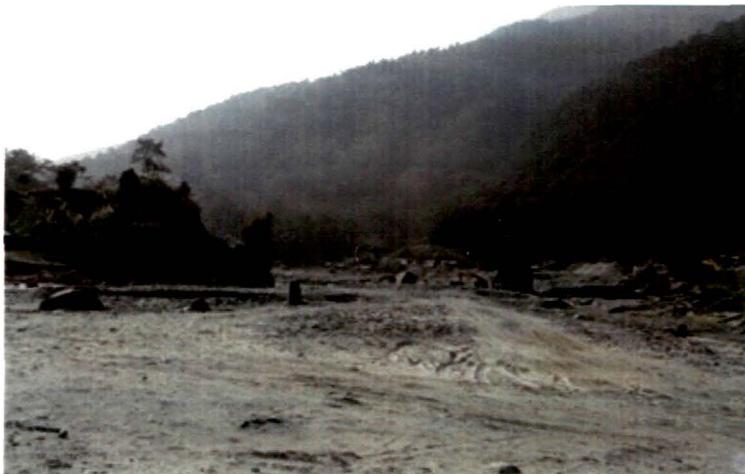
Plate 7.4 Hindrance in flow regime due construction of bridge about 1.5 km away from the confluence of Rayeng.

Construction of bridges and artificial channel diversion at the confluence of the Rayeng River with Tista have been altered the natural flow capacity of this river. Consequently hydrological regimes have been modified (Plate 7.4 & 7.5).

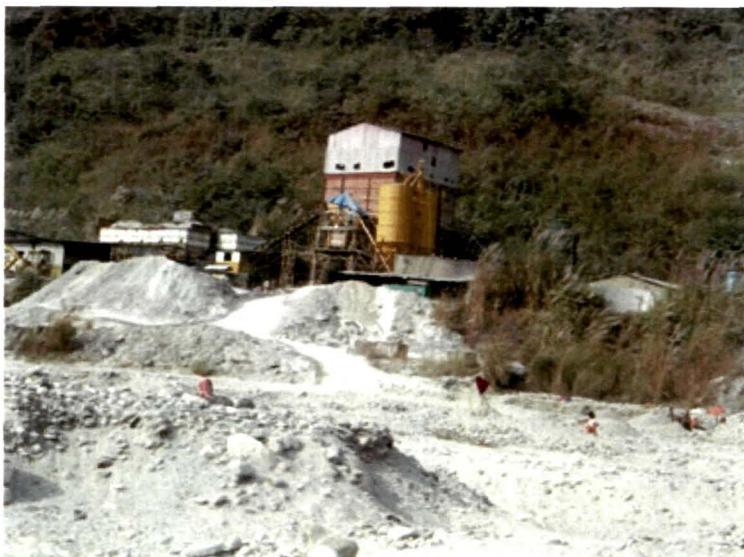
Plate 7.5 Constructional works in the river bed at the confluence of Rayeng River with Tista River altered the character of channel.
