# STUDY OF THE ENVIRONMENTAL GEOMORPHOLOGY IN THE BALASON BASIN, DARJEELING

A Ph. D. Thesis

Submitted by  
Indira Lepcha (nee) Lama,

Department of Geography and Applied Geography  
University of North Bengal  
District: Darjeeling  
West Bengal, India  
734430  
2003

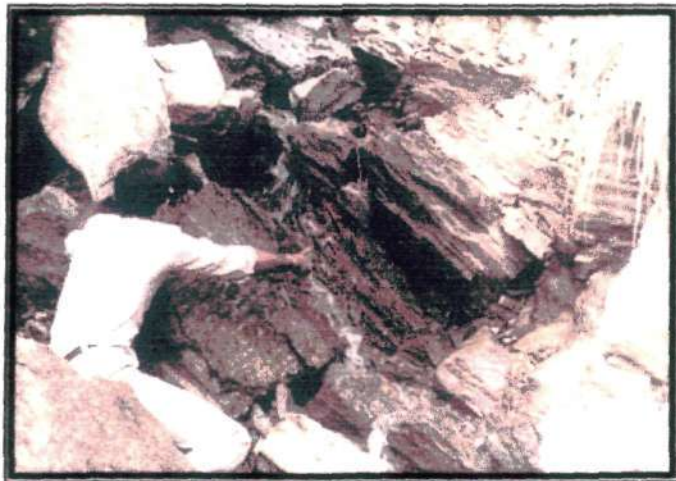
Photo 1.2. Highly jointed Darjiling gneiss

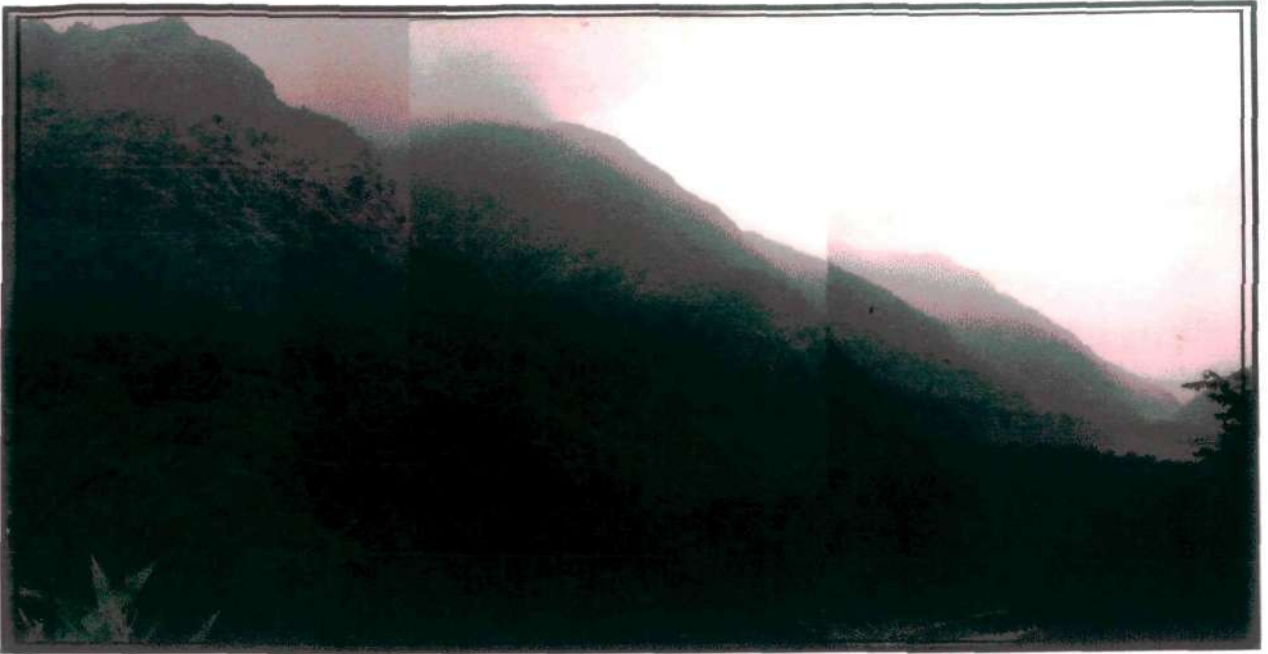
**Photo 2.3 The Bungkulung debris fan : note the Palaeo scars**

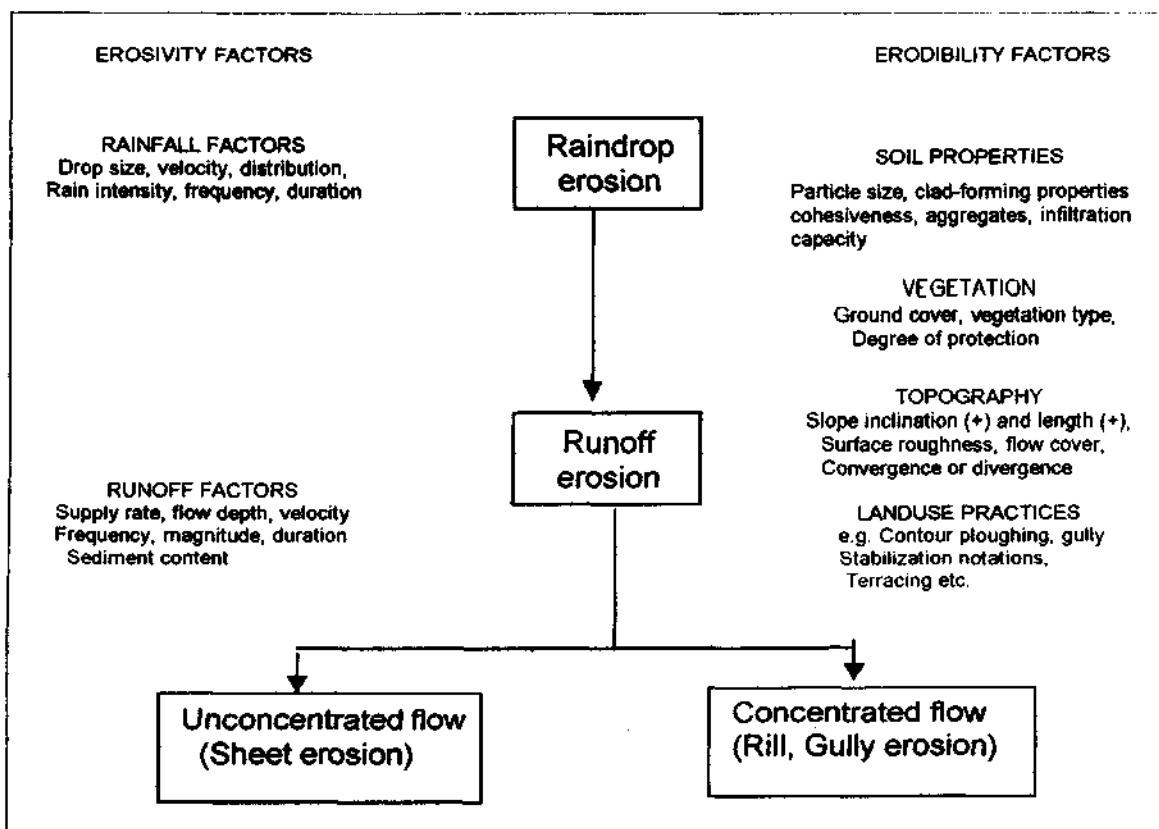
Fig.5.1

### FACTORS IN SOIL EROSION BY WATER

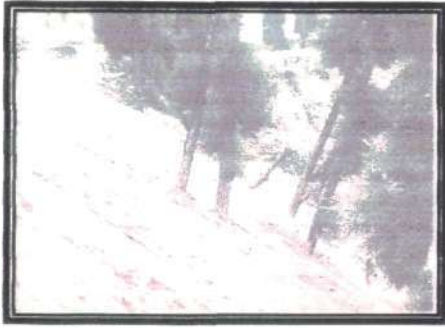
Photo 6.1  
.Soil creep along the Hill Cart Road near Rangbull

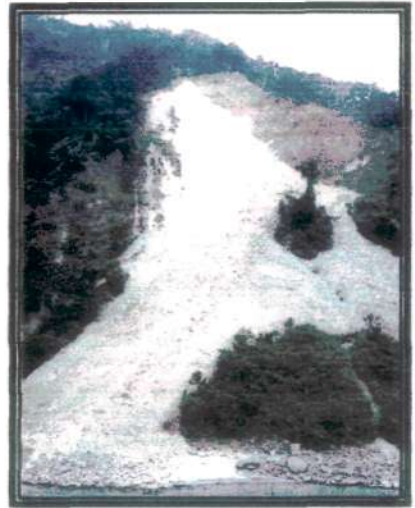
Photo 6.3.  
Debris flow caused by Toe-erosion  
along the Balason valley

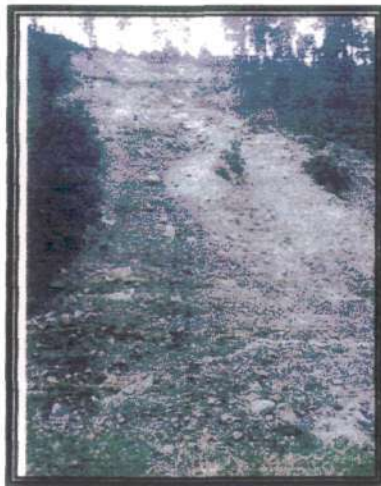
Photo 6.4.  
Pankhabari Landslide

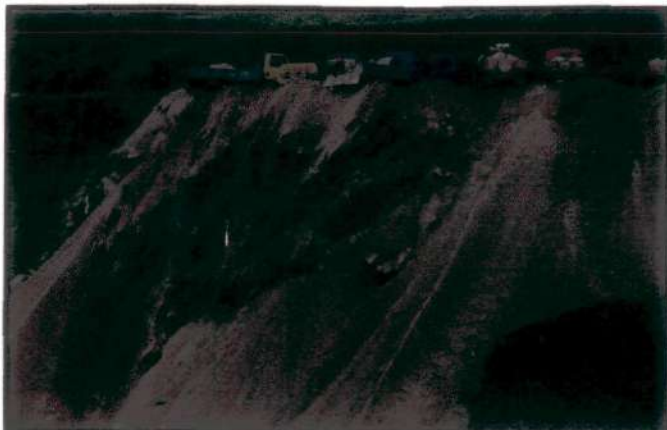
**Photo 9.3 A dumping ground for construction refuse- a future hazard**
