## CHAPTER - VI

### Nature of Intervention

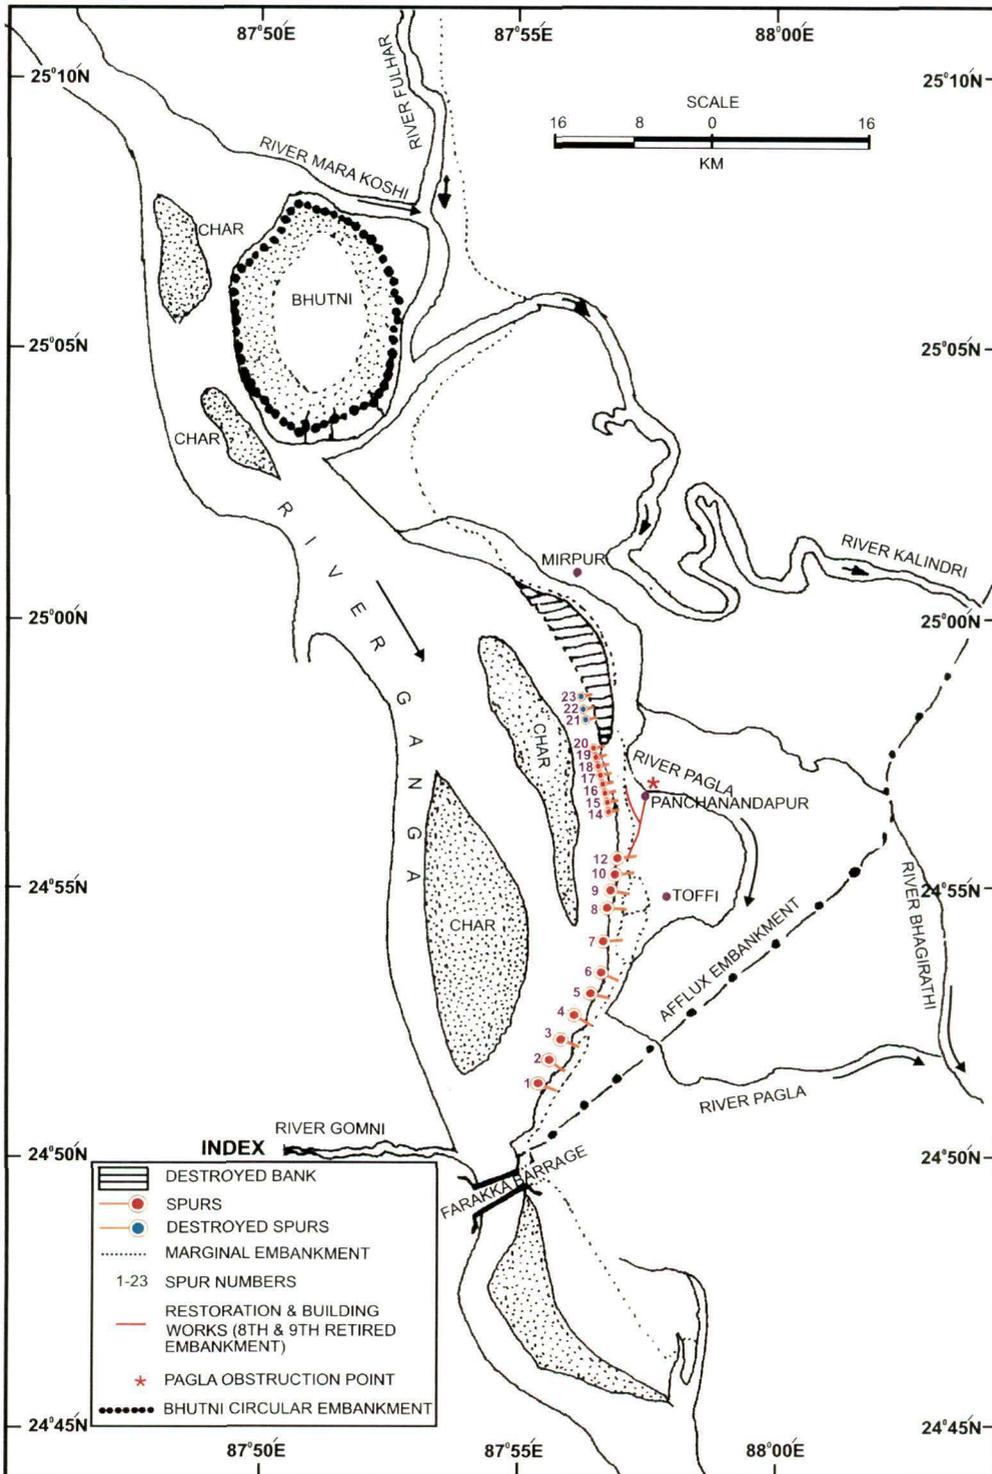
**Figure 6.1** Location of Left Bank Line Spurs of River Ganga in Malda District.

To make out the scenario more prominently the location of the spurs with their identity numbers may thus be presented as in *Fig.6.1*

**SPURS ALONG THE LEFT BANK OF RIVER GANGA**

Source: Based on the Map of Irrigation and Waterways Department, Govt. of West Bengal, 1999 & Field Survey 2011-2012

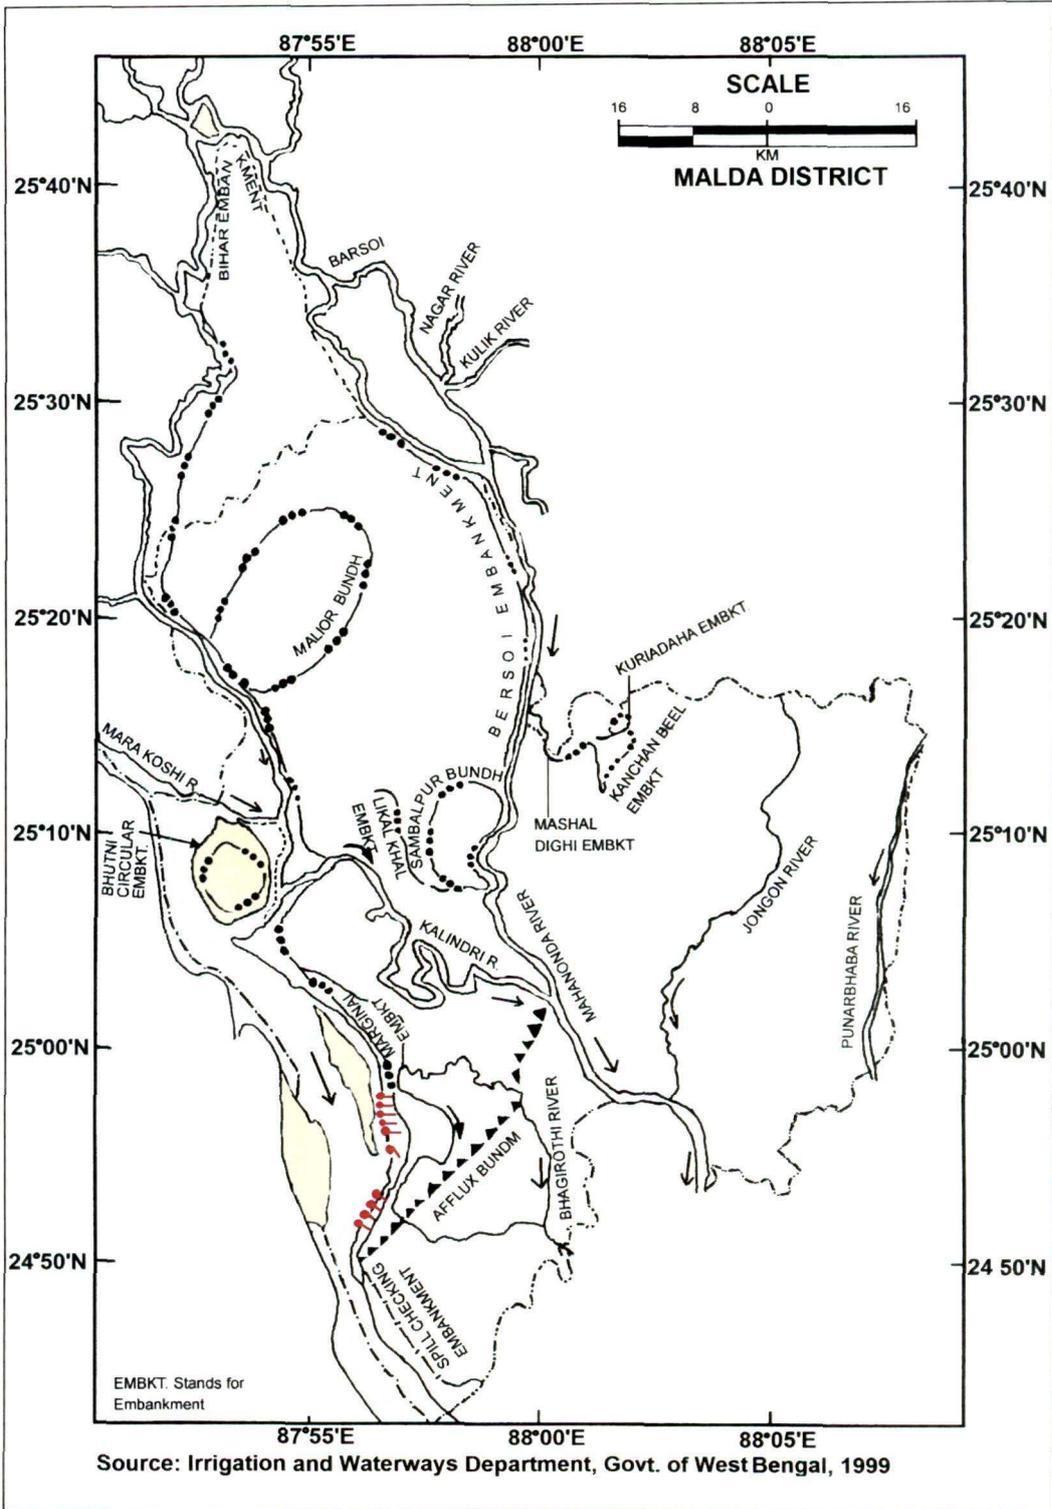
Figure 6.2 Locations of Main Embankments along Left Bank Line of River Ganga in Malda District.

Actually the main embankment here is the eastern Diara Marginal one and the associated retired embankments (*Fig. 6.2*). These are discussed below:

SPURS AND EMBANKMENTS

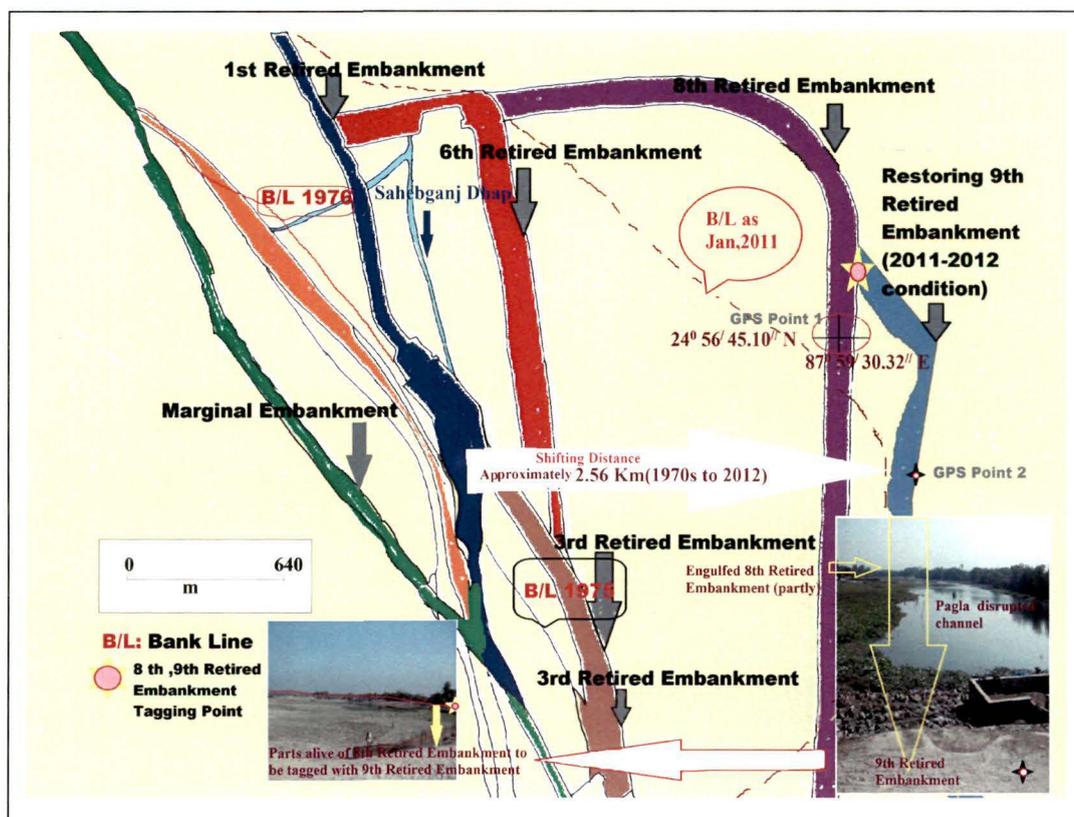
Figure 6.3 a Embankments near Panchanandapur Area.

The location of the last few retired embankments in a comprehensive manner is has been presented latest upto January 2012 in the *fig.6.3 a and b*.

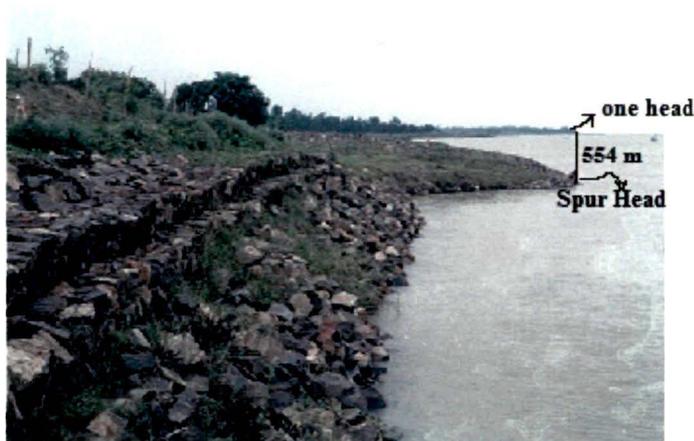
Plate 6.1 Inter spur spacing between Sakullapur-Panchanandapur.

Installation of Manikchak spurs could have placed at least 10 km downstream of Aswinitola to achieve the most possible utility to act as deflecting spur. If the ground pitching of the individual spur is not at a depth at least 20 m, the longevity reduces about 2 to 4 years. Aproning of the sand beds along the bank by iron sheets is needed but which was really a dreamlike plan in Malda in respect of effluences of money. Deflecting spurs should have at best more than  $90^\circ$  in respect of attacking currents. Submersible cameras should be used to view the down pouring of boulder barges. If the launching aproning is inadequate, down pressure will lead to the sub surface undermining more and more, which is a very precise ground reality in Malda.
