CHAPTER V

PROBLEMS RELATED TO SOIL EROSION AND THEIR EFFECTS

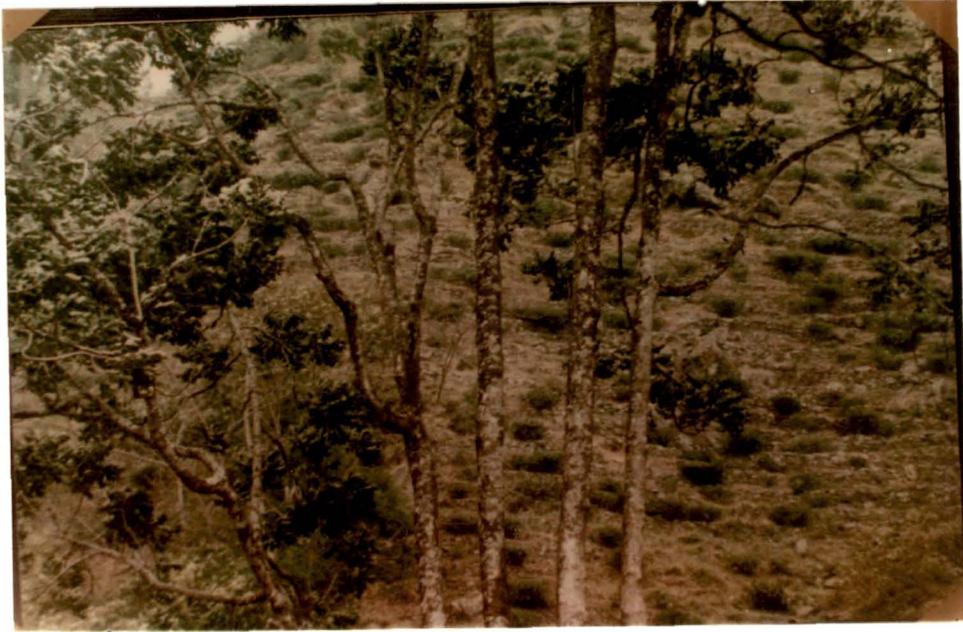
It is seen that several tea gardens have raised tea crops without proper terracing of land. In other cases , even if terraces are made , they are very poorly maintained as in Singel tea garden (Plate 7) and do not provide any protection to soil against run off . Invariably in such tracts the tea bushes are extremely sickly and have very low yields . In some others (Ambootia tea garden) , it is seen that extensive soil working has been done to raise a new plantation without any terracing (Plate 8) . Though the slope is not steep and area is protected from

PLATE 7: POORLY MAINTAINED TERRACES IN TEA GARDEN
(SINGLE TEA ESTATE)

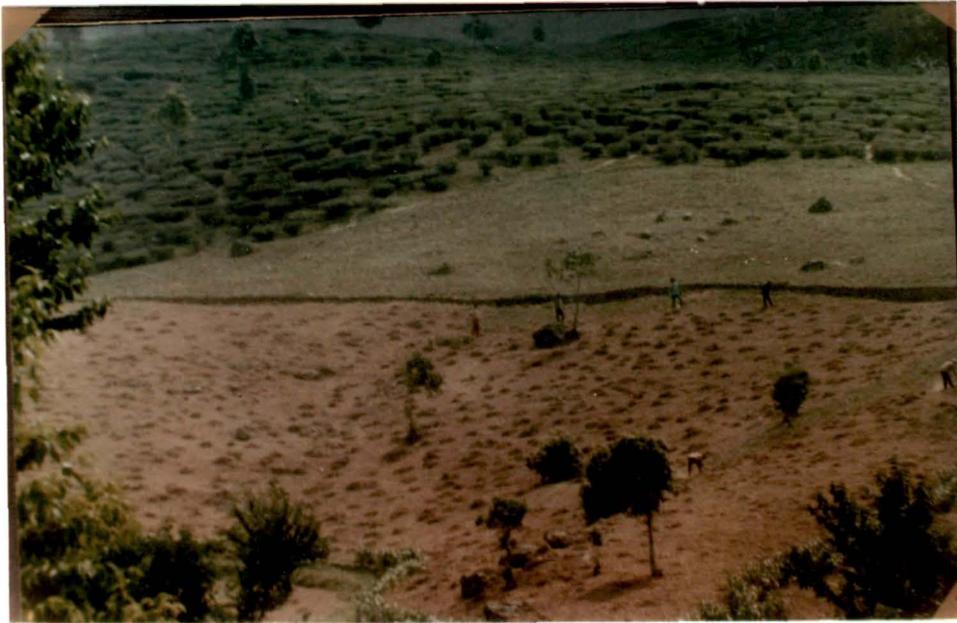
PLATE 8: SOIL WORKING ON SLOPING LAND IN TEA GARDENS
(AMBOOTIA TEA GARDEN)

straw mulch during rains , the soil and nutrient losses are formidable . In agriculture lands , terracing is quite common . But except a few patches on the stretch between Sonada and Ghoom - Jorbunglow , most of terraces are ill maintained and outwardly sloping ones . Since construction and maintenance of terraces is quite costly , it is only the wealthier farmers who are able to afford them . Outward sloping terraces have been seen in and around Gorabari , Dilaram , Tung , Sepoydhura , and Pachim . Among the tea gardens , Cedar , Mandakoti , and Talkat tea gardens are seen having outwardly sloping terraces . Large number of abandoned fields are seen around Gorabari and Pachim , probably , because of low fertility and exposure of rock outcrops due to excessive soil washing . Outward sloping terraces , especially in case of agriculture where intensive soil working is necessary , are instrumental in causing lots of damage by washing down top soil , soil nutrients and soil organic matter . Wherever impounding of water is done for cultivation as for paddy , land slides often result (Plate 6) . This is also seen that no proper arrangement are made for disposal of excess water from terraced fields . Terrace risers get broken here and there and once impounded water is let loose , it goes down breaking a series of them . This results in gullying . Soon landslides over take , devours part of field and renders rest the least fertile and most degraded . Such fields are abandoned as maintaining of terrace risers becomes uneconomical once the top soil is washed .

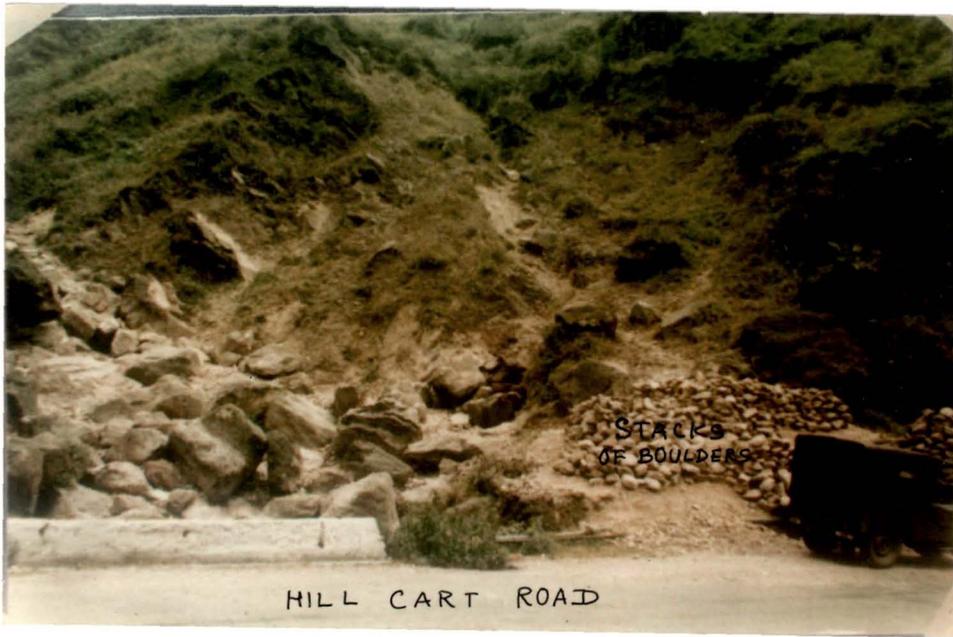
Specific localities where unauthorised quarrying is seen in the study area are large in number . The jhora near Phazi catchpit , meeting river Rinchintong on its left bank , (200 mt down stream from Dilaram factory) is subjected to quarrying . The stretch of Hill Cart road between Gorabari to Rinchintong has several sites of unauthorised quarrying . At the time of survey during November 1993 , about 200 cub. mt. of boulders were seen stacked along the Hill Cart road in this stretch . A site , 100 mt down the road from Dilaram bazaar , is subjected to intensive quarrying . A jhora crossing Hill Cart road , 200 mt north of Tung railway station , too , is subjected to intensive quarrying . So is the case of Chaitapani jhora draining the stretch between Goethal's memorial school and St. Mary's Hill (Plate 9) . On a site 100 mt down the Hill Cart road from Sonada bazaar , a precipitous uphill slope along the road is being quarried dangerously . The Sonā Hollow Block Industry , located on the left bank of Rinchintong jhora on Hill Cart road has been quarrying sand over several decades without any apparent check adding enhanced sediment load in the stream . Near Cedar basti and Pachang bazaar , a few sites of unauthorised quarrying are seen . The list is the least exhaustive . Because of paucity of time and resources , detailed survey could not be undertaken . However , it is believed that unauthorised quarrying has taken very serious dimensions in the study area . There are innumerable spots where

PLATE 9 : UNAUTHORISED QUARRYING ALONG
HILL CART ROAD
STACKS OF BOULDERS SEEN

men and women could be seen breaking boulders into chips and metals for selling . What is even more serious is that , after the loose boulders are exhausted , rock outcrops jutting either in the bed or in the bank are attacked with hammer and chisels . These rock outcrops are the anchors and help transfer the weight of the land mass lying upslope to the deeper strata of earth . When they give way , mass failures occur .

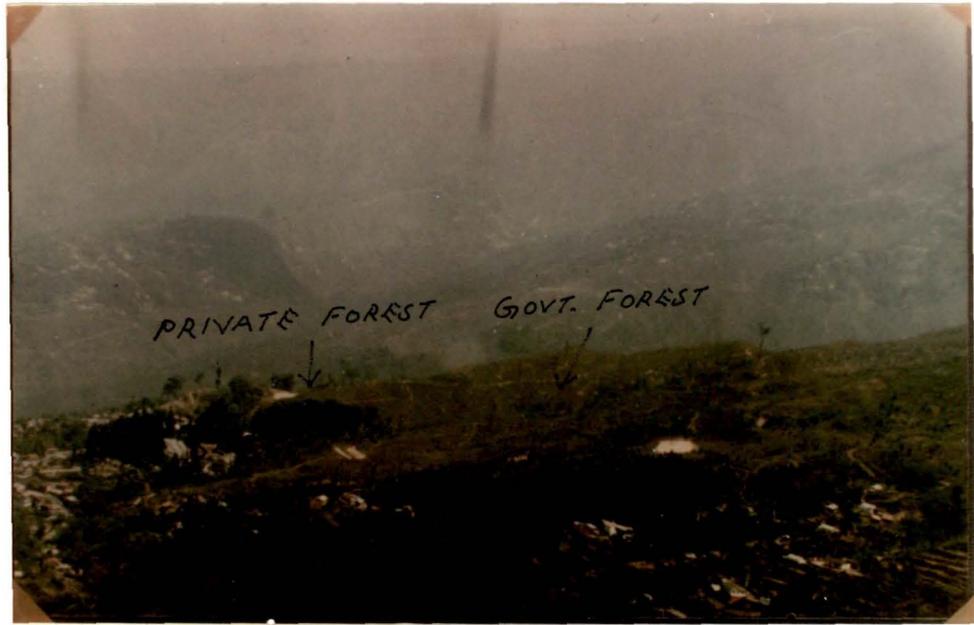
. The Hill Cart road village and the ST. Mary's Khas mahal have high density of 2068 and 2039 persons per km². Among the tea gardens, Maharani is the most and Ambootia the least, populous. Maharani tea garden is located very close to the Mahldram forest, causing spectacular degradation of forests around Sepoydhura, Tung and Dilaram (Plate 10). It is seen that in 1981 the population density for the entire study area is 465 whereas the over all density for the Darjeeling district was 325 (over 143 percent above the average).

PLATE 10: EXTENSIVE DEFORESTATION ABOVE
SEPOYDHURA
